Pit, Below-Grade Tank, or
Proposed Alternative Method Permit or Closure Plan Application

Hilcorp Energy Company
San Juan Basin
Below Grade Tank Closure Report

Lease Name: **Fifield 2**
API No.: **30-045-08688**

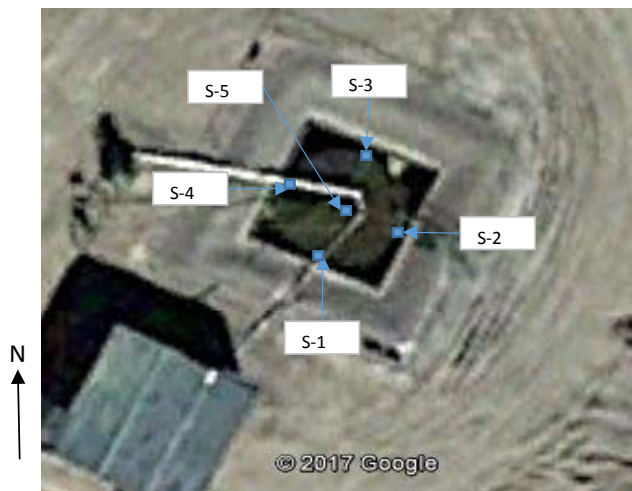
Observations: No excess moisture or staining was observed below the tank.

SC-1 is a 5-point composite of S-1 through S-5, collected 0.5 ft below BGT.

Sample SC-1 was laboratory analyzed for TPH (8015), BTEX (8021) and chlorides (300.0).

On July 13, 2017, following removal of the BGT, Rule personnel conducted a visual inspection for surface/subsurface indications of a release. No excess moisture or staining was observed in the soils below the tank. Rule personnel then collected five soil samples (S-1 through S-5) from 0.5 feet beneath the floor of the BGT excavation. Figure 2 provides the location of the soil samples collected from below the BGT. The field work summary sheet is attached.

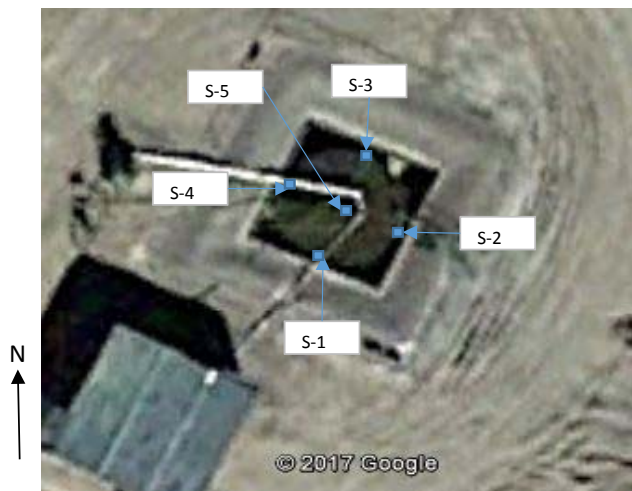
Observations: No excess moisture or staining was observed below the tank.

SC-1 is a 5-point composite of S-1 through S-5, collected 0.5 ft below BGT.

Sample SC-1 was laboratory analyzed for TPH (8015), BTEX (8021) and chlorides (300.0).
