Pit, Below-Grade Tank, or  
Proposed Alternative Method Permit or Closure Plan Application

**Hilcorp Energy Company  
San Juan Basin  
Below Grade Tank Closure Report**

**Lease Name: San Juan 29-5 Unit 68 – BGT 1**

**API No.: 30-039-20712**

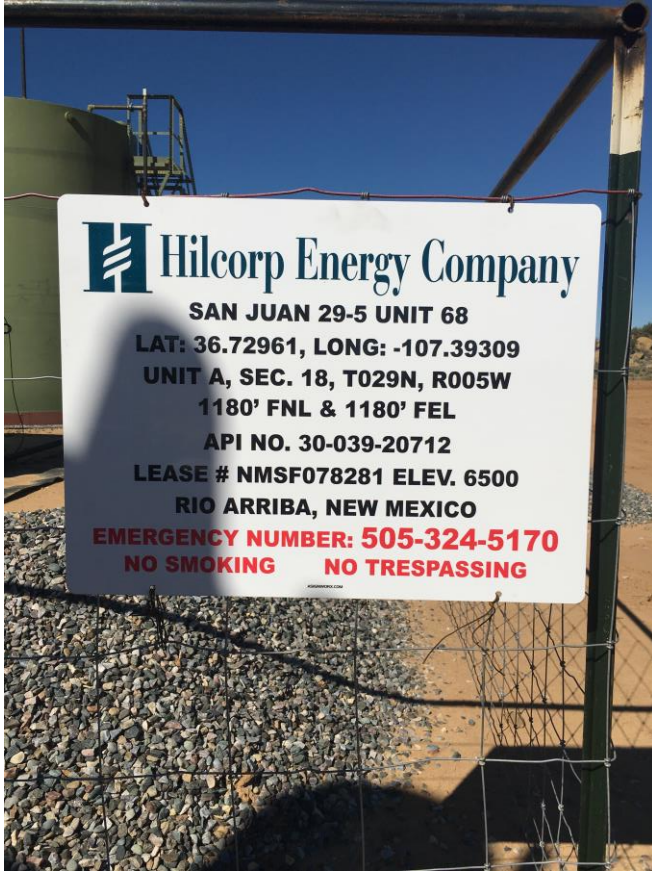
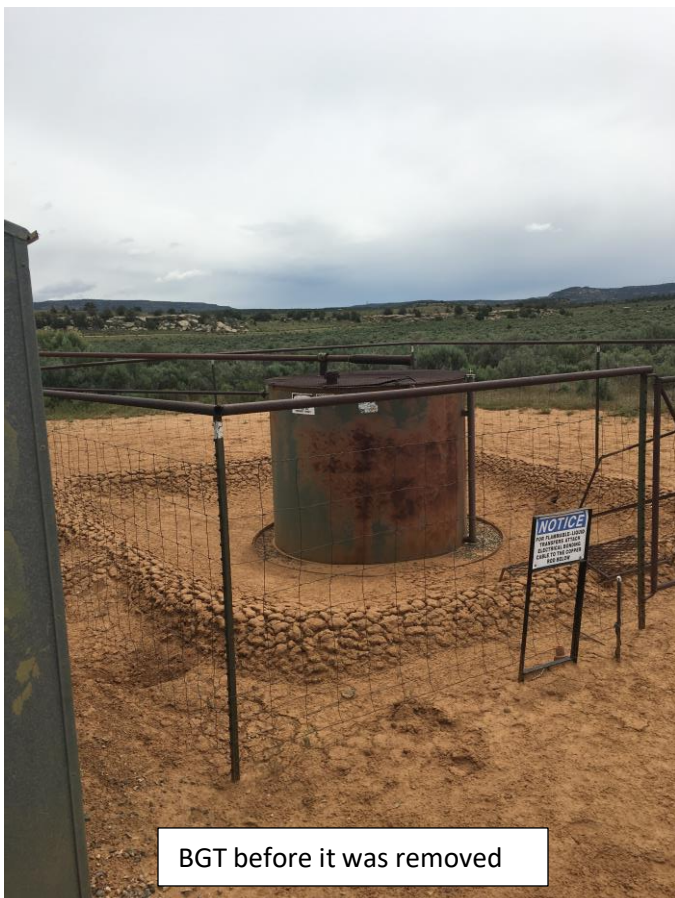
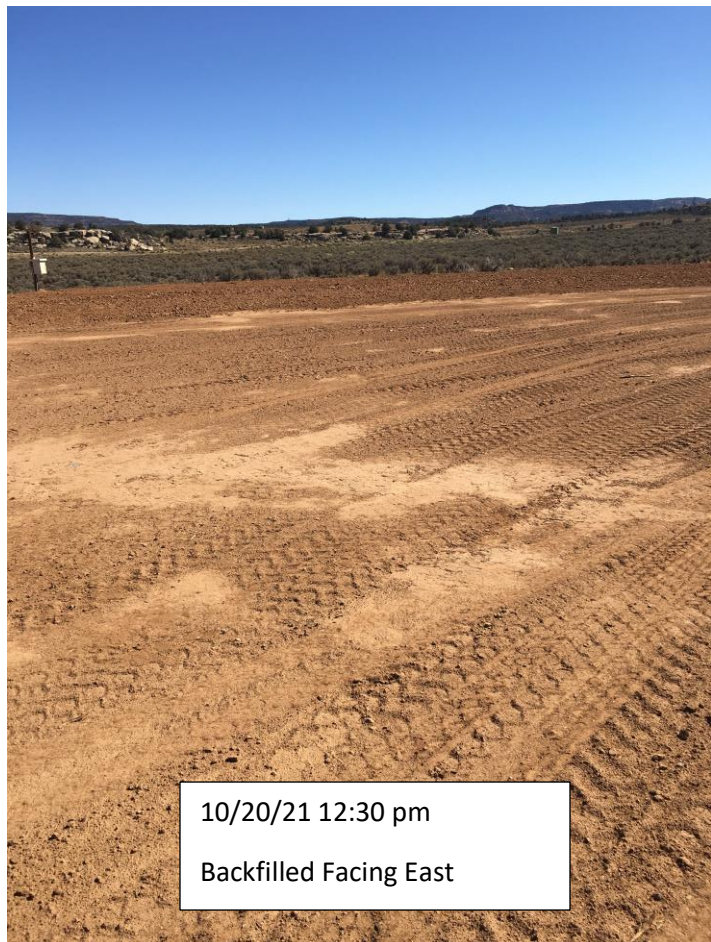
BGT Closure Pictures

**The below-grade tank area passed all requirements of Paragraph (4) of Subsection E of 19.15.17.13 NMAC and was backfilled with compacted, non-waste containing, earthen material.**
