Pit, Below-Grade Tank, or  
Proposed Alternative Method Permit or Closure Plan Application

1.  
Operator: Hilcorp Energy Company OGRID #: 372171  
Address: 382 Road 3100 Aztec, NM 87410  
Facility or well name: San Juan 28-7 Unit 247 West BGT  
API Number: 30-039-21650 OCD Permit Number: \_\_\_\_\_  
U/L or Qtr/Qtr N Section 11 Township 28N Range 7W County: Rio Arriba  
Center of Proposed Design: Latitude 36.67111 Longitude -107.54539 NAD83  
Surface Owner: ☒ Federal ☐ State ☐ Private ☐ Tribal Trust or Indian Allotment

R:\Animas 2000\Dropbox\2013 Projects\ConocoPhillips\SJ 28-7 #247\San Juan 28-7 #247 BGT Closure Report 123013.docx

Record Clean Up: Historic BGT Closure

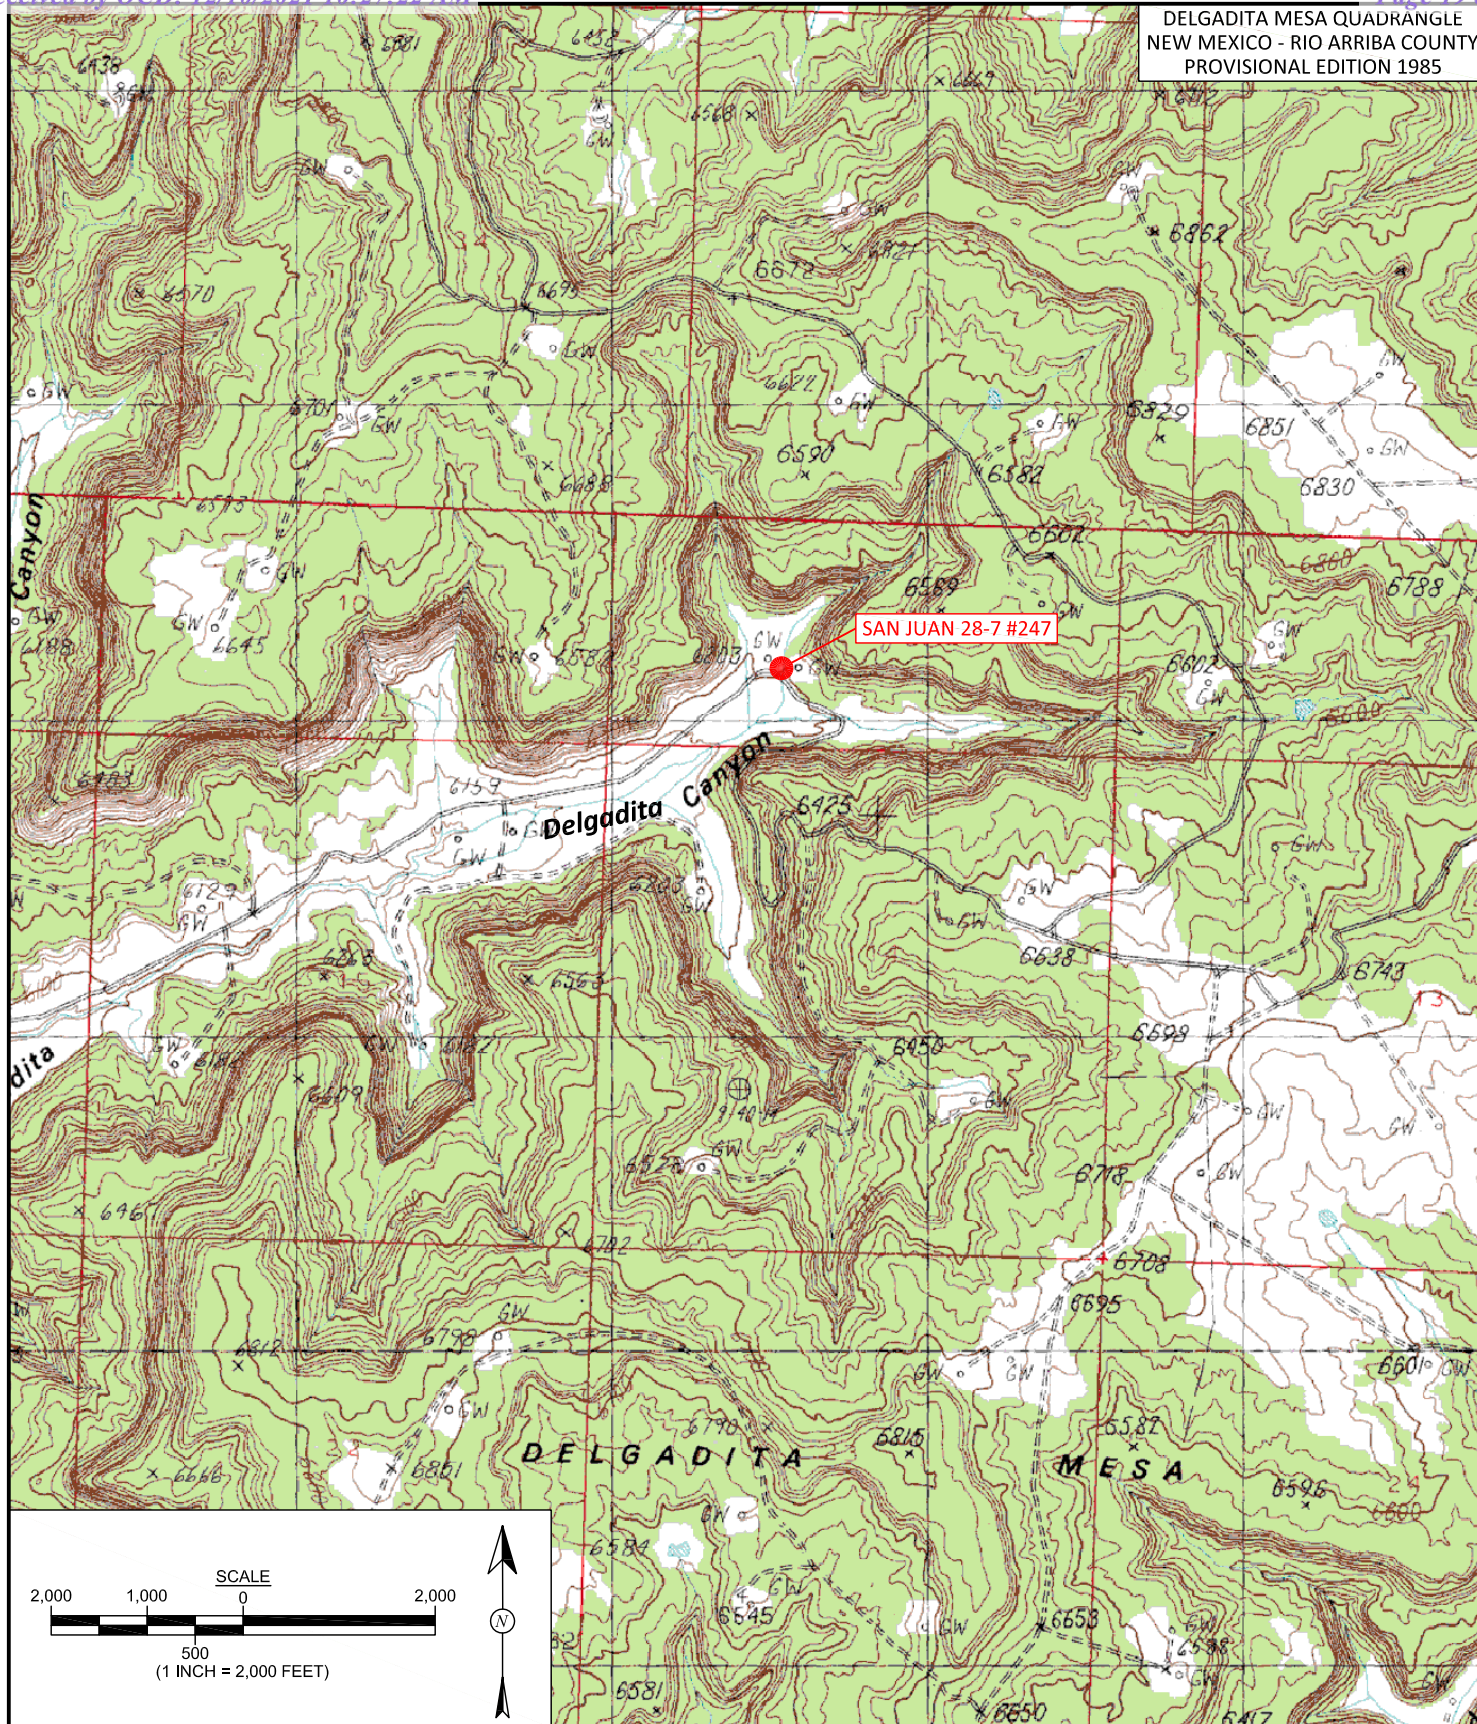
- Figure 1. Topographic Site Location Map
- Figure 2. Aerial Site Map, November 2013
- AES Field Screening Report 111513
- AES Field Screening Report 111913
- Hall Analytical Report 1311703
- Hall Analytical Report 1311862

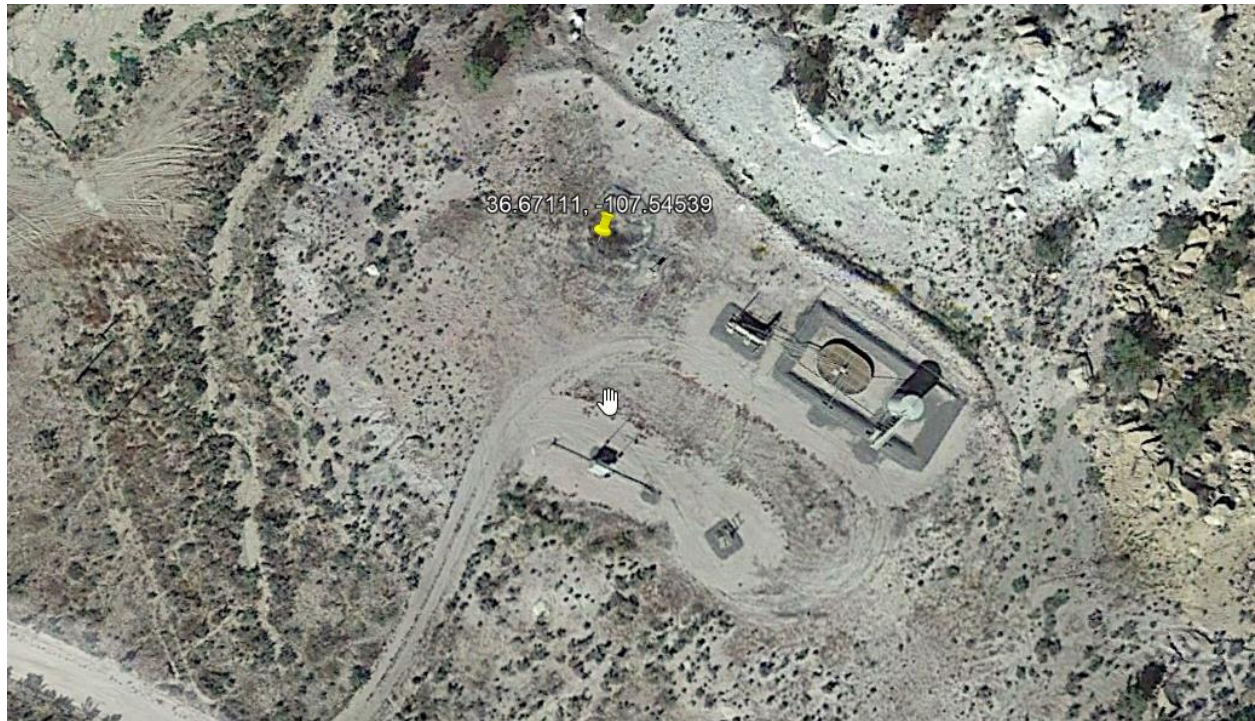
BGT was closed out in 2013 but a C-144 BGT closure permit was never filed. Below is a current image of the BGT closure site.
