Pit, Below-Grade Tank, or  
Proposed Alternative Method Permit or Closure Plan Application

1.  
Operator: Hilcorp Energy Company OGRID #: 372171  
 Address: 382 Road 3100 Aztec, NM 87410  
 Facility or well name: San Juan 28-7 Unit 58A – West Tank  
 API Number: 30-039-23983 OCD Permit Number: \_\_\_\_\_  
 U/L or Qtr/Qtr D Section 29 Township 28N Range 7W County: Rio Arriba  
 Center of Proposed Design: Latitude 36.63792 Longitude -107.60345 NAD83  
 Surface Owner:  Federal  State  Private  Tribal Trust or Indian Allotment

West BGT Closure

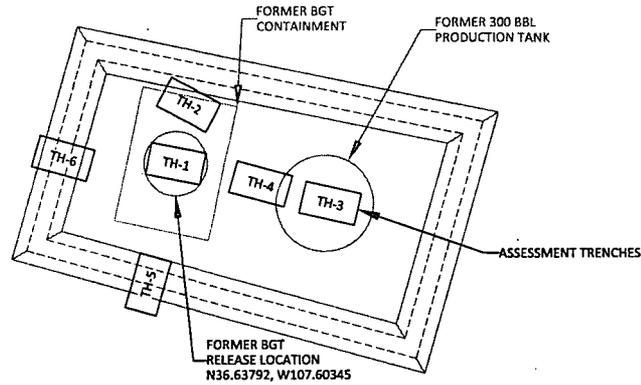
Field Screening Results				
Sample ID	Date	Depth (ft)	OVM-PID (ppm)	TPH (mg/kg)
<b>NMOCD ACTION LEVEL</b>		<b>100</b>	<b>100</b>	
TH-1	3/5/13	10	55.7	124
		12	4.6	<20.0
TH-2	3/5/13	5	1.2	28.9
		9	0.6	NA
TH-3	3/5/13	1.5	1.5	NA
		4.5	2.7	NA
		8	1.6	NA
TH-4	3/5/13	4.5	0.5	<20.0
		9	1.2	NA
TH-5	3/5/13	4	0.2	<20.0
		9.5	0.1	NA
TH-6	3/5/13	4	0.5	NA
		9	2.7	<20.0

FORMER BGT

On March 5, 2013, AES conducted an initial assessment associated with a historical release discovered during BGT closure confirmation sampling. Action levels for releases are determined by the NMOCD ranking score per *NMOCD Guidelines for Leaks, Spills, and Releases* (August 1993), and the site was assigned a ranking of 30. Field screening results for VOCs via OVM were below the NMOCD action level of 100 ppm in each sample, with the highest concentration of 55.7 ppm reported in TH-1. Field TPH concentrations above the NMOCD action level of 100 mg/kg were reported in TH-1 (124 mg/kg).

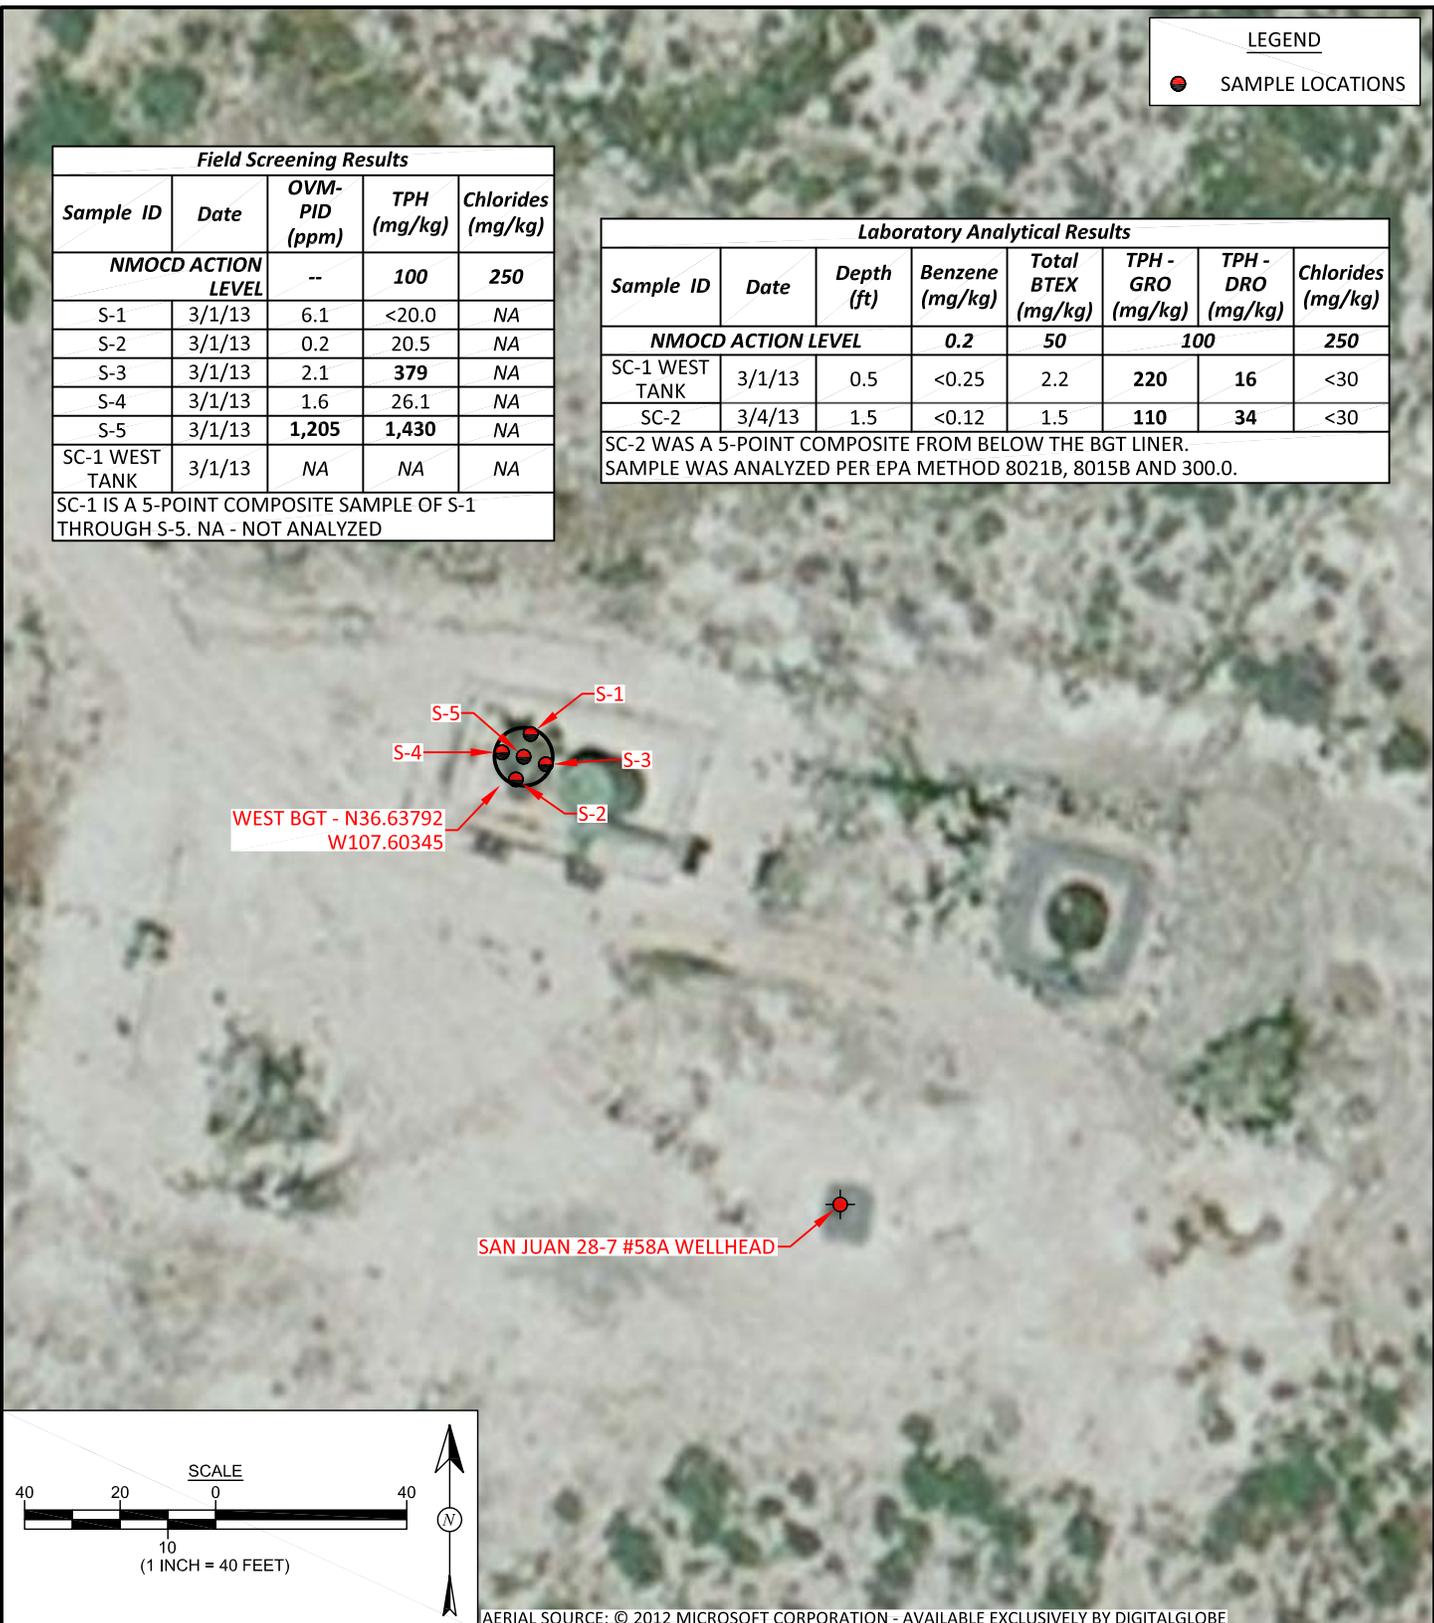
**FIGURE 2**

Laboratory Analytical Results							
Sample ID	Date	Depth (ft)	Benzene (mg/kg)	Total BTEX (mg/kg)	TPH - GRO (mg/kg)	TPH - DRO (mg/kg)	Chlorides (mg/kg)
<b>NMOCD ACTION LEVEL</b>			0.2	50	100	250	
SC-1 WEST TANK	3/1/13	0.5	<0.25	2.2	220	16	<30
SC-2	3/4/13	1.5	<0.12	1.5	110	34	<30

SC-2 WAS A 5-POINT COMPOSITE FROM BELOW THE BGT LINER. SAMPLE WAS ANALYZED PER EPA METHOD 8021B, 8015B AND 300.0.

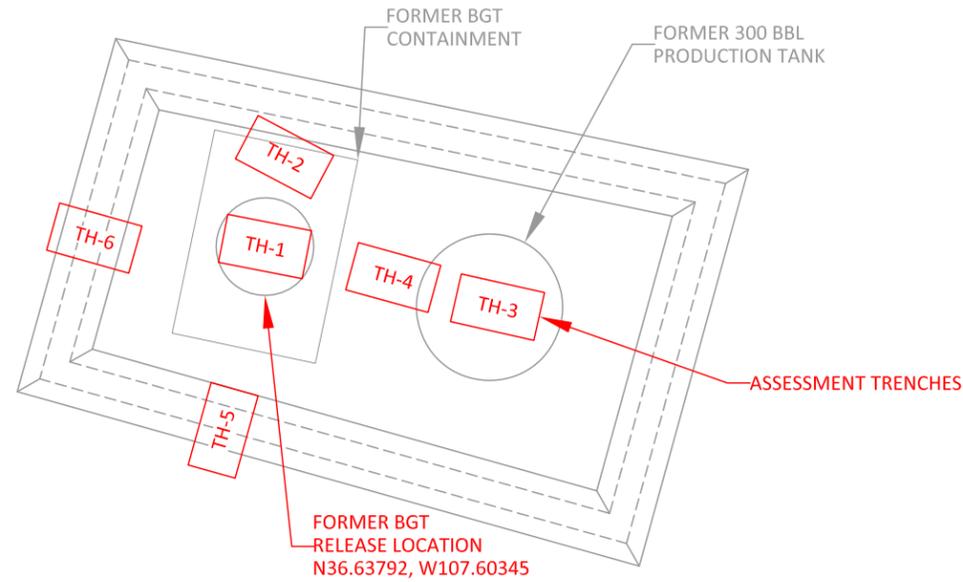
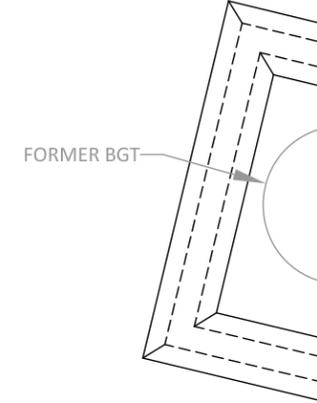
**FIGURE 3**

On March 5, 2013, AES personnel completed the release assessment field work. The assessment included collection and field screening of 13 soil samples from six test holes (TH-1 through TH-6). Based on field screening results, AES recommended excavation of the release area. Sample locations are shown on Figure 3.

Field Screening Results				
Sample ID	Date	Depth (ft)	OVM-PID (ppm)	TPH (mg/kg)
<b>NMOCD ACTION LEVEL</b>			<b>100</b>	<b>100</b>
TH-1	3/5/13	10	55.7	124
		12	4.6	<20.0
TH-2	3/5/13	5	1.2	28.9
		9	0.6	NA
TH-3	3/5/13	1.5	1.5	NA
		4.5	2.7	NA
		8	1.6	NA
TH-4	3/5/13	4.5	0.5	<20.0
		9	1.2	NA
TH-5	3/5/13	4	0.2	<20.0
		9.5	0.1	NA
TH-6	3/5/13	4	0.5	NA
		9	2.7	<20.0

**INITIAL ASSESSMENT SAMPLE LOCATIONS AND RESULTS MARCH 2013**  
 ConocoPhillips  
 SAN JUAN 28-7 #58A  
 NW¼ NW¼, SECTION 29, T28N, R7W  
 RIO ARRIBA COUNTY, NEW MEXICO  
 N36.63769, W107.60322

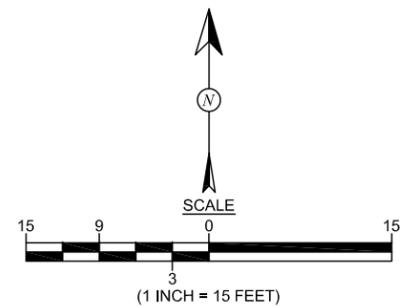
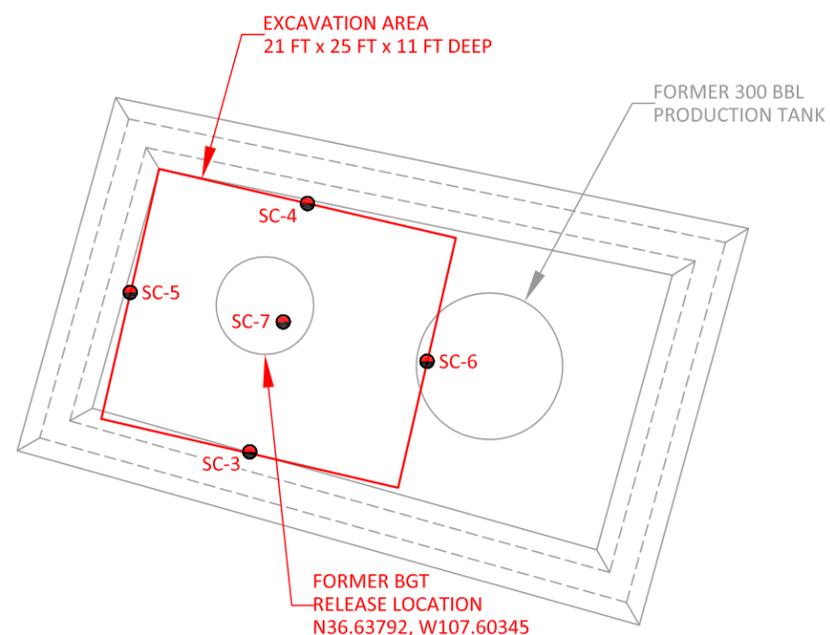
**FIGURE 4**

**FINAL EXCAVATION SAMPLE LOCATIONS AND RESULTS  
JUNE 2013**

Field Screening Results				
Sample ID	Date	Depth (ft)	OVM-PID (ppm)	TPH (mg/kg)
<b>NMOCD ACTION LEVEL</b>			<b>100</b>	<b>100</b>
SC-3	6/18/13	1 to 11	2.1	55.2
SC-4	6/18/13	1 to 11	2.2	82.7
SC-5	6/18/13	1 to 11	2.3	74.4
SC-6	6/18/13	1 to 11	2.5	48.3
SC-7	6/18/13	11	2.5	49.7

ALL SAMPLES WERE COMPOSITE SAMPLES.

On June 18, 2013, final assessment of the excavation area was completed. Field screening results of the excavation showed that concentrations of VOCs and TPH were below NMOCD action levels for each of the final four walls and base of the excavation. No further work is recommended for the San Juan 28-7 #58A west BGT release area.

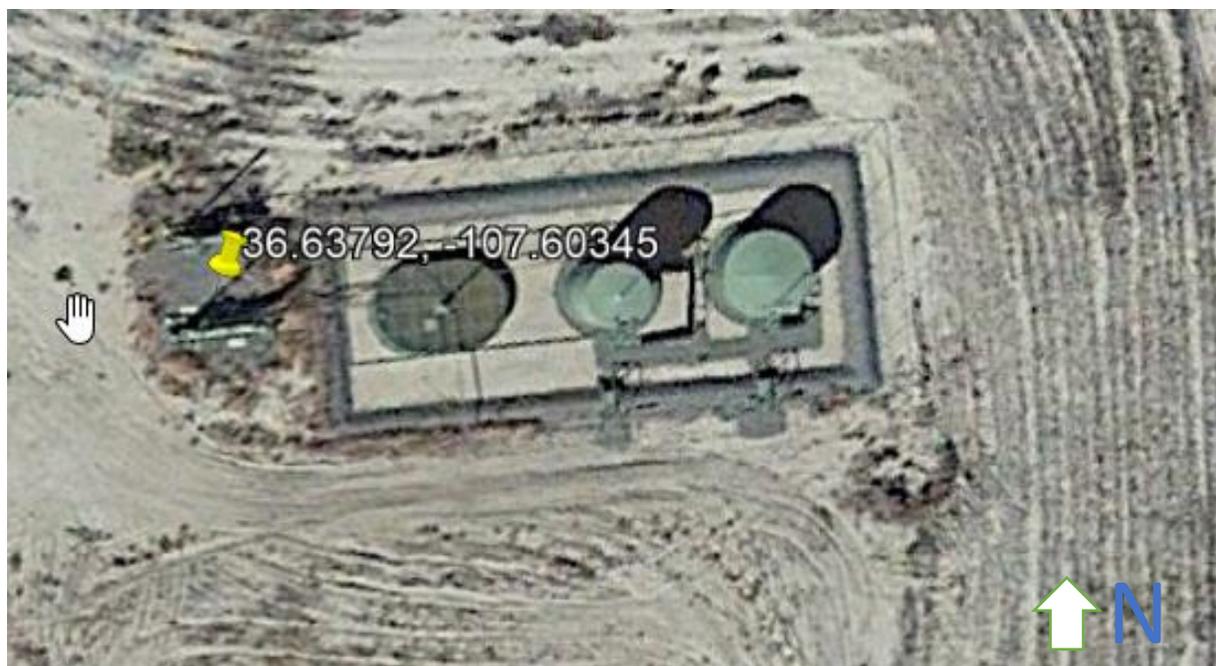
Historic BGT Closure Document clean-up. West BGT was closed 3/1/2013 but C-144 Closure document was never filed. Below is a current aerial shot of the BGT location. Location currently has a AGT.
