Pit, Below-Grade Tank, or Proposed Alternative Method Permit or Closure Plan Application

SIMCOE LLC (Previously BP America)
SAN JUAN BASIN, NORTHWEST NEW MEXICO
Gallegos Canyon Unit 021
Tank ID A
Unit Letter M, Section 18, T28N, R12W

Below-Grade Tank Closure Plan

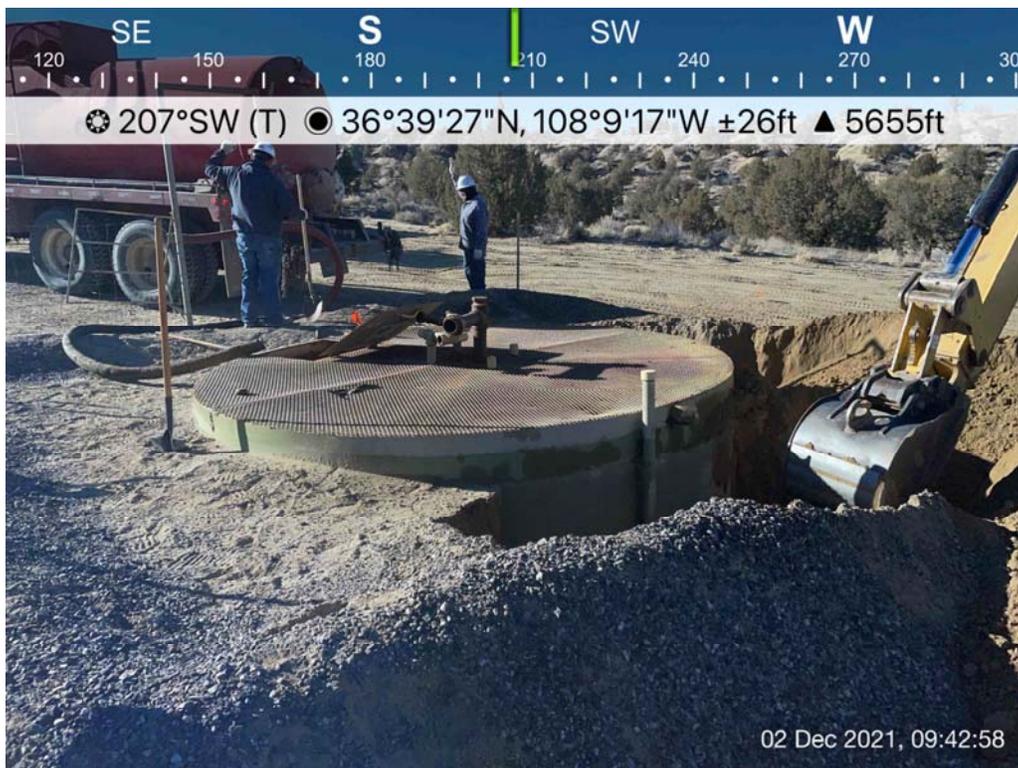
Photo 2: 95 bbls steel tank "A" during removal, 12/2/2021.

4. Simcoe, LLC shall remove the BGT and dispose of it in a NMOCD approved facility or recycle, reuse, or reclaim it in a manner that the NMOCD approves. If a liner is present and must be disposed of it will be cleaned by scraping any soils or other attached materials on the liner to a de minimus amount and disposed at a permitted solid waste facility, pursuant to Subparagraph (m) of Paragraph (1) of Subsection C of 19.15.35.8 NMAC. Documentation as to the final disposition of the removed BGT will be provided in the final closure report. **The tank was transported for reuse or recycling. No liner present.**

5. Simcoe, LLC shall remove any on-site equipment associated with a BGT unless the equipment is required for well production. **Equipment associated with the tank was removed.**

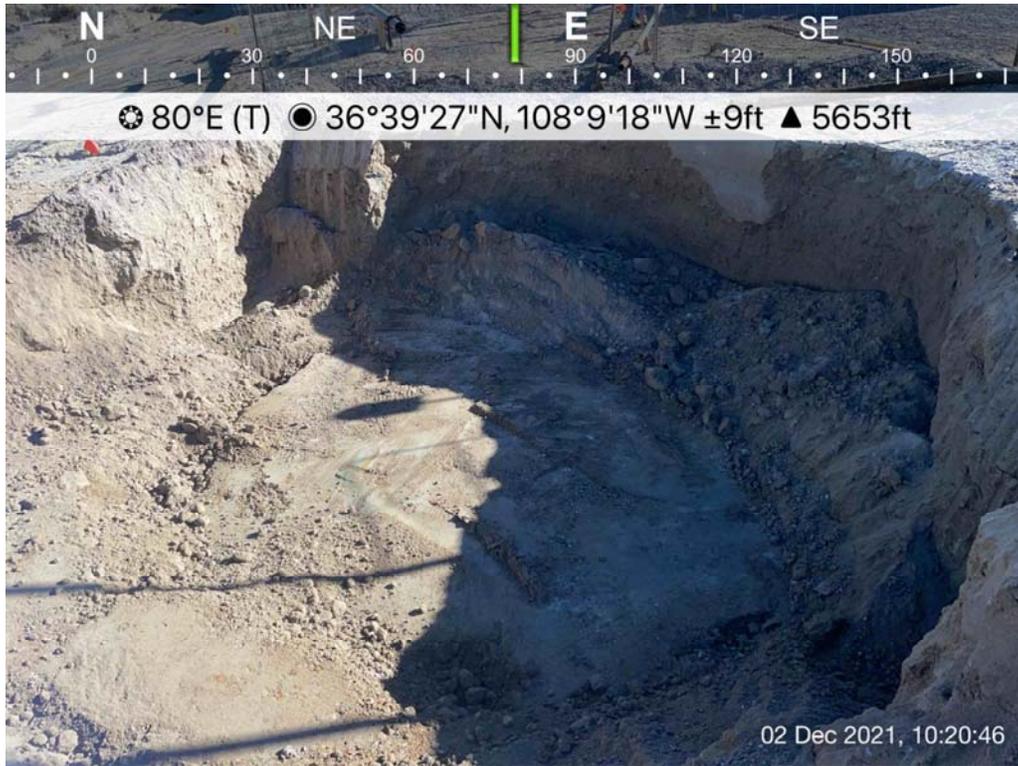
Photo 3: Former location of 95 bbls steel tank “A” following removal, 12/2/2021.

Soil beneath tank sampled for TPH, BTEX, and Chloride. TPH and BTEX were non-detect and chloride was below current NMOCD standard for BGT closures and releases.

7. Simcoe, LLC shall notify the division District III office of its results on form C-141. **Form C-141 is attached.**
8. If it is found that a release has occurred, then Simcoe, LLC will comply with 19.15.30 NMAC and 19.15.29 NMAC, as appropriate. **No evidence of a release. See attached C-141.**

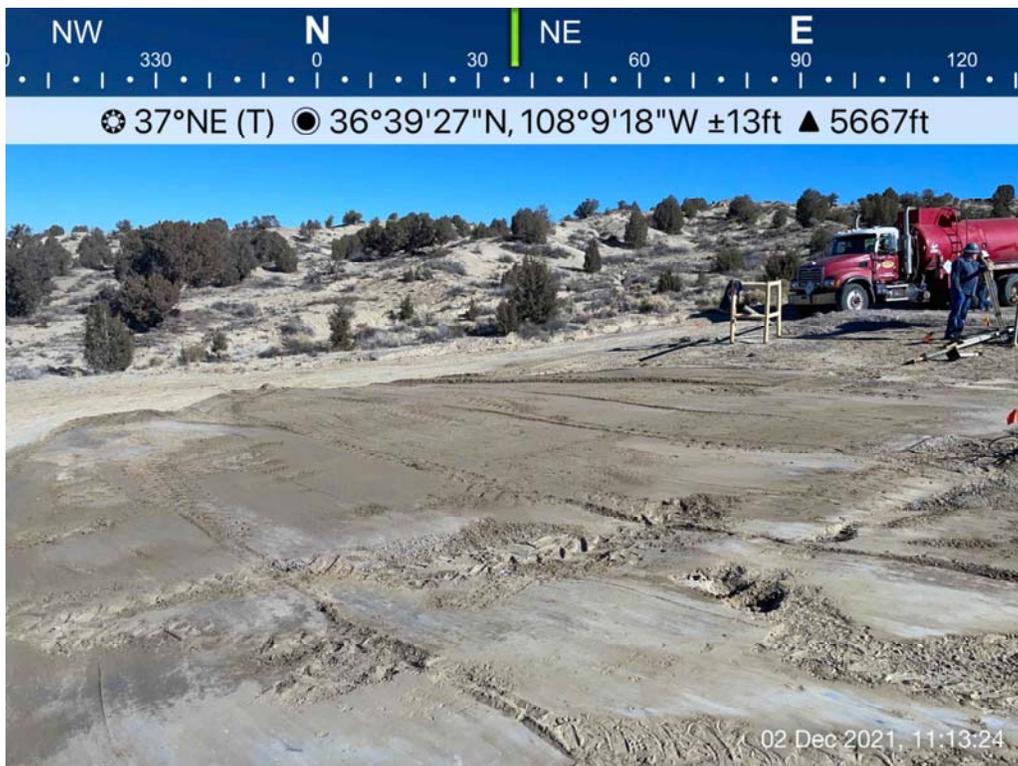
Photo 4: Former location of 95 bbls steel tank “A” following removal and re-grading, 12/2/2021.

9. If the sampling demonstrates that a release has not occurred or that any release does not exceed the concentrations specified above, then BP shall backfill the excavation, with compacted, non-waste containing, earthen material; construct a division-prescribed soil cover, re-contour and re-vegetate the location. The location will be reclaimed if it is not within the active process area. **No evidence of a release. Area was backfilled/re-graded. AST to be installed at location of former BGT.**

10. Simcoe, LLC shall reclaim the BGT location, and all areas associated with the BGT including associated access roads to a safe and stable condition that blends with the surrounding undisturbed area. Simcoe, LLC shall substantially restore the impacted surface area to the condition that existed prior to oil and gas operations by placement of the soil cover as provided in Subsection H of 19.15.17.13 NMAC, re-contour the location and associated areas to a contour that approximates the original contour and blends with the surrounding topography and re-vegetate according to Subsection I of 19.15.17.13 NMAC. 11. The soil cover for closures where the BGT has been removed or remediated to the NMOCD's satisfaction shall consist of the background thickness of topsoil or one foot of suitable material to establish vegetation at the site, whichever is greater. **No evidence of a release. Area was backfilled/re-graded. AST to be installed at location of former BGT.**
