Pit, Below-Grade Tank, or
Proposed Alternative Method Permit or Closure Plan Application

**RE: Below Grade Tank Closure Report
Florance #11A
API No. 30-045-22521
San Juan County, New Mexico**

Animas Environmental Services, LLC (AES) is pleased to provide the final closure report for one 45-bbl below grade tank (BGT) under operational control of Harvest Four Corners (Harvest) at the Florance #11A (API #30-045-22521), located in San Juan County, New Mexico. Tank removal and closure sampling was completed by Harvest.

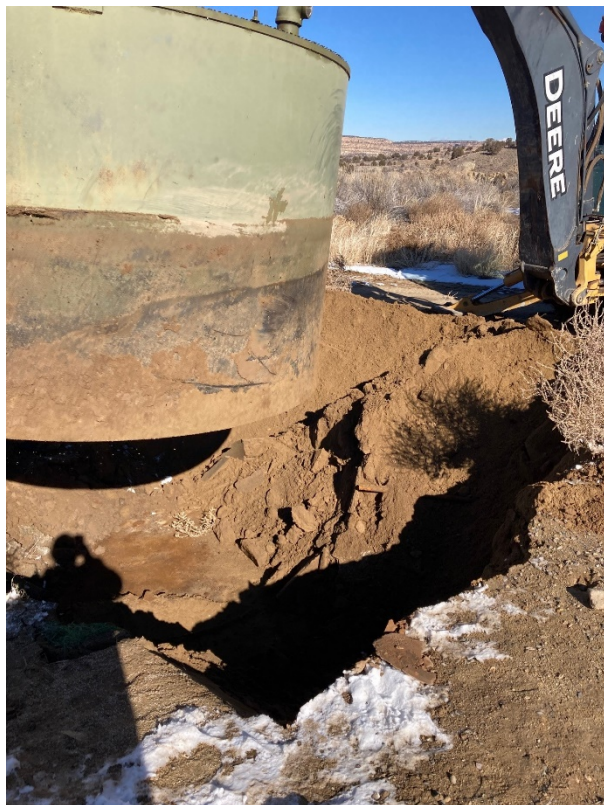
Photo 1: Florance #11A BGT.

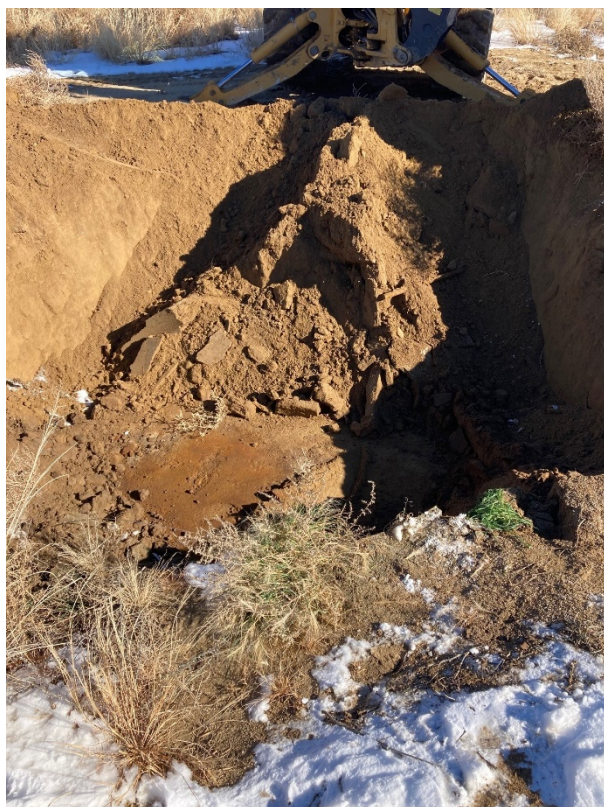
Photo 2: Florance #11A BGT location following removal.

In accordance with standard procedures as outlined in the tank closure plans, Harvest removed any liquids and sludge found within the BGTs within 60 days of their ceasing operations. Liquids and sludge were disposed of only at the NMOCD-approved facilities named in the closure plans. Subsequently, Harvest removed the BGTs. All removed Harvest BGTs are properly disposed of, recycled, or reused in an approved manner. All associated equipment was also removed from the location.

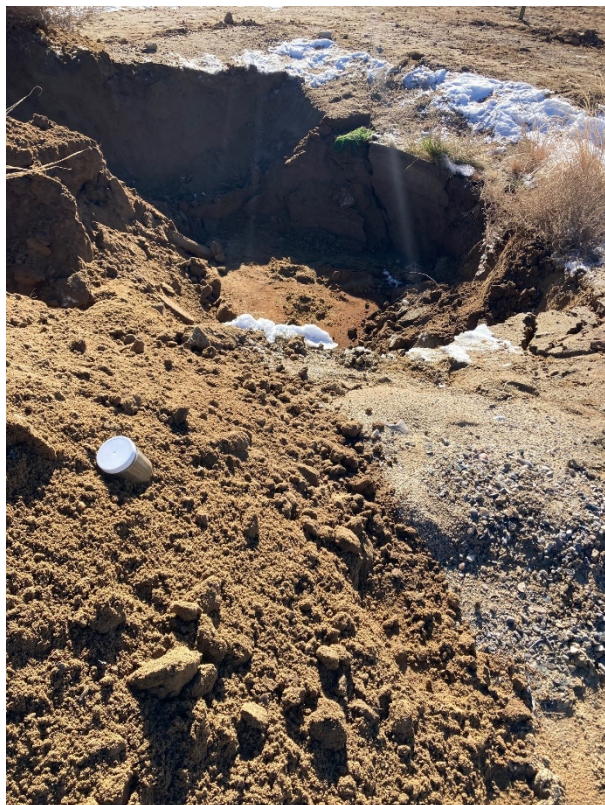
Photo 3: Florance #11A composite soil sample.

On December 17, 2021, in accordance with NMAC 19.15.17.13C(3)(a), Harvest personnel collected one 5-point bottom composite confirmation closure soil sample at the removed BGT footprint.

NMOCD action levels for BGT closures are specified in NMAC 19.15.17.13 Table 1 (2013). Laboratory analytical results for benzene and total BTEX concentrations were below the NMOCD action levels of 10 mg/kg and 50 mg/kg, respectively. Laboratory analytical results (per USEPA Method 8015) reported GRO, DRO, and MRO below the NMOCD action level of 2,500 mg/kg for depths to groundwater between 50 and 100 feet. Chloride concentrations were below the NMOCD action level of 10,000 mg/kg.

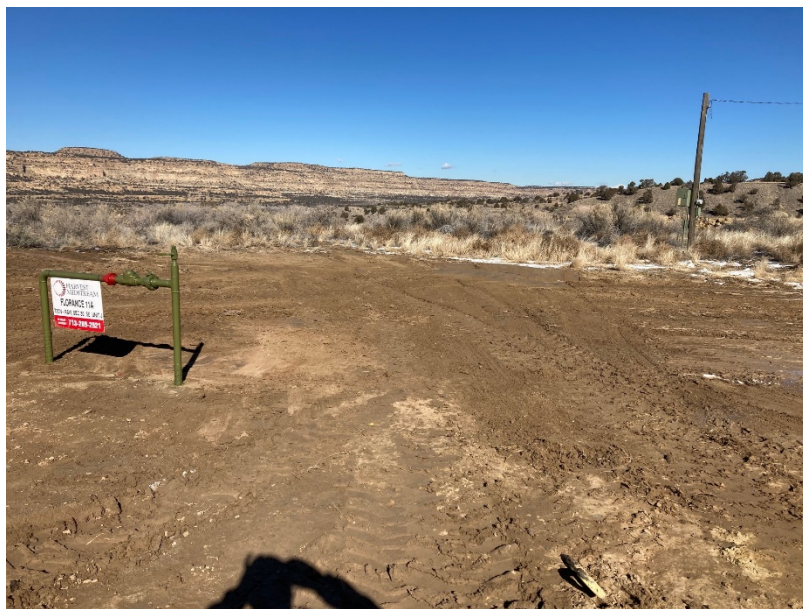
Photo 4: Florance #11A BGT location following backfill.

Based on BGT laboratory analytical results for benzene, total BTEX, TPH, and chloride at the location of the removed Harvest BGT, the site was backfilled with clean soil obtained from on-site. No further work is recommended at the Florance #11A for this Harvest BGT Closure.
