Pit, Below-Grade Tank, or
Proposed Alternative Method Permit or Closure Plan Application

1.
Operator: Harvest Four Corners, LLC OGRID #: 37388
Address: 1755 Arroyo Dr., Bloomfield, NM 87413
Facility or well name: Richardson 11
API Number: 30-045-12178 Richardson #011 – Hilcorp (318679) OCD Permit Number: _____
U/L or Qtr/Qtr NW/NW (D) Section 22 Township 31N Range 12W County: San Juan
Center of Proposed Design: Latitude 36.888632 Longitude -108.089858 NAD83
Surface Owner: Federal State Private Tribal Trust or Indian Allotment

3.
 Below-grade tank: Subsection I of 19.15.17.11 NMAC
Volume: 45 bbl Type of fluid: Produced water
Tank Construction material: Metal
 Secondary containment with leak detection Visible sidewalls, liner, 6-inch lift and automatic overflow shut-off
 Visible sidewalls and liner Visible sidewalls only Other no liner
Liner type: Thickness _____ mil HDPE PVC Other _____

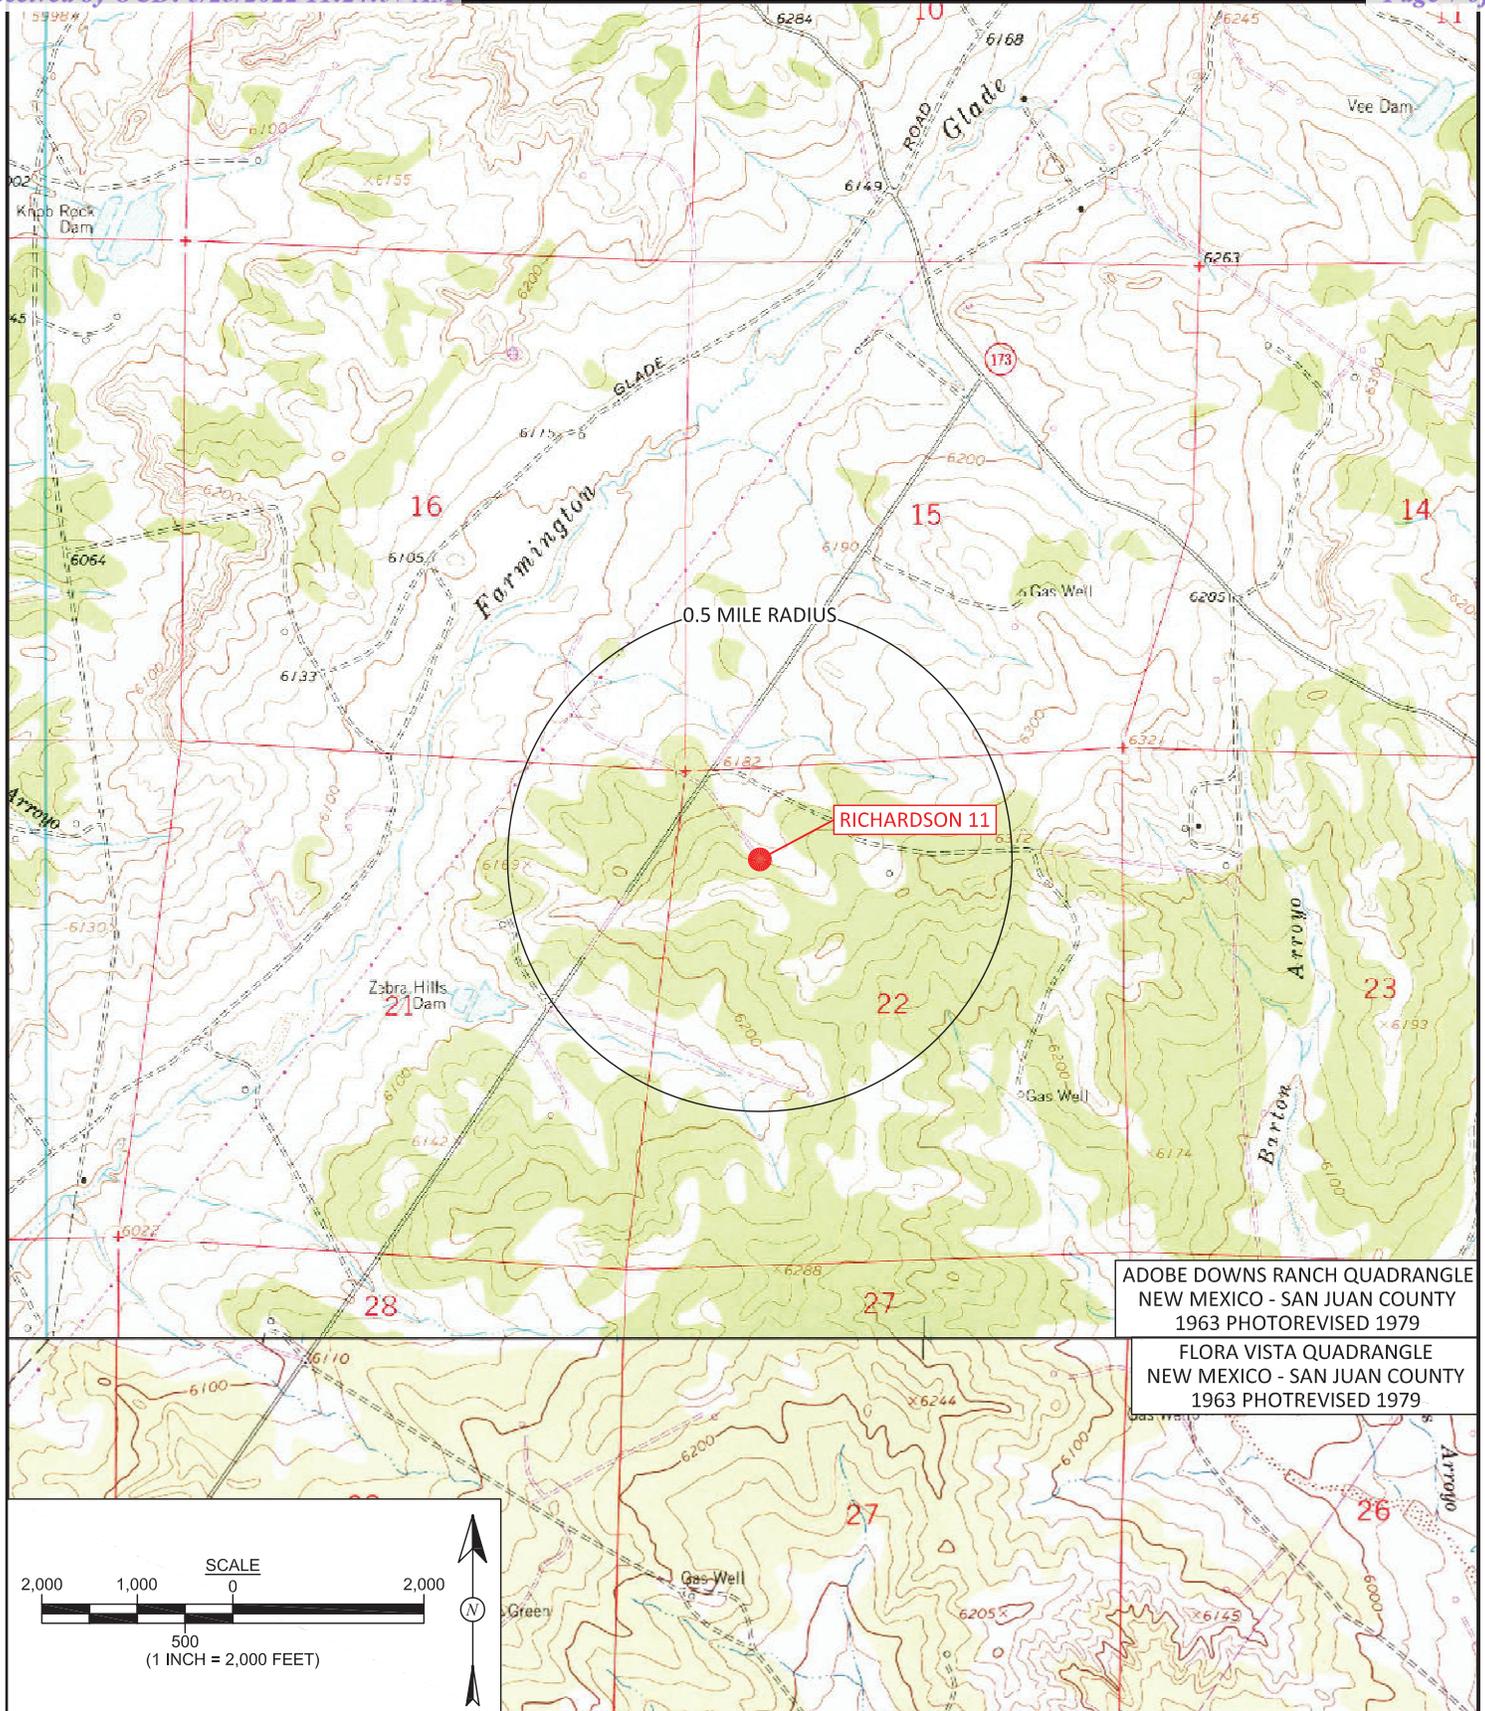
ADOBE DOWNS RANCH QUADRANGLE
 NEW MEXICO - SAN JUAN COUNTY
 1963 PHOTOREVISED 1979

FLORA VISTA QUADRANGLE
 NEW MEXICO - SAN JUAN COUNTY
 1963 PHOTOREVISED 1979

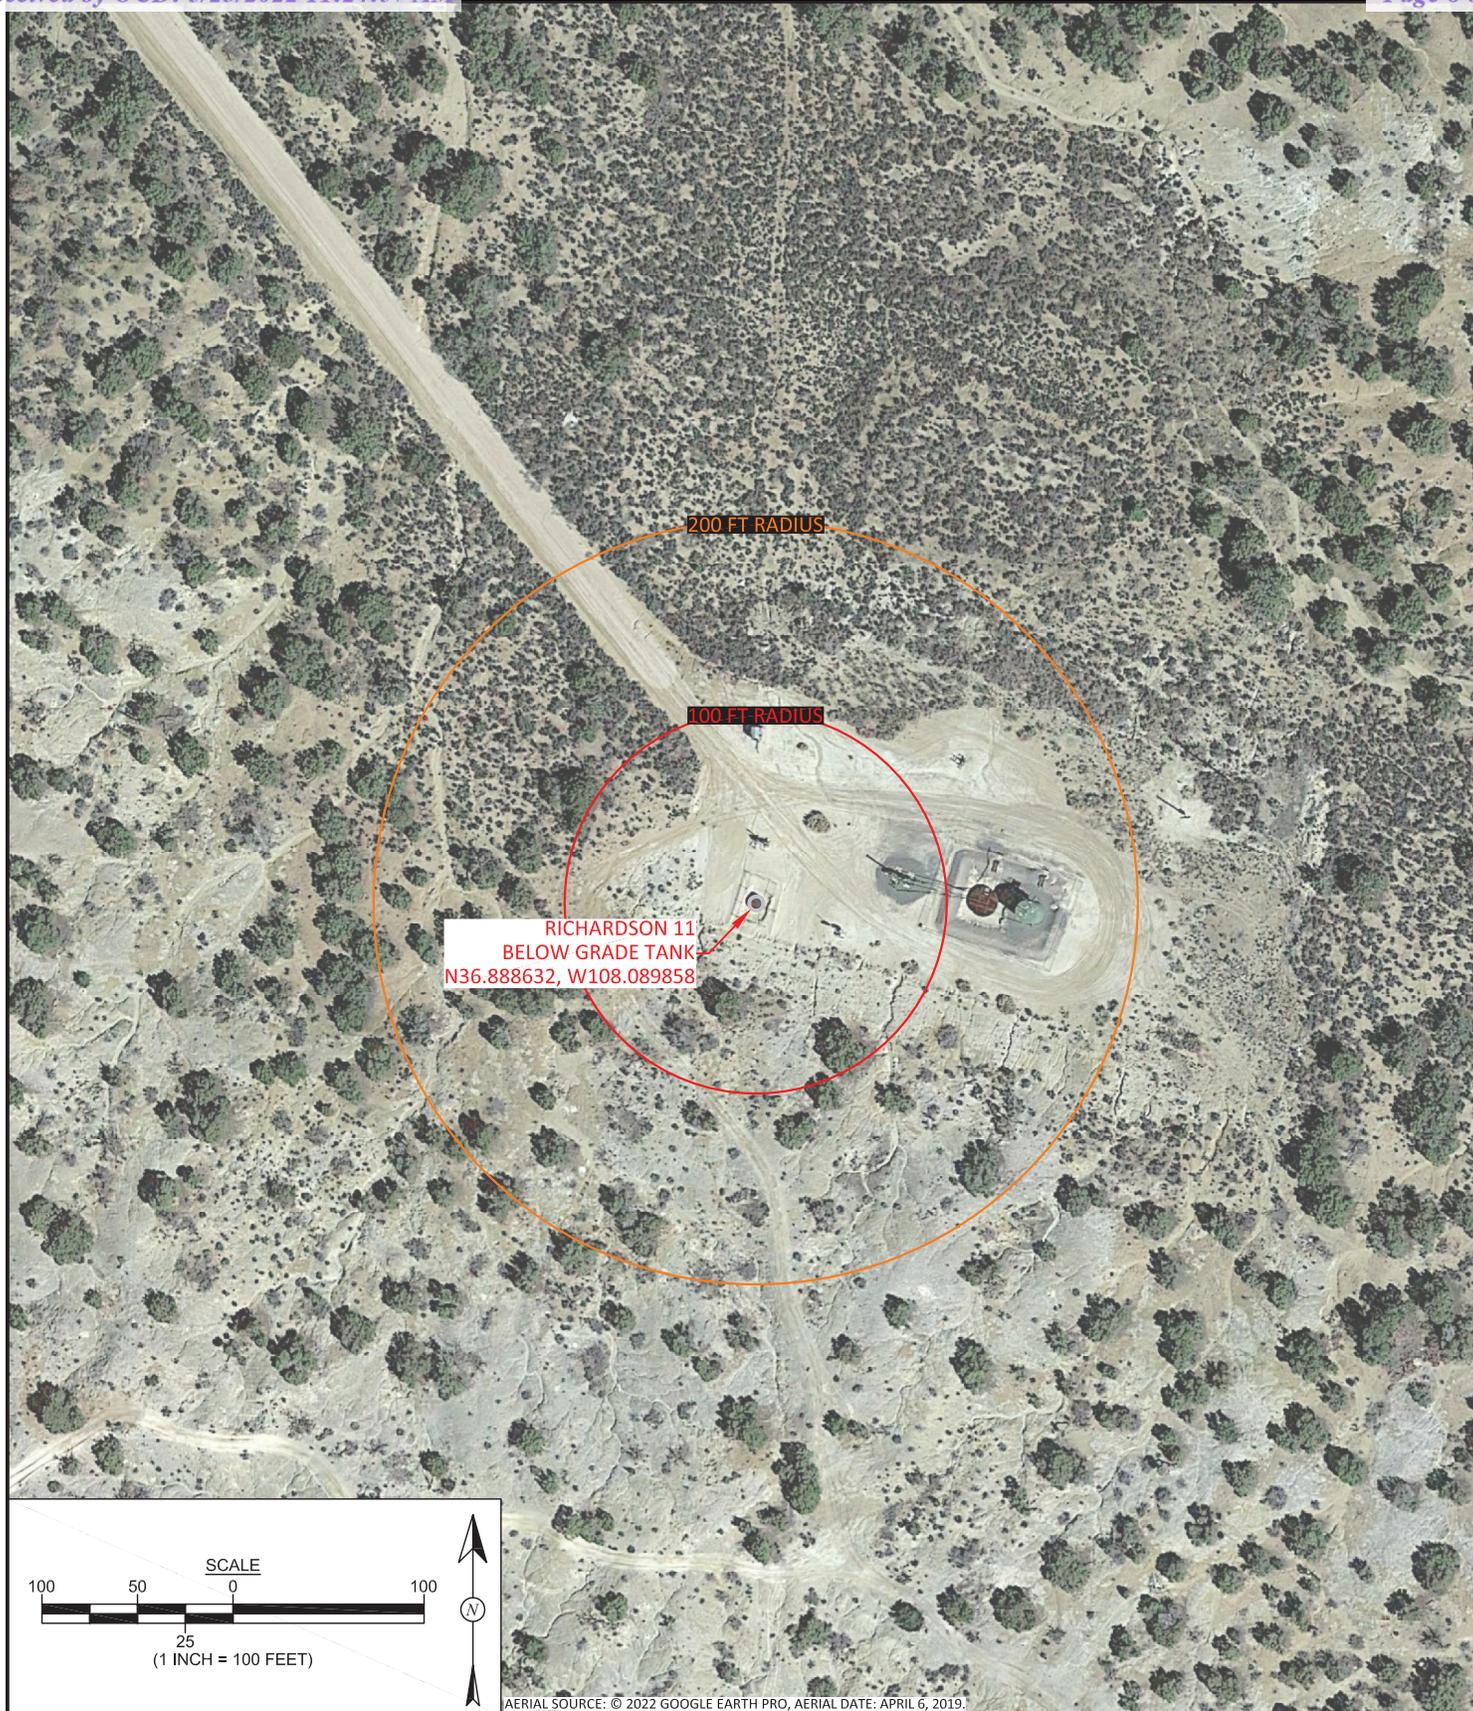
RICHARDSON 11

AERIAL SOURCE: © 2022 GOOGLE EARTH PRO, AERIAL DATE: APRIL 6, 2019.

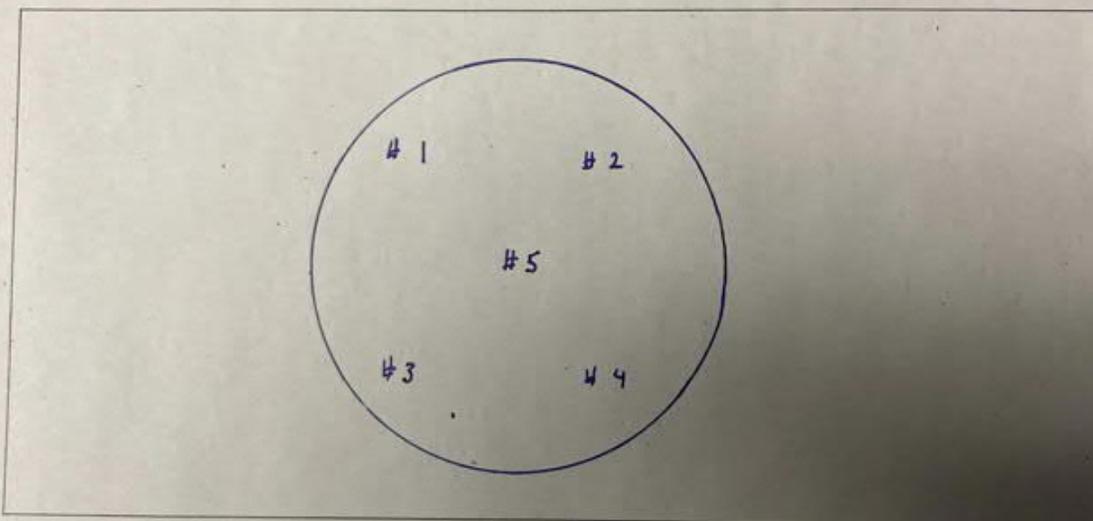
Excavation Diagram and Sample Locations

(Depict notable site features, excavation extents, visual observations, sample locations, north arrow, etc.)
