**Roddy Production Co., Inc.  
San Juan Basin  
Below Grade Tank  
Closure Narrative**

**Well Name: Owen 2A**

**API No.: 30-045-30235**

**Roddy Production Co., Inc.**  
**San Juan Basin**  
**Below Grade Tank (BGT)**  
**Closure Report**

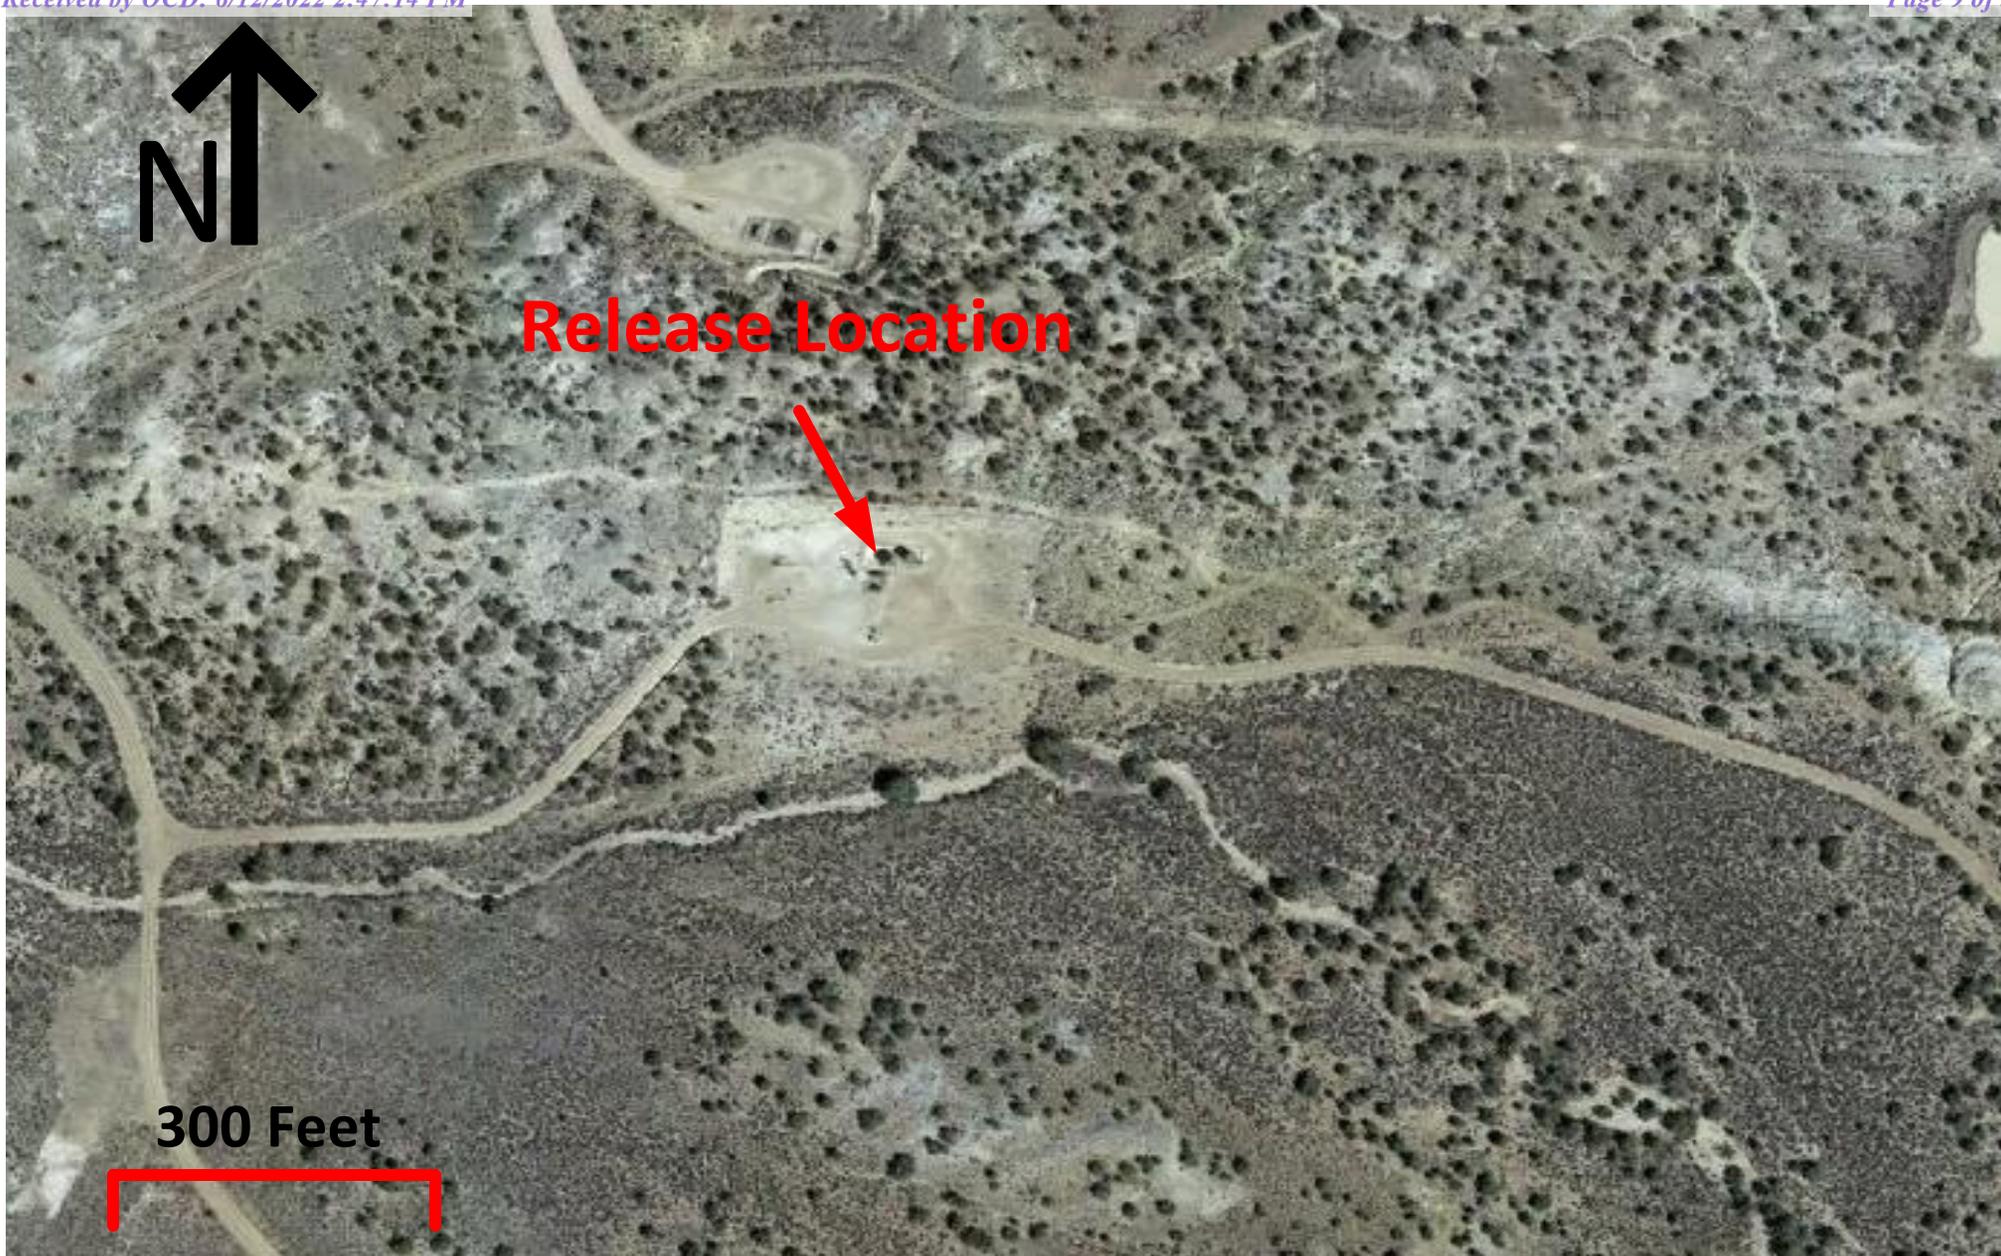
Drawn By: James McDaniel  
Date: 4/20/2022

JAKD Personnel, Roddy Production personnel, Knock-Out Construction and Emanuel Adeloyle with the BLM were on-site for BGT closure activities. Approximately 1 foot of soil was excavated from the BGT cellar beneath the former location of the BGT due to visual salt staining on the surface. A hard sandstone layer was encountered at 3' below ground surface (1' below the BGT bottom), and additional excavation could not take place. A composite sample was collected at 3' below ground surface of the sandstone material beneath the former location of the BGT. The sample was analyzed at Hall Environmental Laboratory.

Time	Sample #	Sample Description	Characteristics	OVM (ppm)	Analysis Requested
	NA	100 Standard	NA	-	NA
9:15	1	Bottom Composite @ 3'	Sandy, some stone, no odor	-	BO15, BO21, CI

Approximately 1 foot of soil was excavated from beneath the BGT after the tank was removed, and a 5-point composite sample was collected beneath the former location of the BGT. Additional information can be found on the attached *Field Sheet* and the attached *Sample Map*. The composite sample was analyzed at Hall Analytical Laboratory for TPG (DRO/GRO/ORO) via USEPA Method 8015, benzene and total BTEX via USEPA Method 8021, and for Chlorides via USEPA Method 300.0. The sample returned results of 880 mg/kg total chlorides, 32 mg/kg DRO+GRO and 126 mg/kg TPH. The sample returned results of non-detect (ND) for both benzene and total BTEX. The sample results were below the closure standards approved in the BGT registration approved by the NMOCD on March 9, 2015.

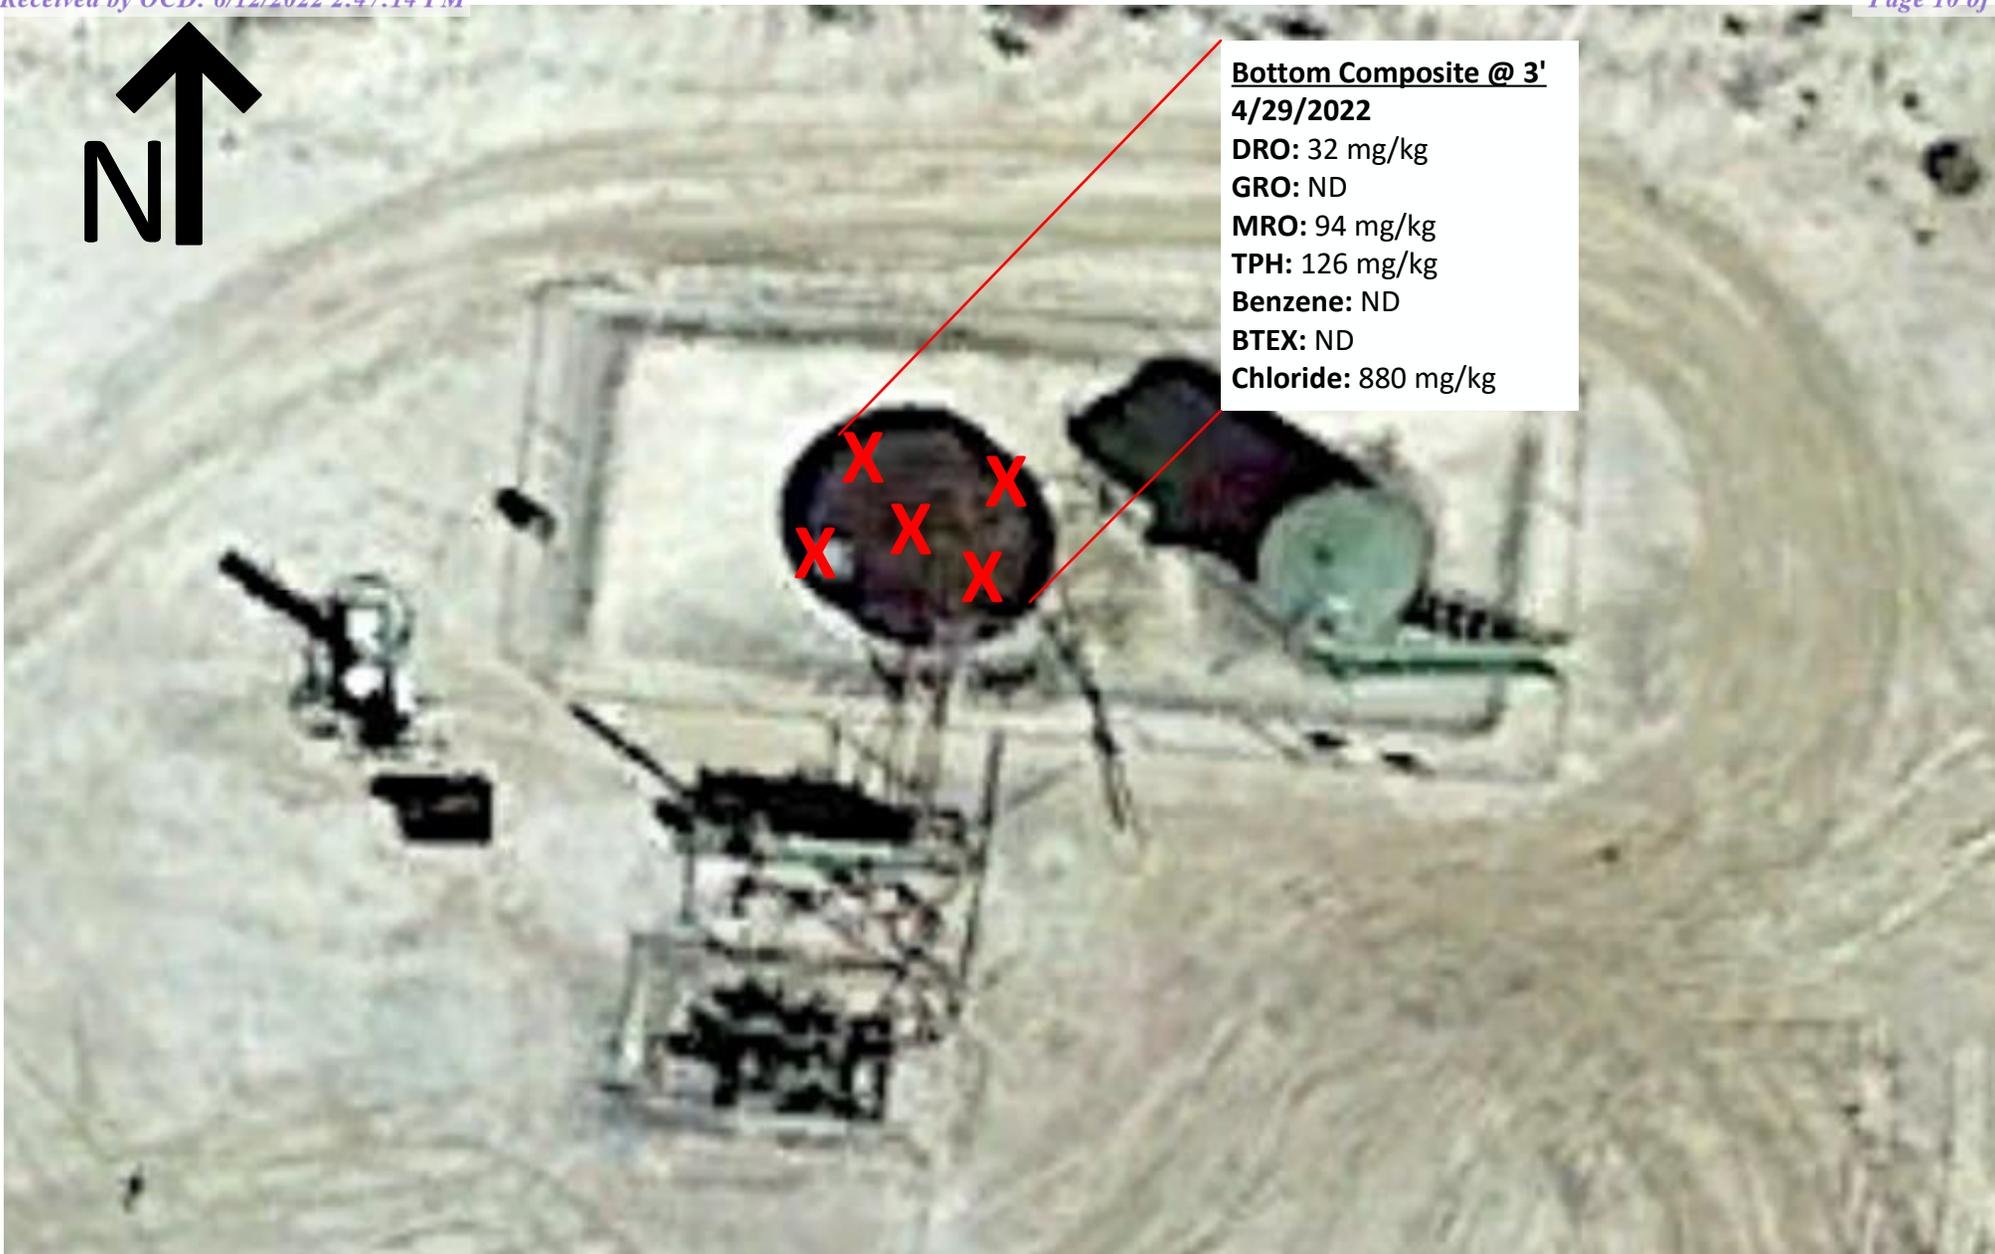
**SAMPLING MAP**

**Bottom Composite @ 3'**  
**4/29/2022**  
**DRO: 32 mg/kg**  
**GRO: ND**  
**MRO: 94 mg/kg**  
**TPH: 126 mg/kg**  
**Benzene: ND**  
**BTEX: ND**  
**Chloride: 880 mg/kg**

Sample results from the BGT composite demonstrated that all constituents analyzed were below the closure requirements approved in the BGT registration approved by the NMOCD on March 9, 2022.

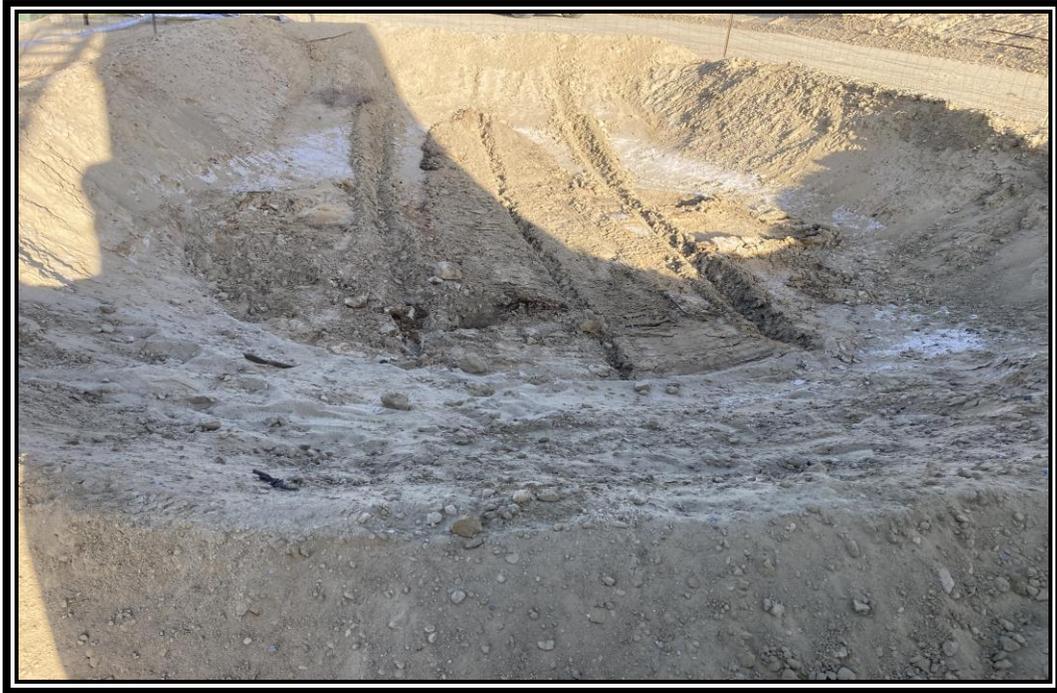
Photo 1: BGT Cellar after BGT was Removed

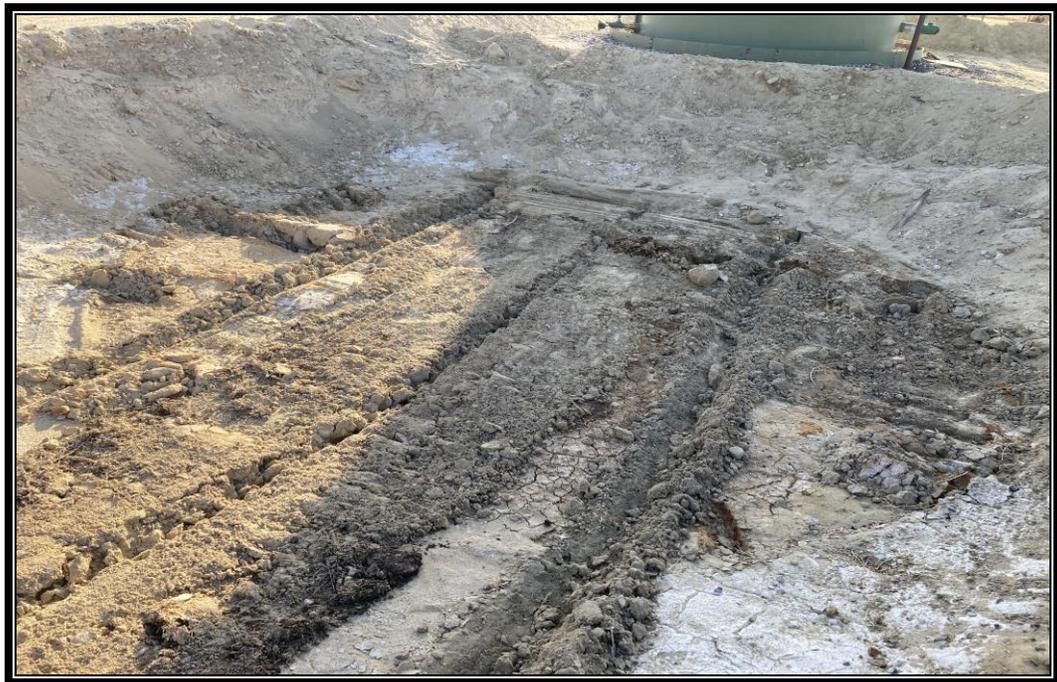
Photo 2: BGT Cellar after BGT Removed (View 2)

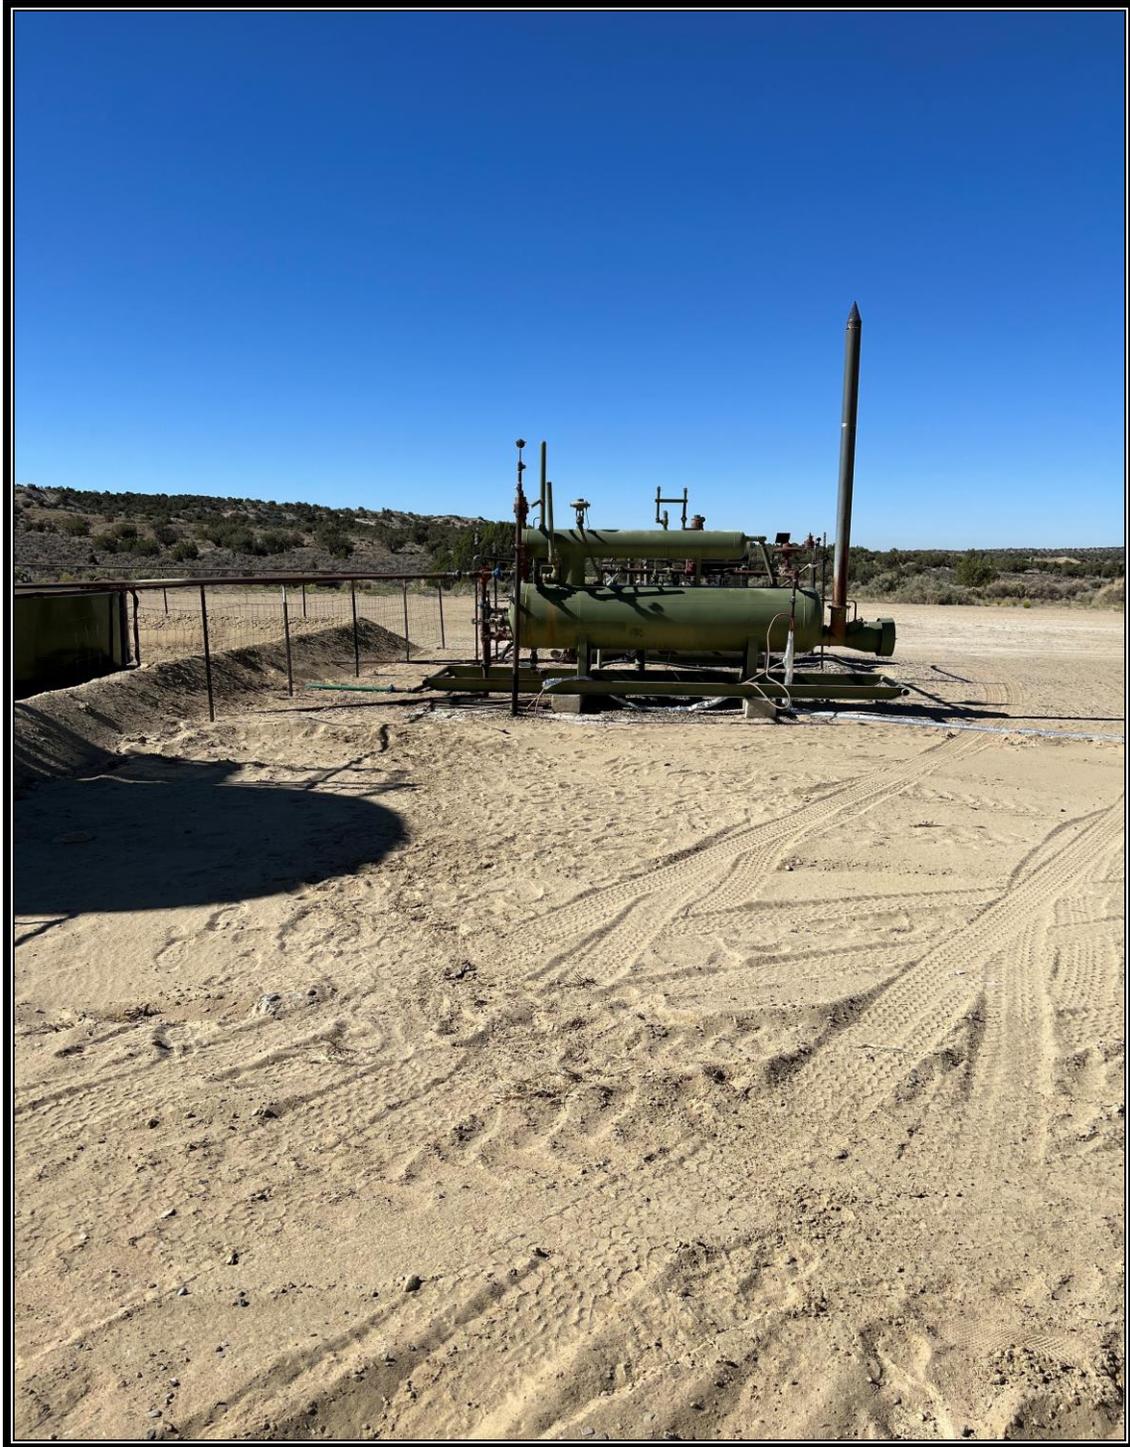
Photo 3: BGT Area after Backfill

The former BGT area was backfilled using soil from on-site and compacted. The area will continue to be used for the operation of the Owen 2A wellsite.
