Pit, Below-Grade Tank, or  
**Proposed Alternative Method Permit or Closure Plan Application**

1.  
Operator: LOGOS Operating, LLC OGRID #: 289408  
Address: 2010 Afton Place, Farmington, NM 87401  
Facility or well name: ROSA UNIT 031C  
API Number: 30-039-26578 OCD Permit Number: \_\_\_\_\_  
U/L or Qtr/Qtr N Section 17 Township 31N Range 5W County: Rio Arriba  
Center of Proposed Design: Latitude 36.8939018 Longitude -107.3864822 NAD83  
Surface Owner: ☒ Federal ☐ State ☐ Private ☐ Tribal Trust or Indian Allotment

**Below Grade Tank Removal  
Rosa Unit #031C  
API# 30-039-26578**

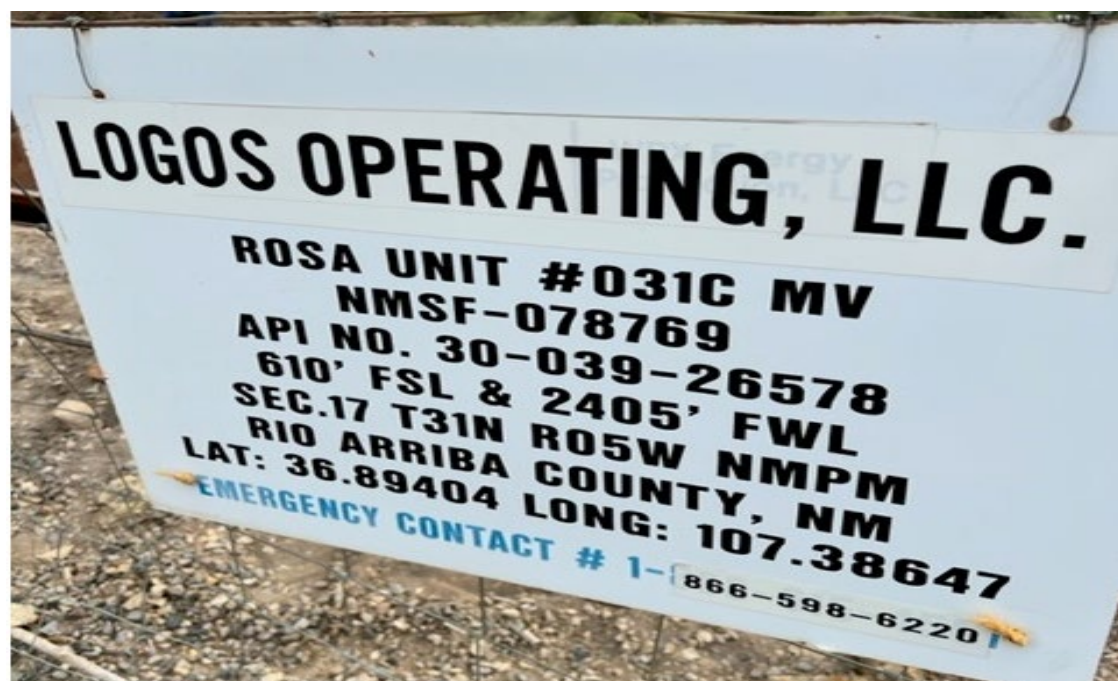
**On August 17, 2022, LOGOS Operating LLC. removed the fiberglass below grade tank on the Rosa Unit #031C. When the BGT was removed no visible signs of staining or wet soil was observed. LOGOS collected (1) 5-point composite sample from where the BGT was removed. The closure samples were analyzed by Envirotech Labs, and all constituents analyzed were non-detect. No representative from the BLM or NMOCD was onsite to witness all confirmation sampling.**

7. Upon closing of the BGT, Logos will reclaim the unused BGT location to a safe and stable condition that blends with the surrounding undisturbed area as provided in Paragraph 2 of subsection H of 19.15.17.13 as well as recontouring the area in accordance with paragraph 5 in subsection H of 19.15.17.13 NMAC. The soil cover will be constructed to prevent ponding of water and erosion of the cover material.
