Pit, Below-Grade Tank, or  
Proposed Alternative Method Permit or Closure Plan Application

1.  
Operator: LOGOS Operating, LLC OGRID #: 289408  
Address: 2010 Afton Place, Farmington, NM 87401  
Facility or well name: ROSA UNIT 098  
API Number: 30-039-23265 OCD Permit Number: \_\_\_\_\_  
U/L or Qtr/Qtr L Section 23 Township 31N Range 6W County: Rio Arriba  
Center of Proposed Design: Latitude 36.8829536 Longitude -107.4384918 NAD83  
Surface Owner: ☒ Federal ☐ State ☐ Private ☐ Tribal Trust or Indian Allotment

3.  
☒ **Below-grade tank:** Subsection I of 19.15.17.11 NMAC  
Volume: 120 bbl Type of fluid: Produced Water  
Tank Construction material: Fiberglass tank w/banded 20-mil HDPE Secondary Liner  
☒ Secondary containment with leak detection ☐ Visible sidewalls, liner, 6-inch lift and automatic overflow shut-off  
☐ Visible sidewalls and liner ☐ Visible sidewalls only ☐ Other \_\_\_\_\_  
Liner type: Thickness \_\_\_\_\_ mil ☐ HDPE ☐ PVC ☐ Other \_\_\_\_\_

**Closure Report (required within 60 days of closure completion):** 19.15.17.13 NMAC

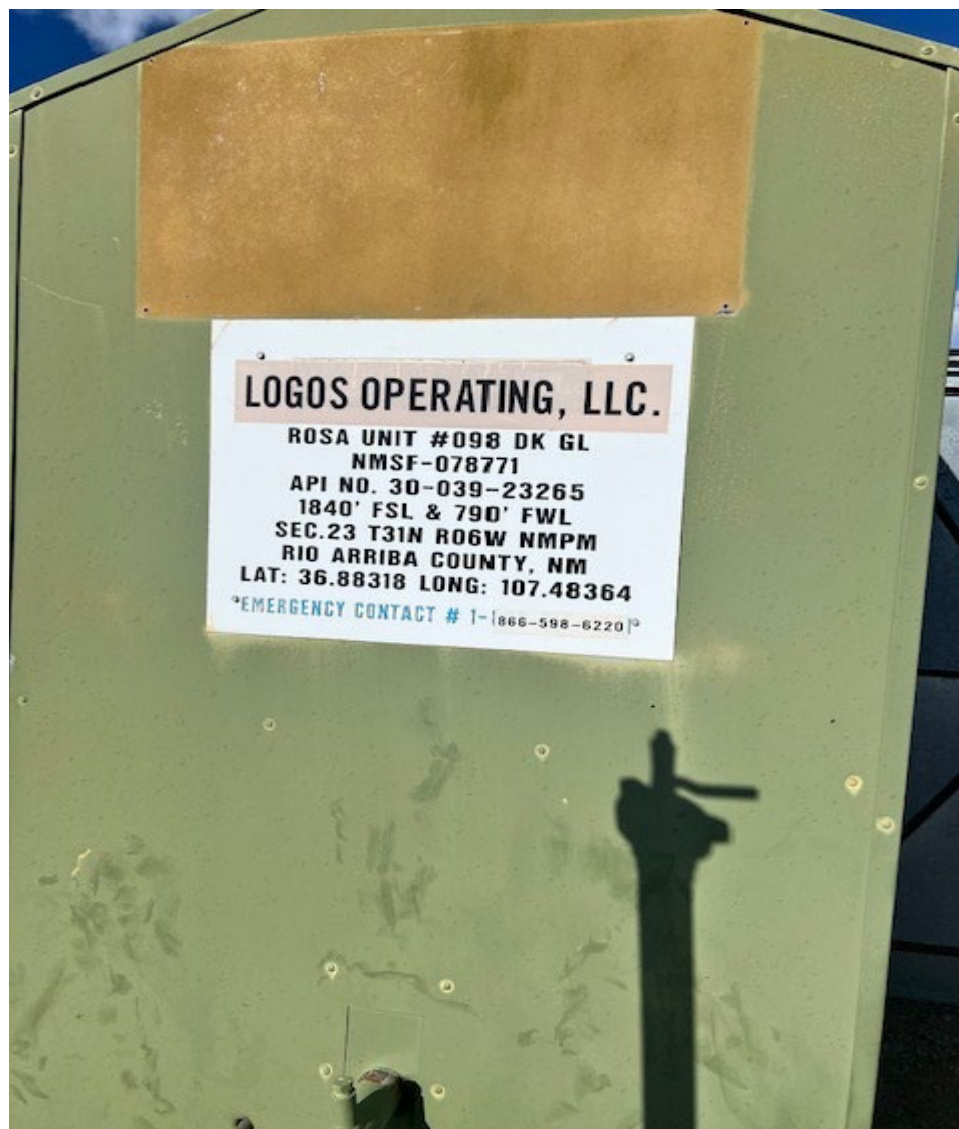
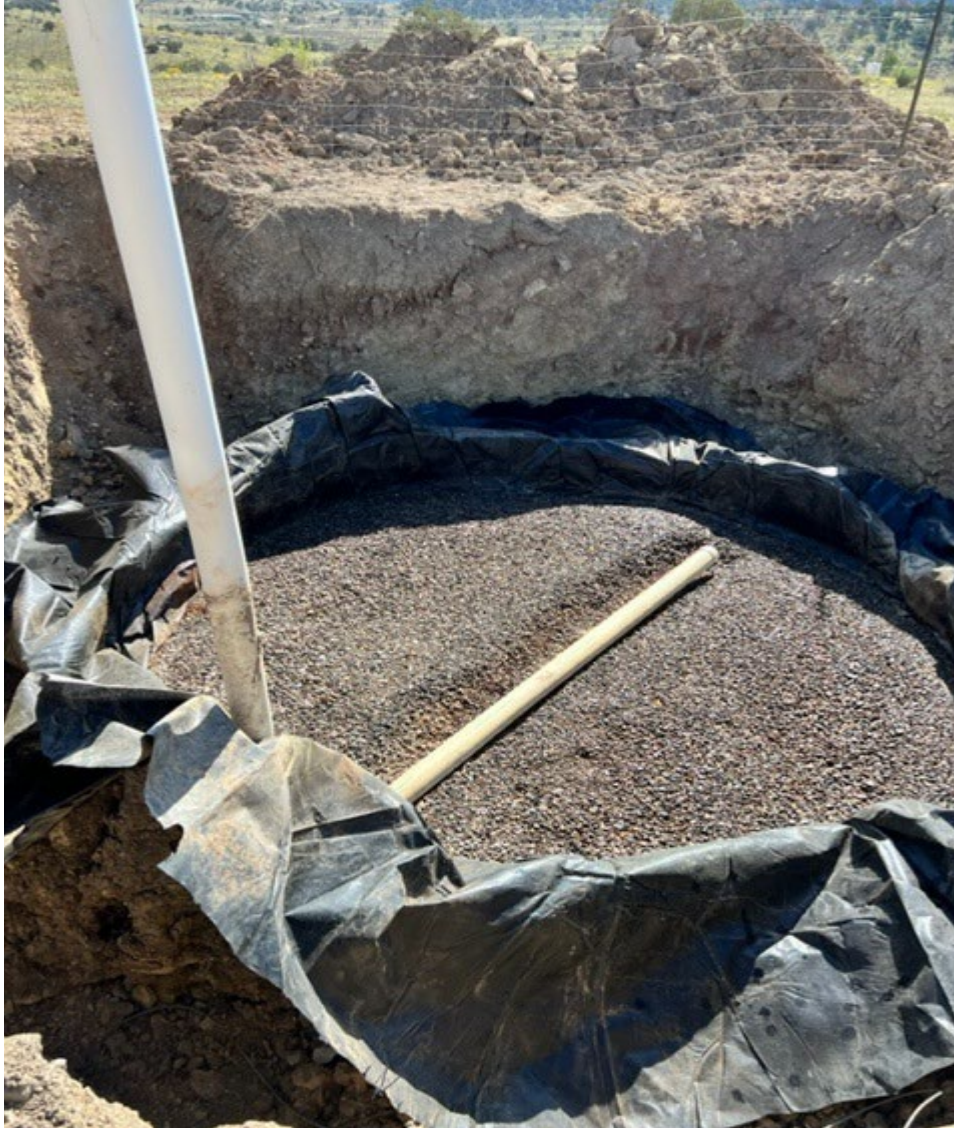
**On August 30, 2022, LOGOS Operating LLC. removed the fiberglass below grade tank on the Rosa Unit #098. When the BGT was removed no visible signs of staining or wet soil was observed. LOGOS collected (1) 5-point composite sample from where the BGT was removed. The closure samples were analyzed by Envirotech Labs, and all constituents analyzed were non-detect. No representative from the BLM or NMOCD was onsite to witness all confirmation sampling.**

- Soil Backfilling and Cover Installation (See Report)
- Re-vegetation application rates and seeding techniques (See Report)
- Photo documentation of the site reclamation (Included as an attachment)
- Confirmation Sampling Results (Included as an attachment)
- Proof of closure notice (Included as an attachment)

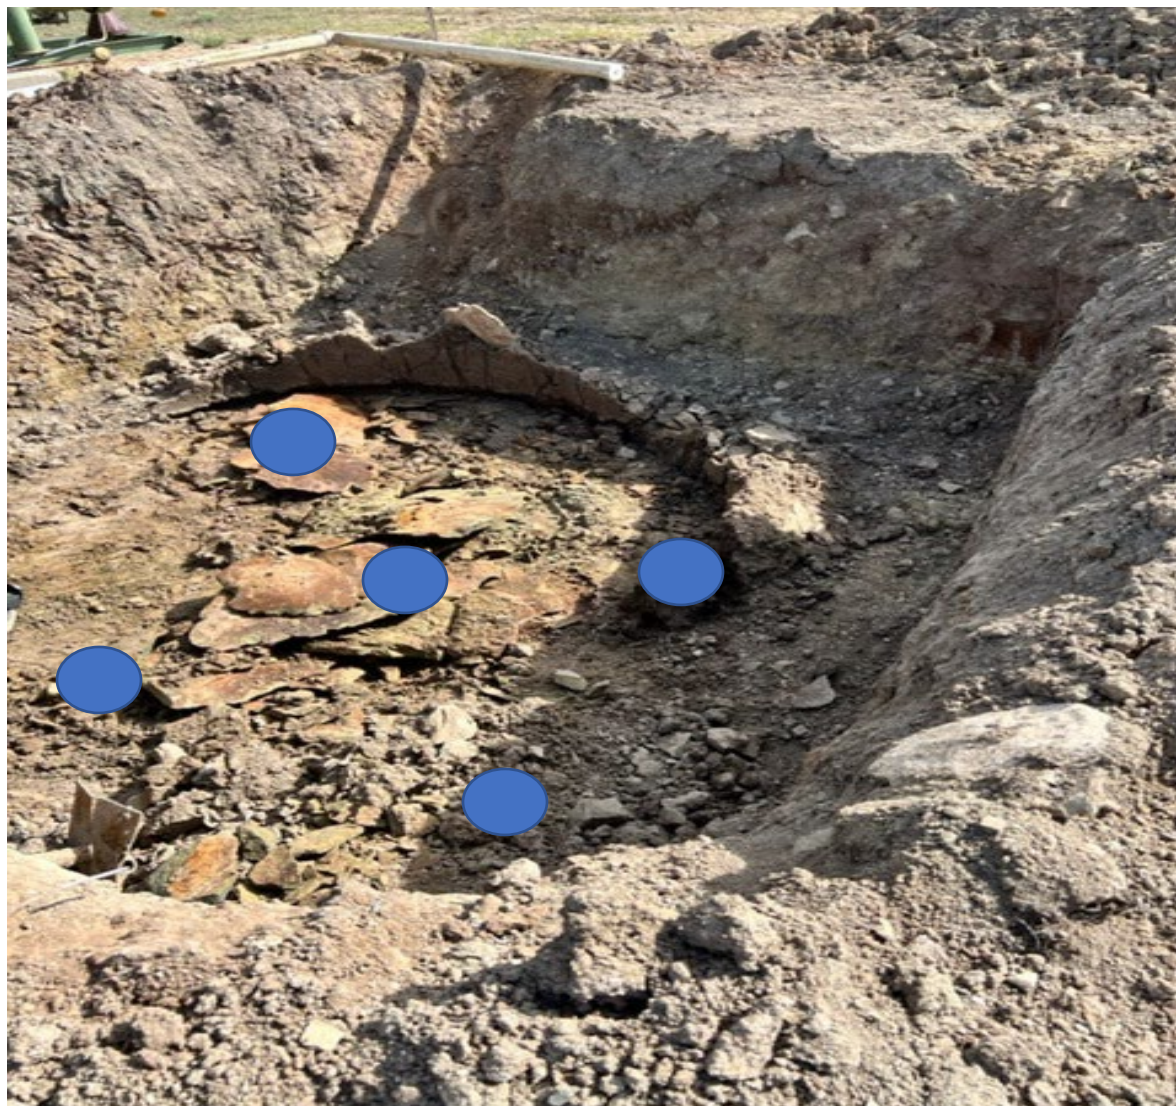
5- point composiste sampling
