Pit, Below-Grade Tank, or
Proposed Alternative Method Permit or Closure Plan Application

1.
Operator: LOGOS Operating, LLC OGRID #: 289408
Address: 2010 Afton Place, Farmington, NM 87401
Facility or well name: ROSA UNIT 030A
API Number: 30-039-26068 OCD Permit Number: _____
U/L or Qtr/Qtr M Section 12 Township 31N Range 6W County: Rio Arriba
Center of Proposed Design: Latitude 36.9090691 Longitude -107.4204178 NAD83
Surface Owner: ☒ Federal ☐ State ☐ Private ☐ Tribal Trust or Indian Allotment

3.
☒ **Below-grade tank:** Subsection I of 19.15.17.11 NMAC
Volume: 120 bbl Type of fluid: Produced Water
Tank Construction material: Fiberglass tank w/banded 20-mil HDPE Secondary Liner
☒ Secondary containment with leak detection ☐ Visible sidewalls, liner, 6-inch lift and automatic overflow shut-off
☐ Visible sidewalls and liner ☐ Visible sidewalls only ☐ Other _____
Liner type: Thickness _____ mil ☐ HDPE ☐ PVC ☐ Other _____

OCD Approval: ☐ Permit Application (including closure plan) ☒ Closure ^{Report}Plan (only) ☐ OCD Conditions (see attachment)

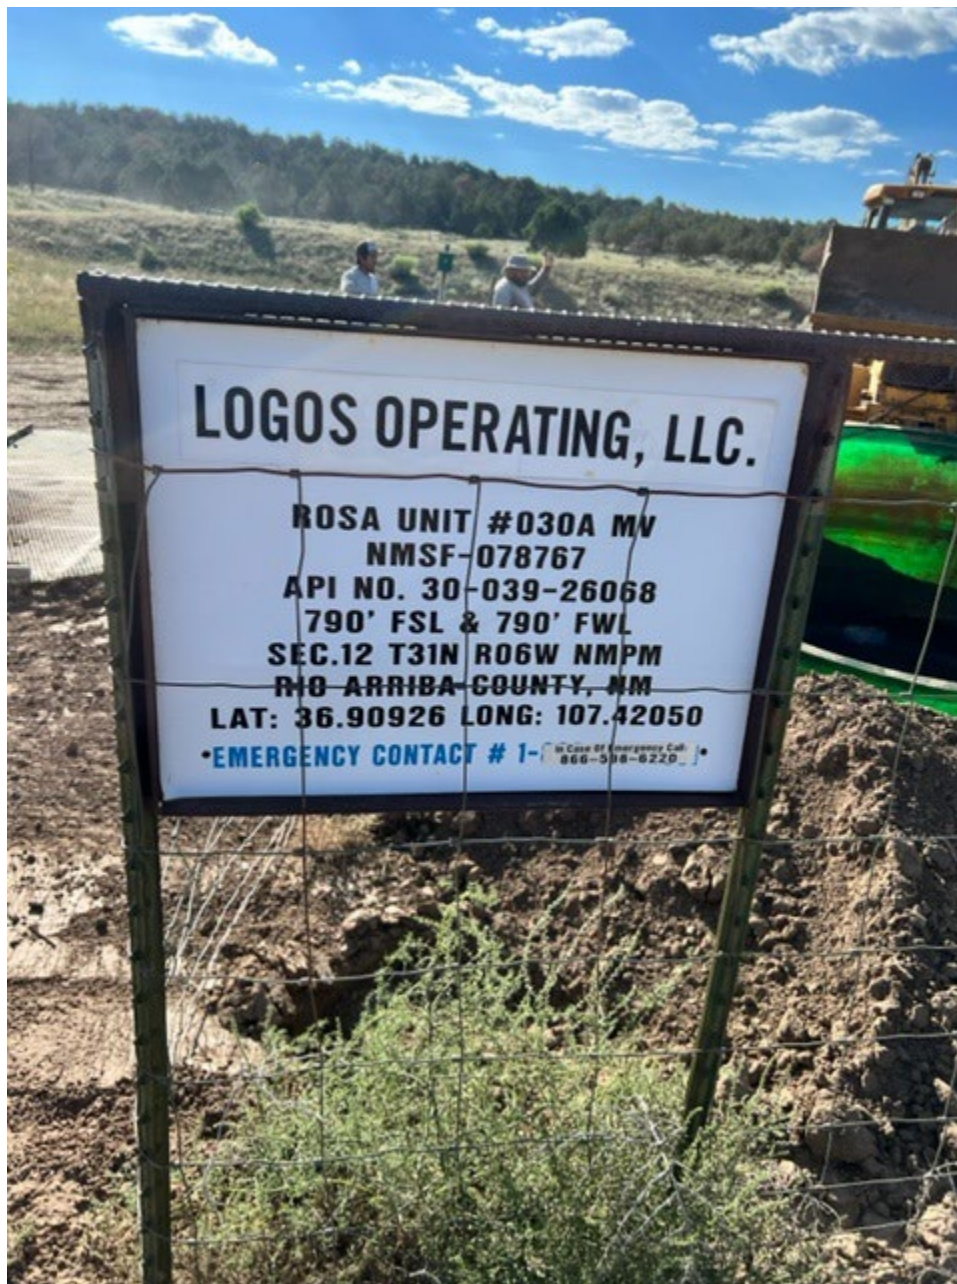
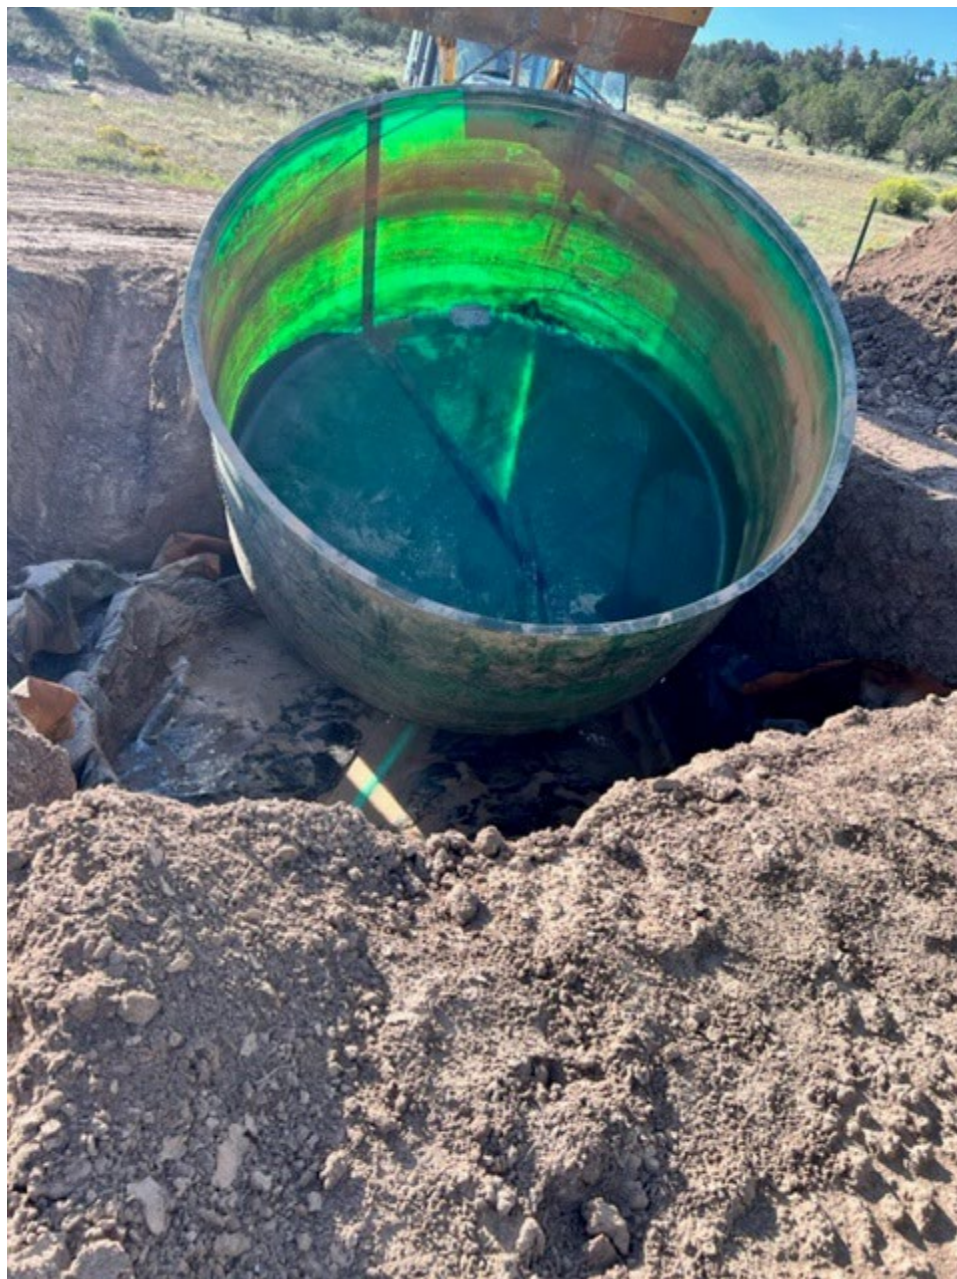
On August 30, 2022, LOGOS Operating LLC. removed the fiberglass below grade tank on the Rosa Unit #030A. When the BGT was removed no visible signs of staining or wet soil was observed. LOGOS collected (1) 5-point composite sample from where the BGT was removed. The closure samples were analyzed by Envirotech Labs, and all constituents analyzed were non-detect. No representative from the BLM or NMOCD was onsite to witness all confirmation sampling.

7. Upon closing of the BGT, Logos will reclaim the unused BGT location to a safe and stable condition that blends with the surrounding undisturbed area as provided in Paragraph 2 of subsection H of 19.15.17.13 as well as recontouring the area in accordance with paragraph 5 in subsection H of 19.15.17.13 NMAC. The soil cover will be constructed to prevent ponding of water and erosion of the cover material.
