Pit, Below-Grade Tank, or
Proposed Alternative Method Permit or Closure Plan Application

**Hilcorp Energy Company**  
**San Juan Basin: New Mexico Assets**  
Below Grade Tank Closure Report

**Lease Name:** Hamner 2E – BGT 2  
**API No.:** 30-045-24689

Hamner 2E  
3004524689  
BGT # 2 Closure Photos

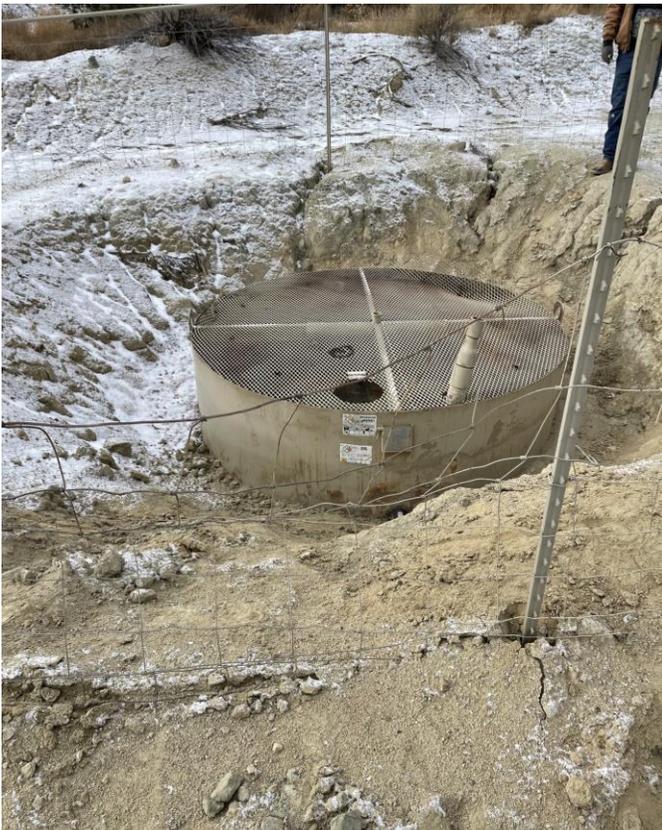
12/14/22, 9:00 am. BGT Before Removal

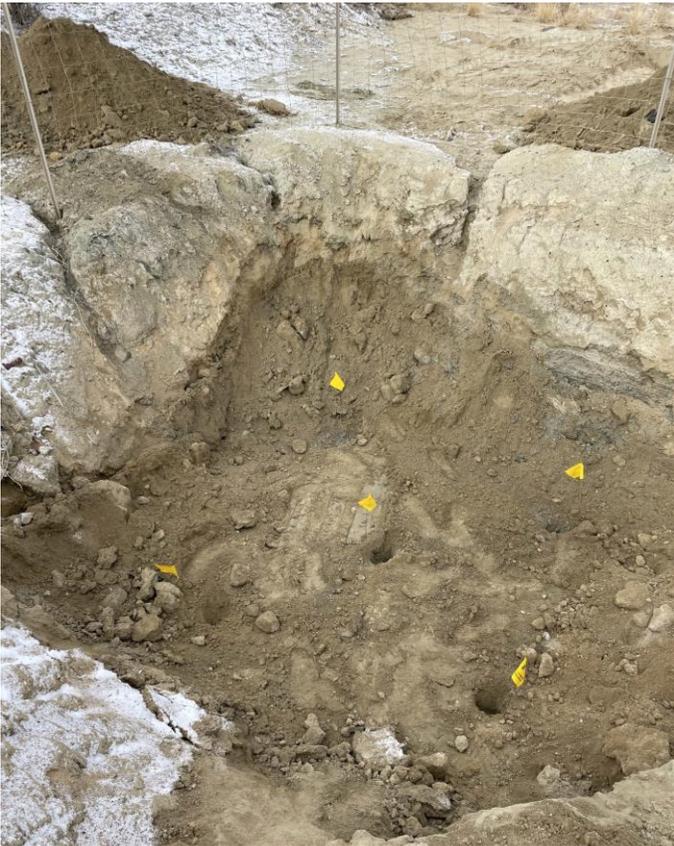
12/14/22, 10:00 am. BGT Soil Samples Taken

**A five point composite sample was taken of the below-grade tank using sampling tools and all samples tested per Table I of 19.15.17.13 and the results are attached.**

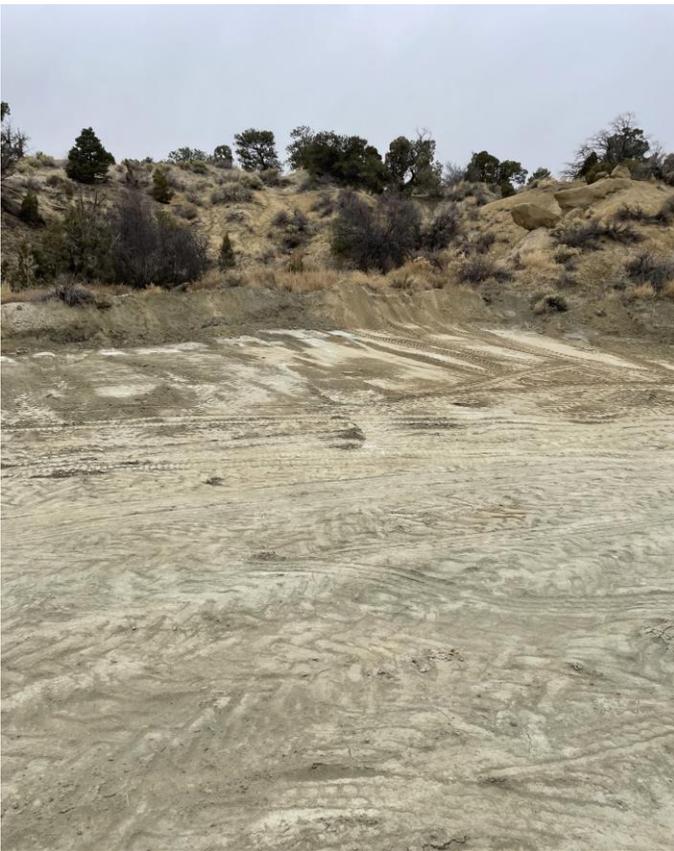
3/10/23, 2:45 pm. Backfill photo: Facing West

**The tank removal area passed all requirements of Table I of 19.15.17.13 NMAC and was backfilled with compacted, non-waste containing, earthen material which included at least one foot of suitable material to establish vegetation at the site.**
