Pit, Below-Grade Tank, or
Proposed Alternative Method Permit or Closure Plan Application

**Hilcorp Energy Company
San Juan Basin
Below Grade Tank Closure Report**

Lease Name: Henderson 5 3

API No.: 30-045-32588

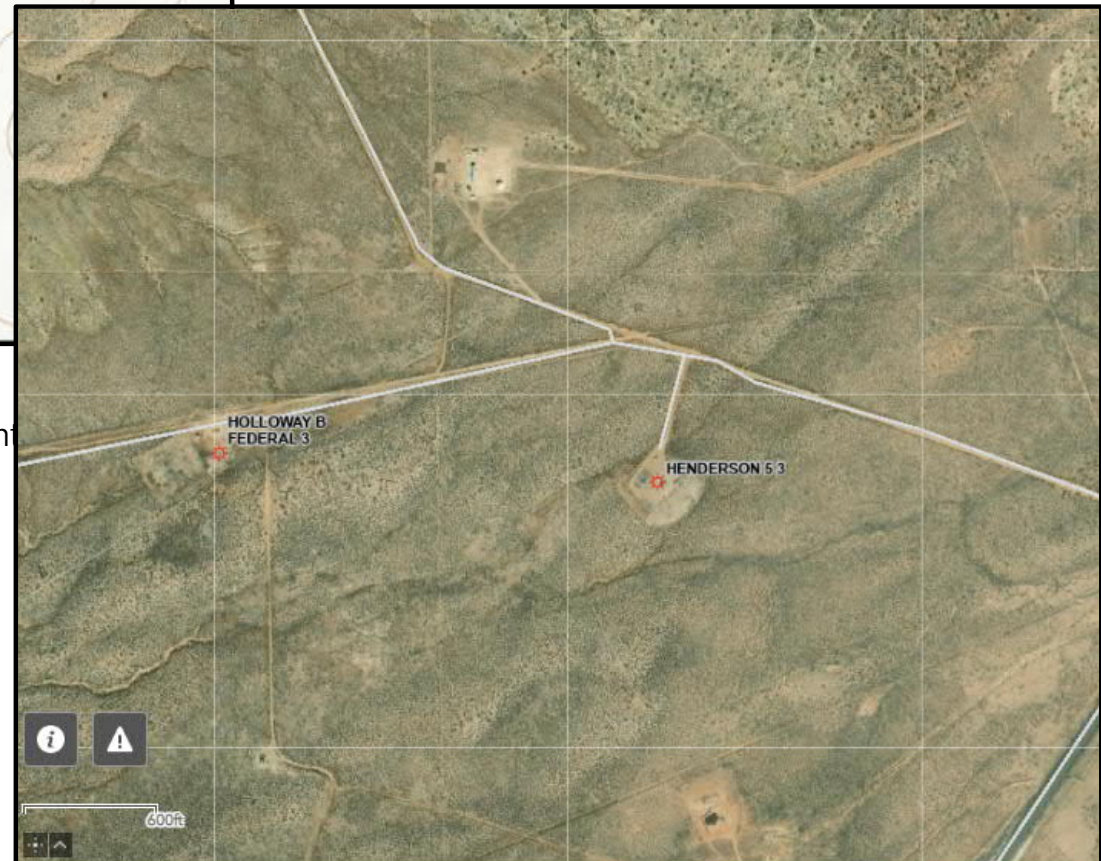
NMAC 19.15.29 Siting Criteria for Closure Standards

Within defined municipal fresh water well field: No				
Wetland within 500': No		Mining Activity: None		
Within unstable area: No				
Within 100 year flood plain: No-FEMA Zone 'X'

BGT is not shown to be within:

- 300 ft of any continuously flowing watercourse or any other significant water course.
- 200 feet of any lakebed, sinkhole or playa lake
- 300 feet of any occupied permanent residence
- 500 feet of a spring or private, domestic fresh water well.
- 1000 feet of any fresh water well
- 300 feet of a wetland
- Incorporated municipal boundaries
- Overlying a subsurface mine
- An unstable area
- A 100-year floodplain
