Proposed Alternative Method Permit or Closure Plan Application		
Type of action: Below grade tank registration Permit of a pit or proposed alternative method Closure of a pit, below-grade tank, or proposed alternative method Modification to an existing permit/or registration Closure plan only submitted for an existing permitted or non-permitted pit, below-grade tank, or proposed alternative method		
Instructions: Please submit one application (Form C-144) per individual pit, below-grade tank or alternative request		
Please be advised that approval of this request does not relieve the operator of liability should operations result in pollution of surface water, ground water or the		
environment. Nor does approval relieve the operator of its responsibility to comply with any other applicable governmental authority's rules, regulations or ordinances.		
Operator: Hilcorp Energy Company OGRID #: 372171

Hilcorp Energy Company San Juan Basin Below Grade Tank Closure Report

Lease Name: Larcher 2 API No.: 3004521143

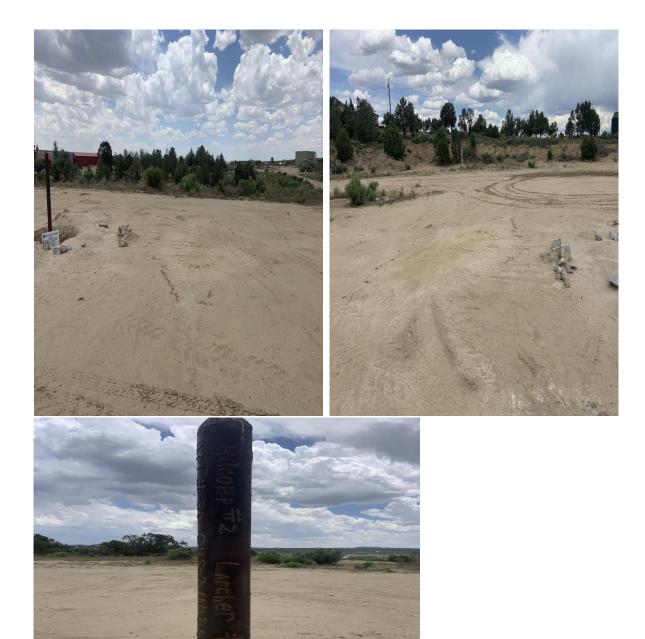
Larcher 2 Post Closure Photos

The below-grade tank area was re-contoured to match fit, shape, line, form and texture of the surrounding area. Re-shaping including drainage control, to prevent ponding and erosion. Natural drainages were unimpeded and water bars and/or silt traps were placed in areas where needed to prevent erosion on a large scale. Final recontour has a uniform appearance with smooth surface, fitting the natural landscape.

The below-grade tank area was backfilled and more than four feet of cover was achieved and the cover included one foot of suitable material to establish vegetation at the site.
