Pit, Below-Grade Tank, or
Proposed Alternative Method Permit or Closure Plan Application

**Hilcorp Energy Company
San Juan Basin
Below Grade Tank Closure Report**

Lease Name: DUSTIN 1E

API No.: 30-045-24773

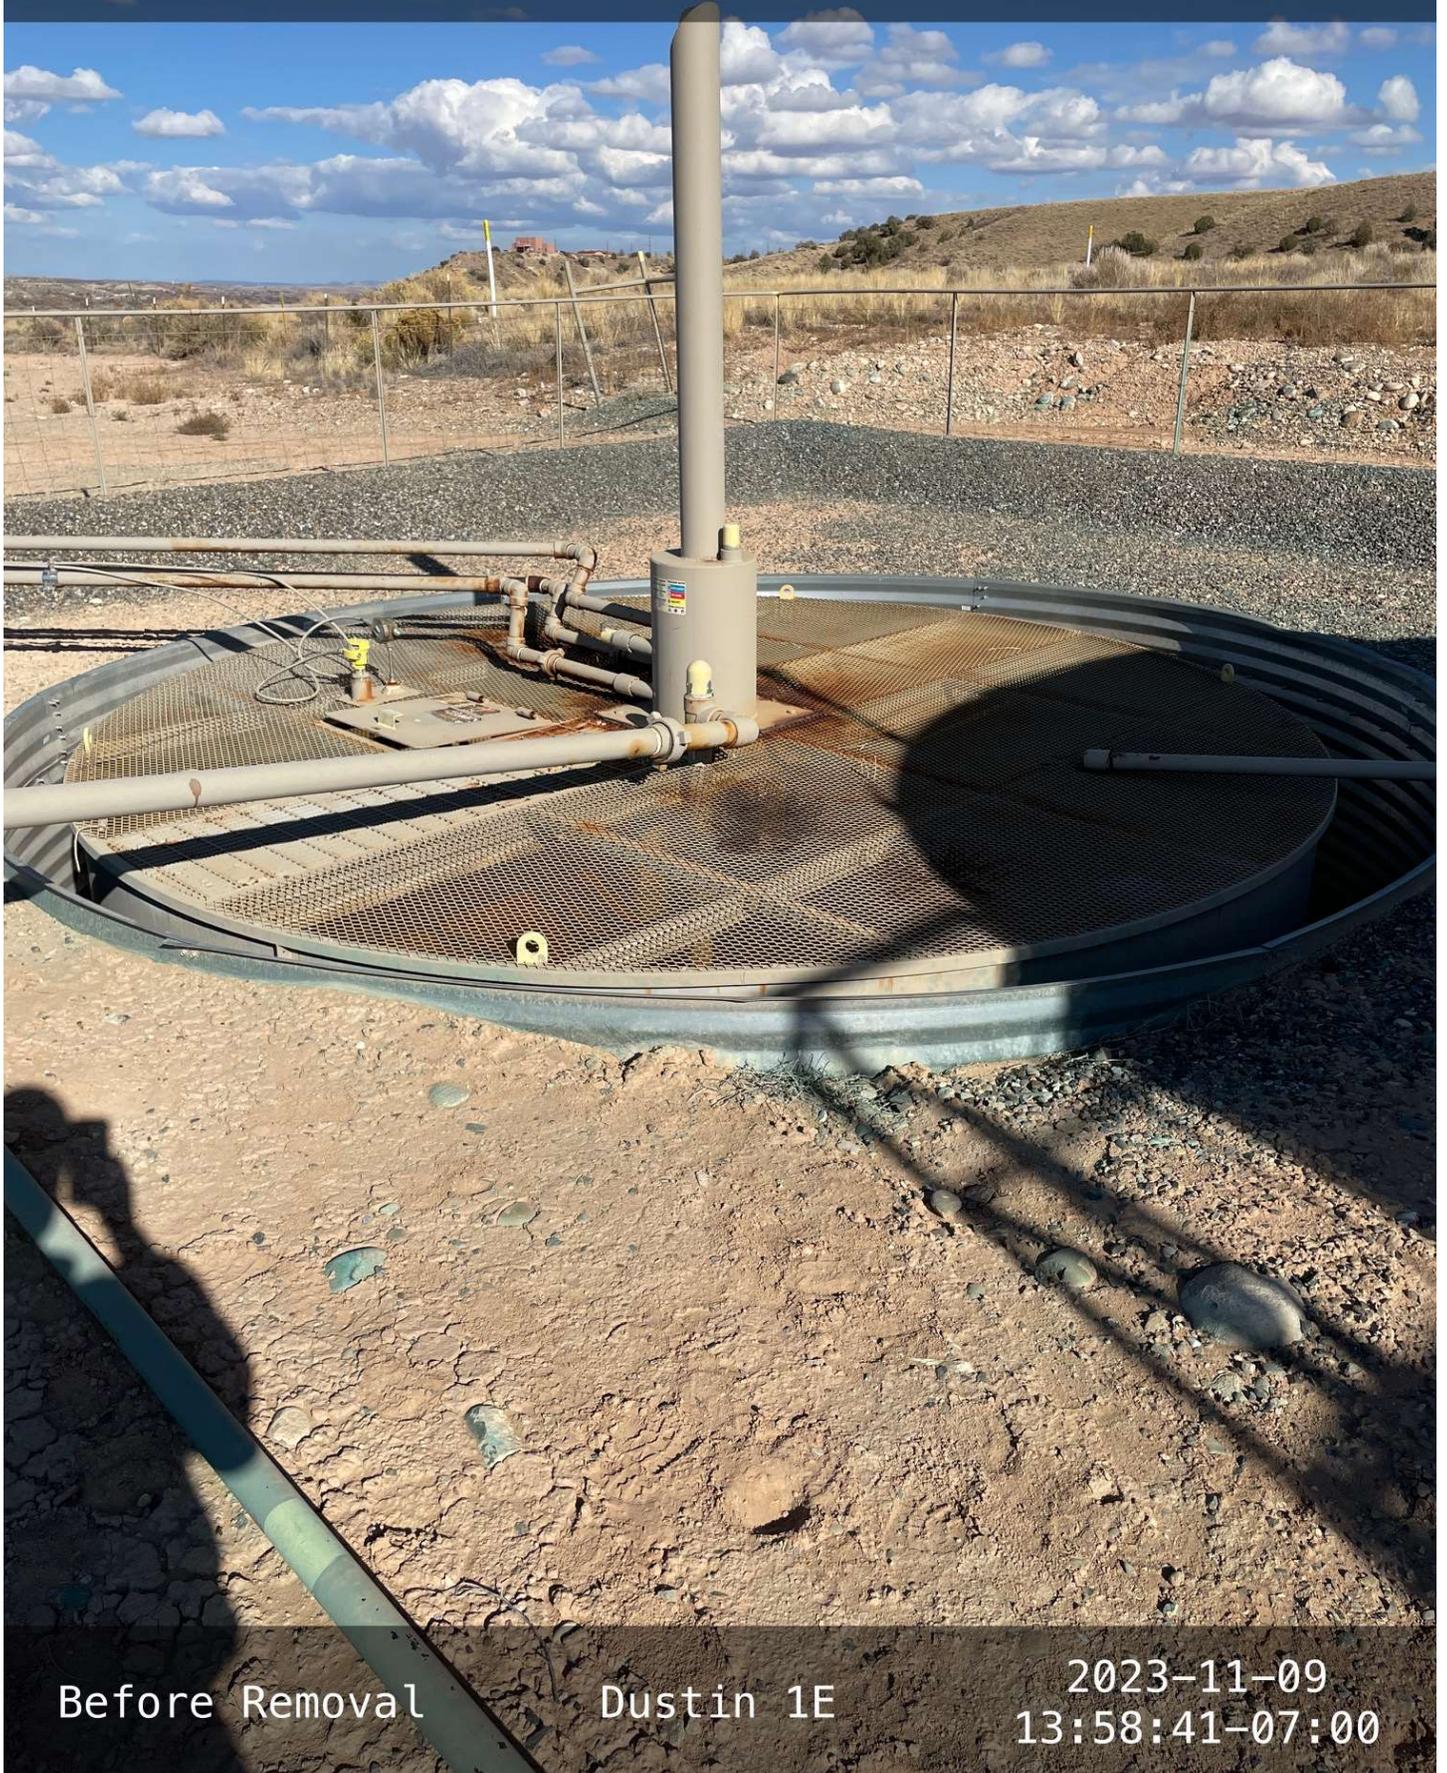
Dustin 1E

Before Removal

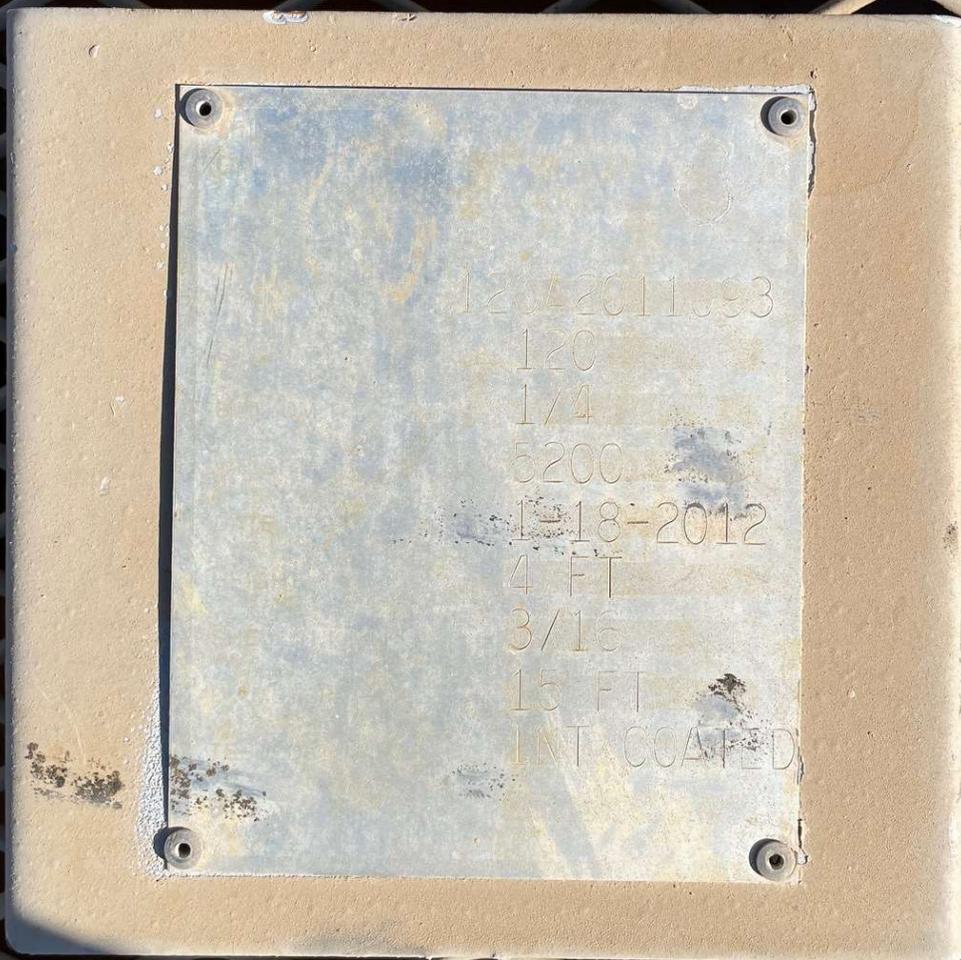
Dustin 1E

Tank Information
