Pit, Below-Grade Tank, or  
Proposed Alternative Method Permit or Closure Plan Application

Operator: LOGOS Resources, LLC OGRID #: 289408  
Address: 2010 Afton Place, Farmington NM 87401  
Facility or well name: Rosa Unit 168 API Number: 30-039-25916 OCD Permit Number:     
U/L or Qtr/Qtr P Section 28 Township 31N Range 5W County: Rio Arriba  
Center of Proposed Design: Latitude 36.8666 Longitude -107.36141 NAD83  
Surface Owner: Federal State Private Tribal Trust or Indian Allotment  
☒ ☐ ☐ ☐

Rosa Unit #168 30-039-25916

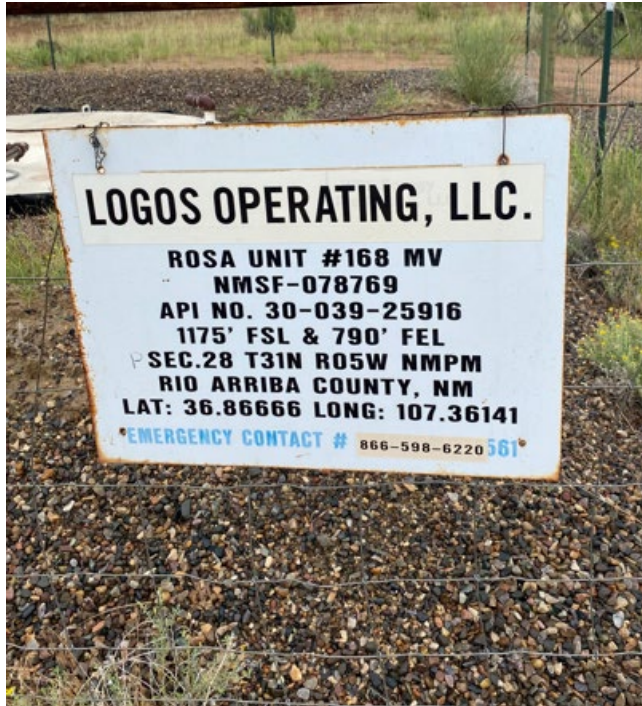
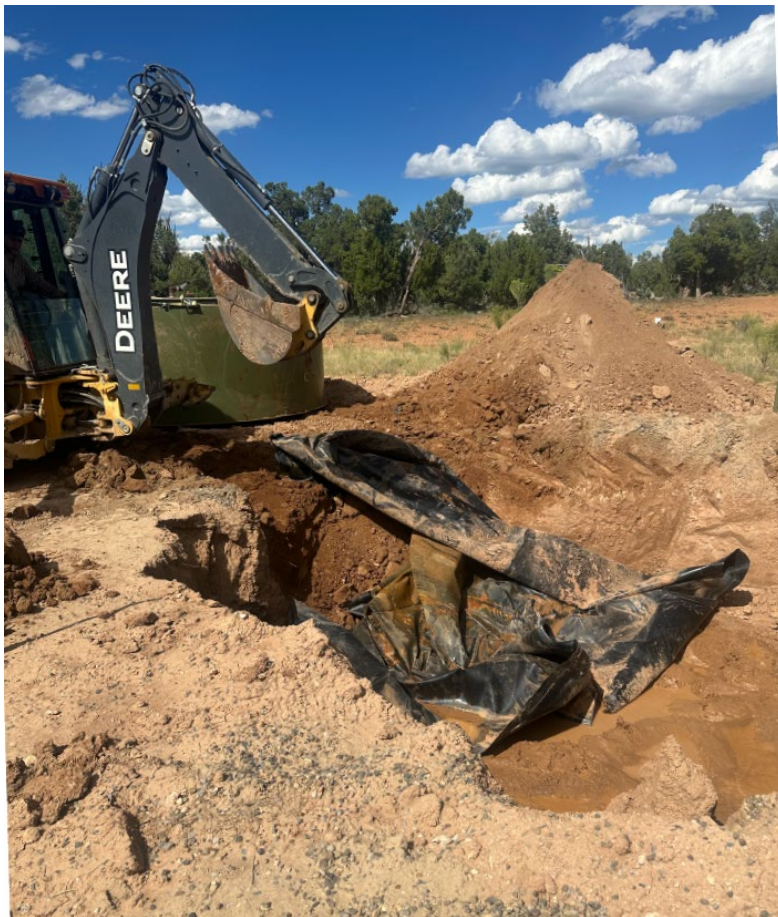
BGT Removal- Note: rain water present the day of removal.

On August 23, 2024, LOGOS Operating LLC. removed the steel single wall below grade tank (BGT) on the Rosa Unit #168. When the BGT was removed no visible signs of staining were observed. The location did receive rain prior to removal so wet soil was observed. LOGOS collected (1) 5-point composite sample from where the BGT was removed. The closure samples were analyzed by Envirotech Labs, and all constituents analyzed were non-detect. No representative from BLM, Forest Service or NMOCD was onsite to witness all confirmation sampling. An above ground tank (AGT) has been installed.

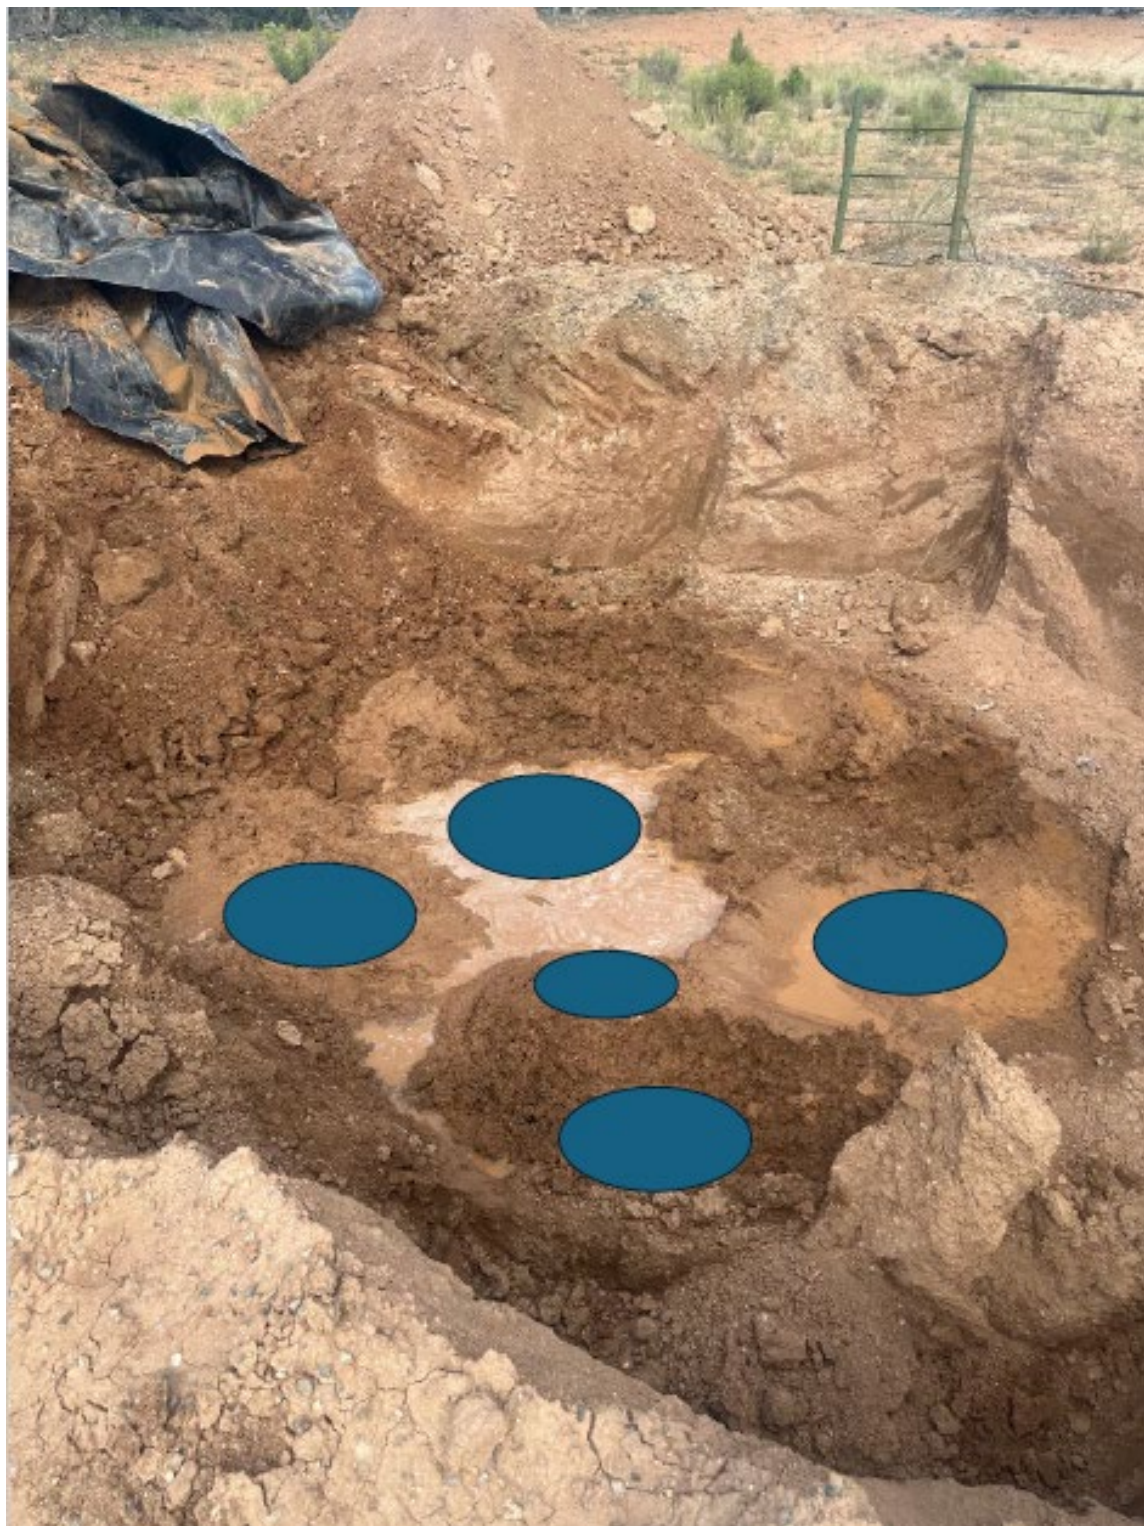
Rosa Unit #168 30-039-25916

BGT Removal- Note: rain water present the day of removal.

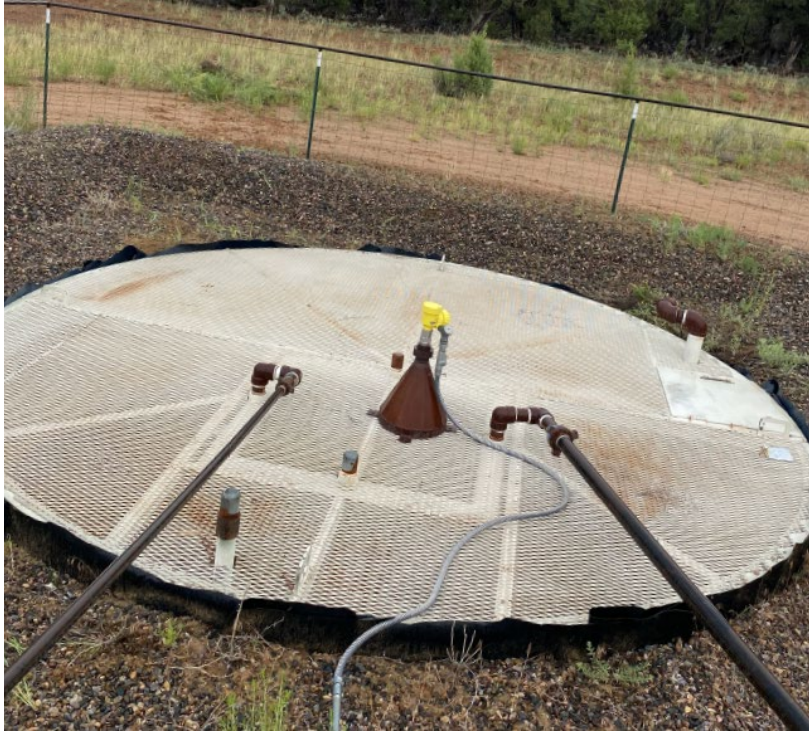
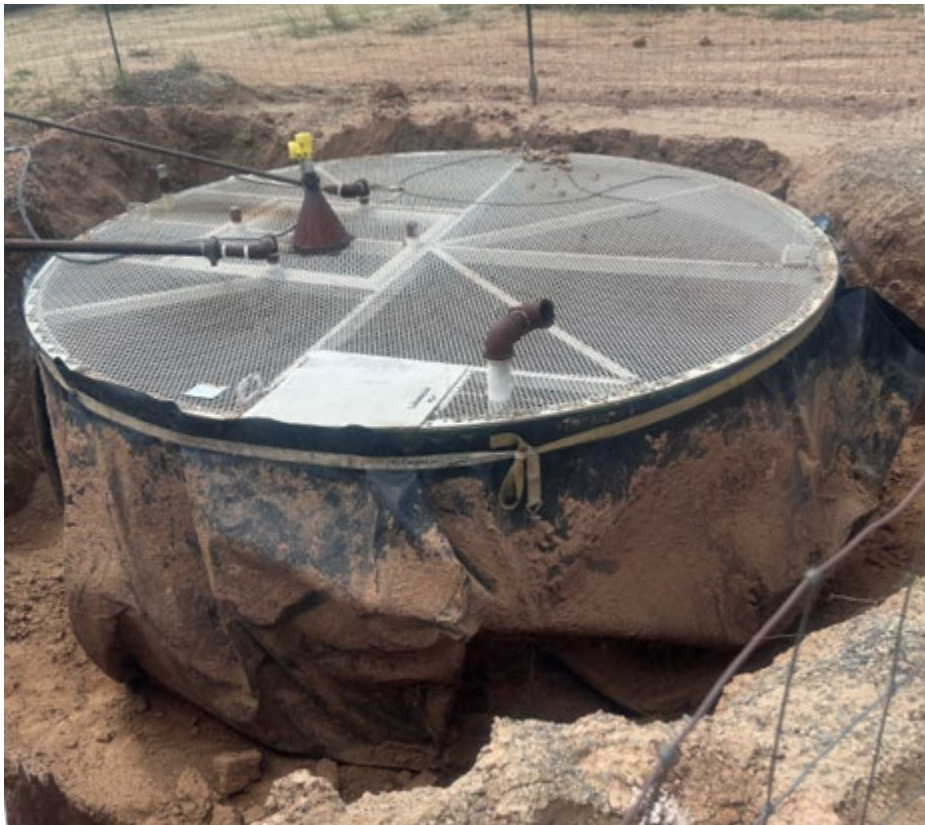
Rosa Unit #168 30-039-25916

BGT Removal- Note: rain water present the day of removal.

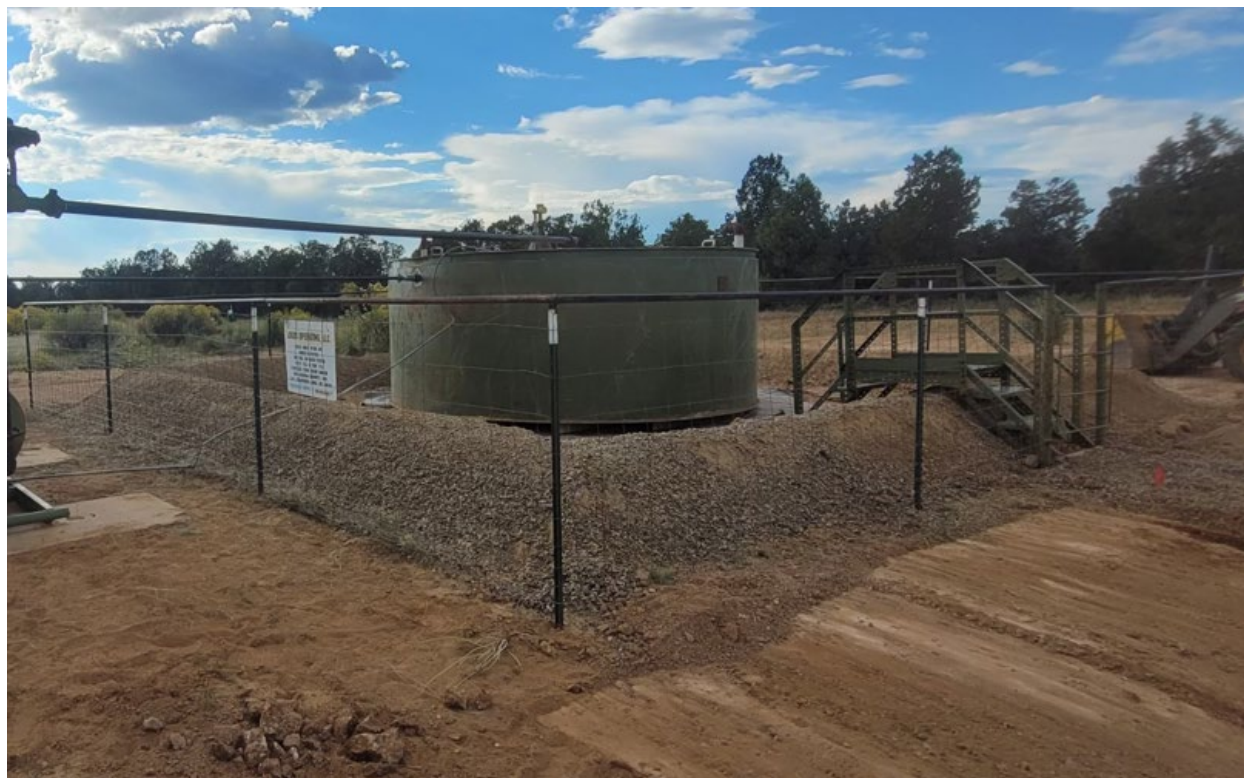
Rosa Unit #168 30-039-25916

AGT Installed
