Notice of Completion Pit Closure and Interim Reclamation

Shell Exploration & Production Co., CD-1 (API No. 30-019-20134)

CD-1 Gas Well Completion Pit Closure Report Webb and Hage Land and Cattle Company Lease

**Cuervo, Guadalupe County, New Mexico**

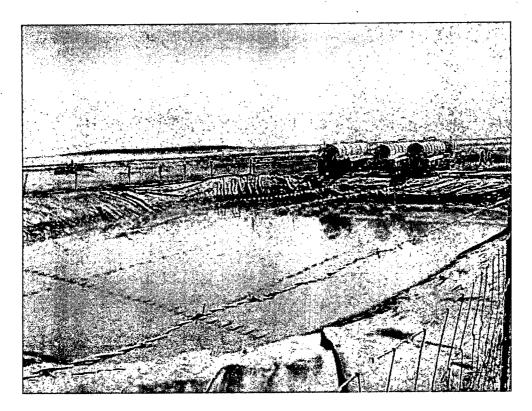
Photo 1: Removing fluid from the pit (looking southeast).

Robinson Construction Group (Robinson) began removing the fluids and mud from the pit on November 17, 2010 (Appendix A, Photos 1-4). Robinson completed the removal of approximately 100 cubic yards of soil and rock beneath the liner on December 5, 2010 (Appendix A, Photo 5 and 6). Robinson removed approximately 5,300 barrels of fluids (222,600 gallons), 120 cubic yards of mud contained in the liner and 10 cubic-yards of soil/rock beneath the liner. Fluid was removed and transported in vacuum trucks and the mud, liner and soil/rock were transported in end dump trucks to the Gandy-Marley Inc. (GMI) oil-field waste disposal facility located in Tatum, New Mexico (facility ID # NM 711-1-0020) for proper disposal.

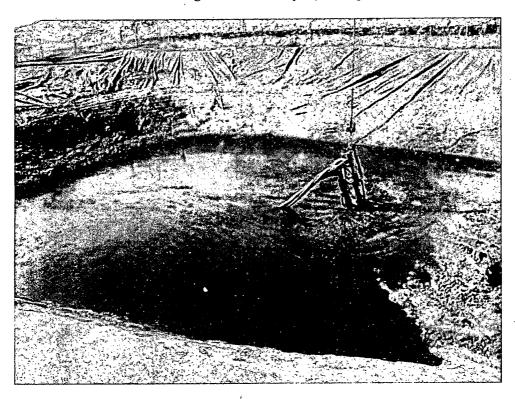
Photo 2: Removing fluid and mud from the pit (looking southwest).

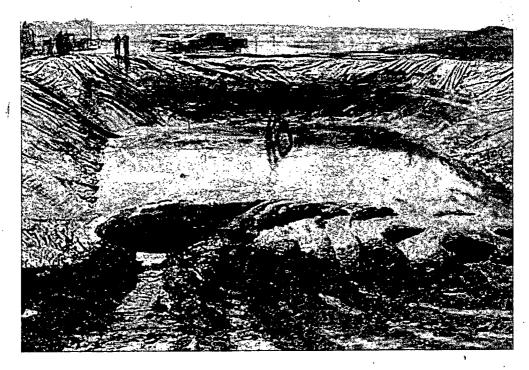
Photo 3: Removing mud from the pit (looking south).

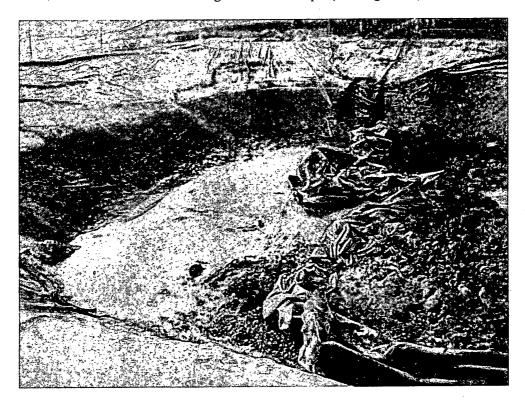
§ Photo 4: Removing the pit liner (looking west).

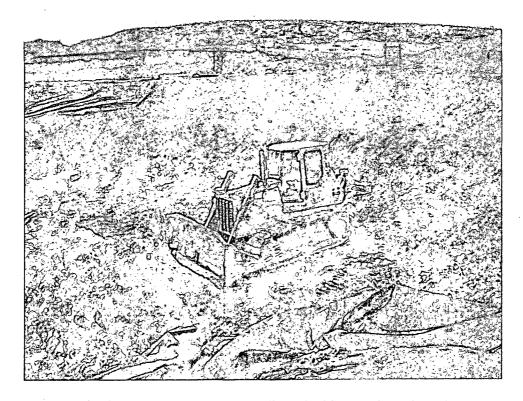
As the liner was being removed, no visible indications of a breech were observed in the liner. There were, however, two wet areas in the bedrock exposed in the northwest corner of the excavation bottom. Inspection of the excavation indicated that bedrock was exposed over the majority of the excavation bottom. The two wet areas were contained in depressions that were approximately 6-inches in width and approximately 9-feet long, parallel to one another and oriented northwest to southeast. The depressions appeared to be caused by the ripper teeth of the dozer used to construct the pit. The moisture did not appear to extend into the bedrock below the depressions.

Photo 5: Removing the pit liner (looking northwest).

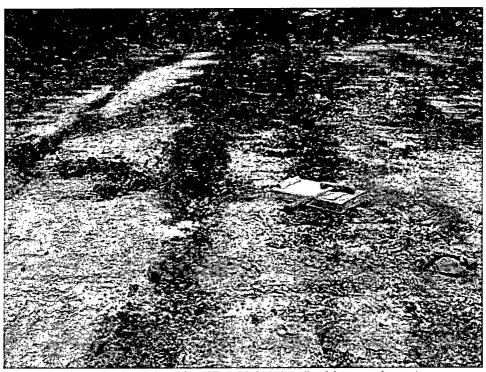
Photo 8: Sample point CD1-12610-3A (looking southwest).

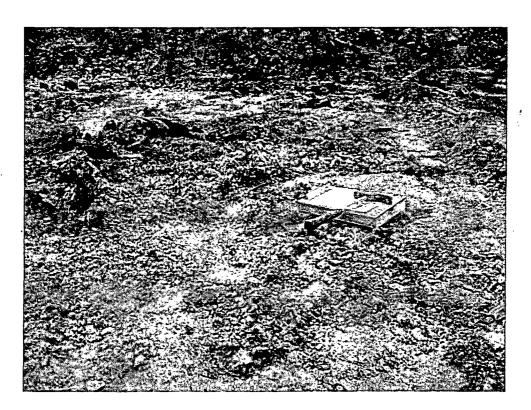
Photo 9: Sample point CD1-12610-3B (looking southeast).

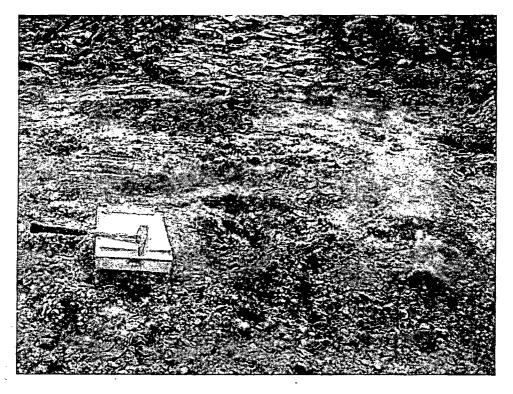
Photo 10: Sample point CD1-12610-3C (looking southwest).

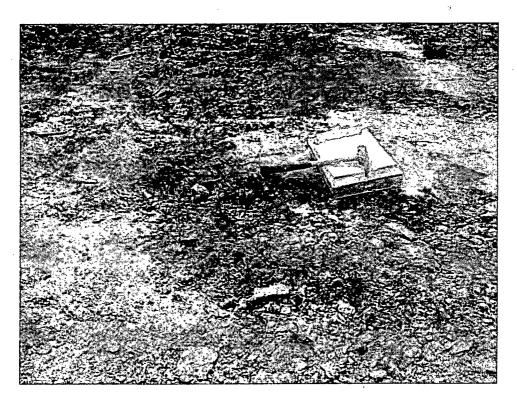
Photo 11: Sample point CD1-12610-3D (looking southeast).

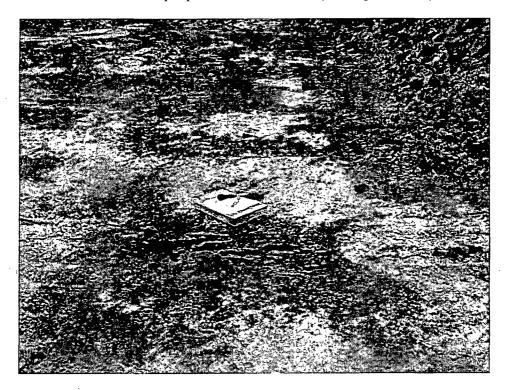
Photo 12: Sample point CD1-12610-3E (looking south).
