Final Closure Report

# RE: South Lined Contact Water Pond Final Closure Report

Re: Sediment and Blow Sand Disposition  
South Lined Contact Water Pond  
Chaco Gas Plant  
Off County Road 7100  
San Juan County, New Mexico

Final Closure Report  
 South Lined Contact Water Pond  
 Chaco Gas Plant  
 N36° 29' 09.27"; W108° 07' 28.19"  
 Off CR 7100  
 San Juan County, New Mexico  
 SWG Project No. 0410001B

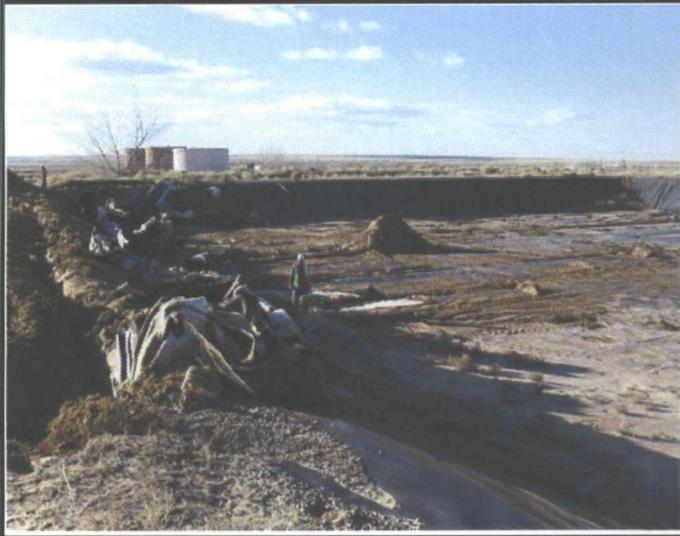
1.) Representative view of the initiation of liner removal activities at the Site.

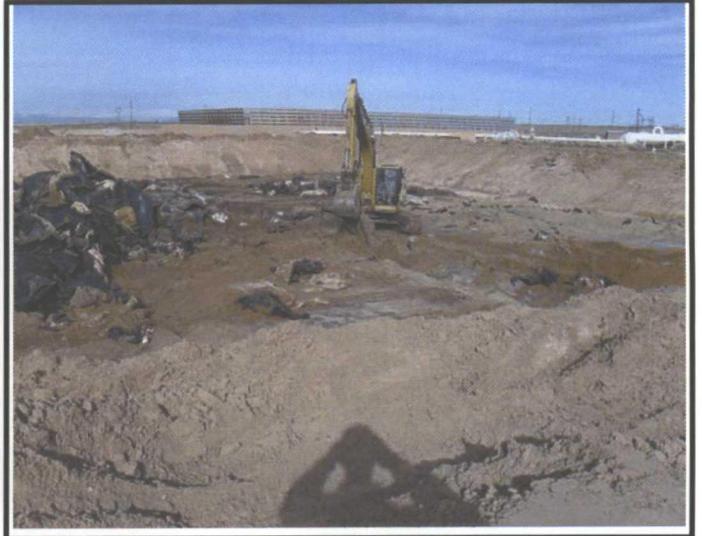
2.) General view of the removal of the liners from the South Contact Water Pond at the Site.

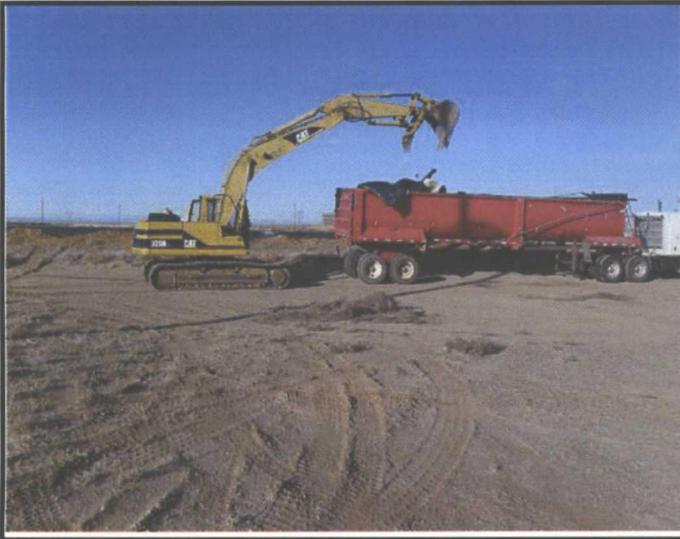
3.) General view of the liners being loaded for off-site disposal.

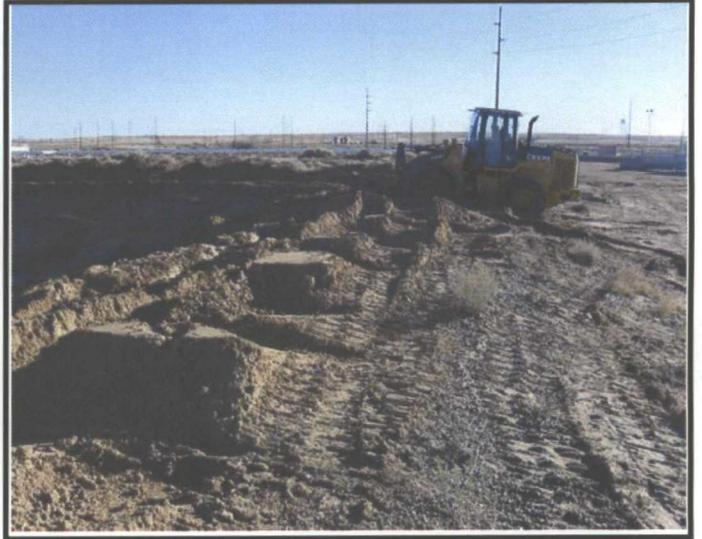
4.) Representative view of the initiation of pond backfilling and grading activities.

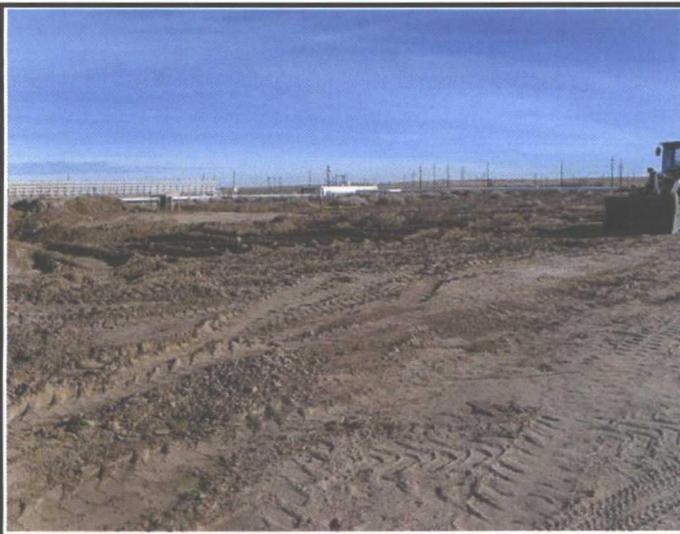
5.) Representative view of the conclusion of Site restoration and grading activities.

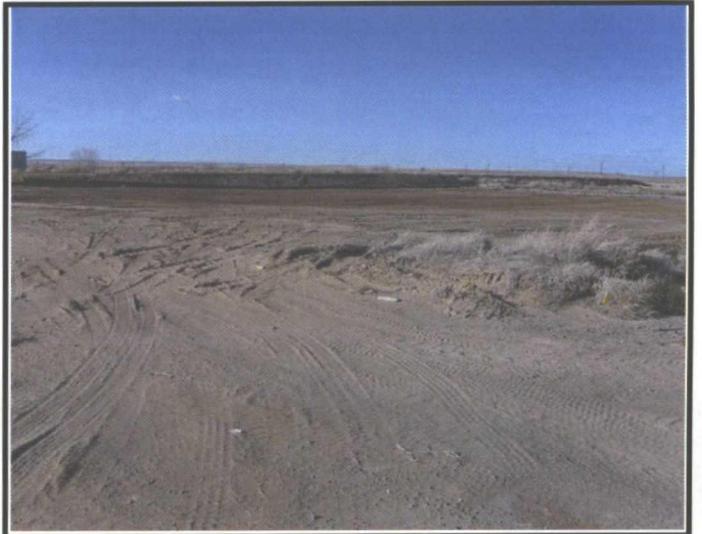
6.) General view of the Site subsequent to the completion of Site restoration.

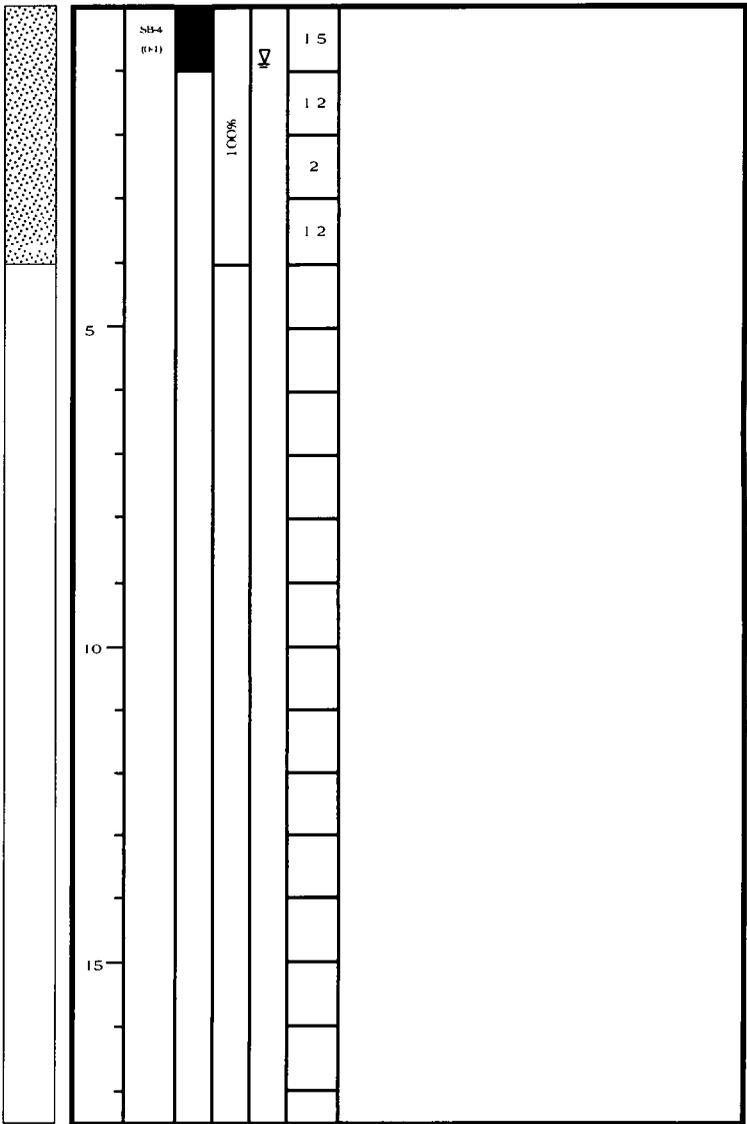
# SOIL BORING LOG

SILTY SAND, Moderate Yellowish Brown, Moist to 1.0' then Wet, No odor

1 3  
1 2  
2  
1 2  
Black staining @ ~ 4'

During the completion of each soil boring, an on-Site geoscientist documented the lithology encountered and constructed a continuous profile of the soil column from the surface to the boring terminus. Undisturbed soil samples from each boring location were visually inspected and classified in the field. The lithology observed during the advancement of soil boring SB-1 at the Site included silty sand and clay stratum from the surface to approximately 8.0 feet below ground surface (bgs). The

lithologies observed in the remaining soil borings (SB-2 through SB-5) were similar to soil boring SB-1. Detailed lithologic descriptions are presented on the soil borings logs included in Appendix D.

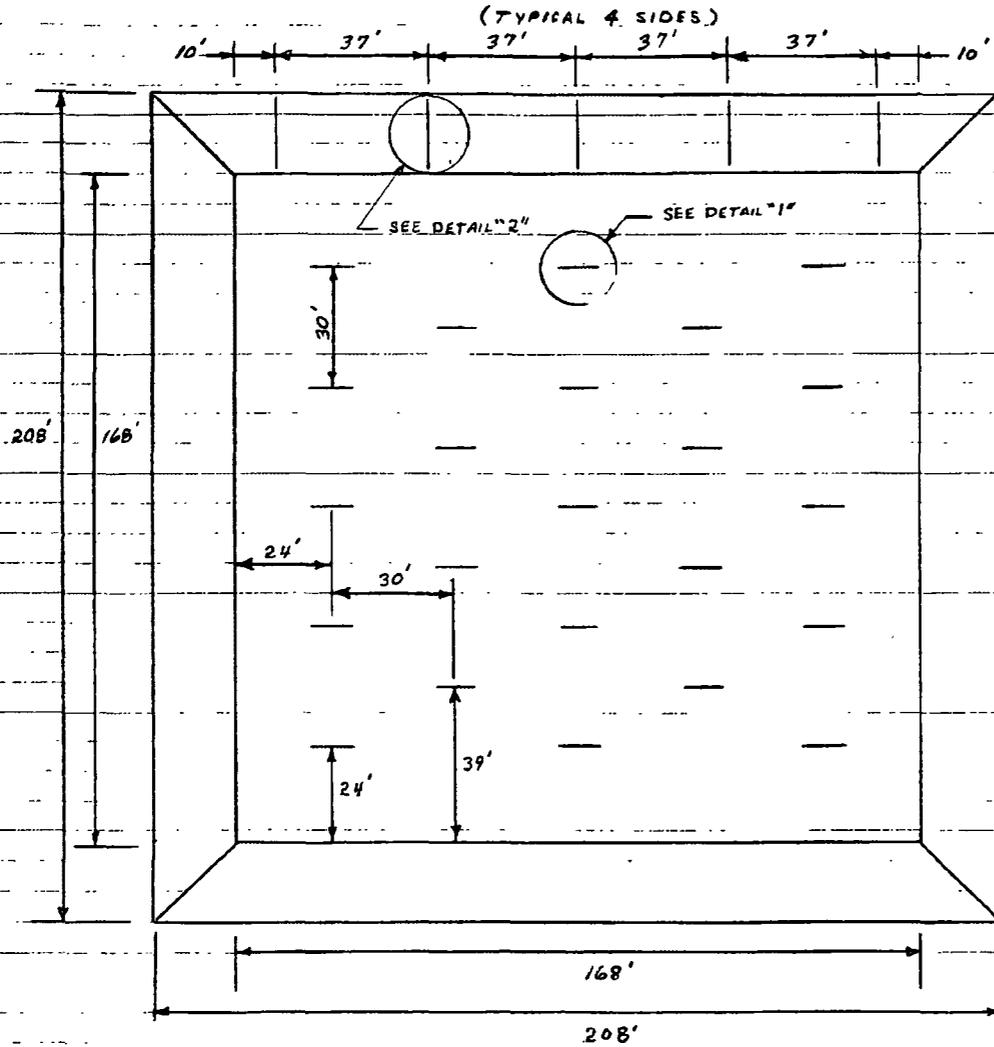
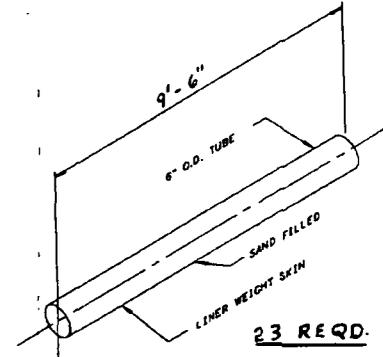
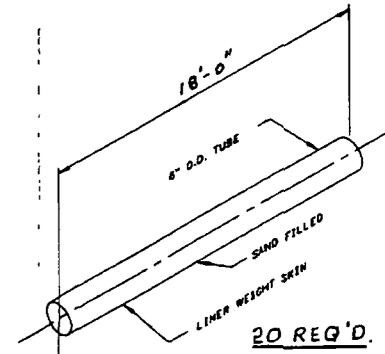
PROJECT CHACO LINED PONDS SKETCH # 4  
SUBJECT POND LINER WEIGHTS  
POND BOTTOM & SIDES (2 REQ'D)

DETAIL "1"  
POND LINER WEIGHT  
SCALE: NONE

DETAIL "2"  
POND LINER WEIGHT  
SCALE: NONE

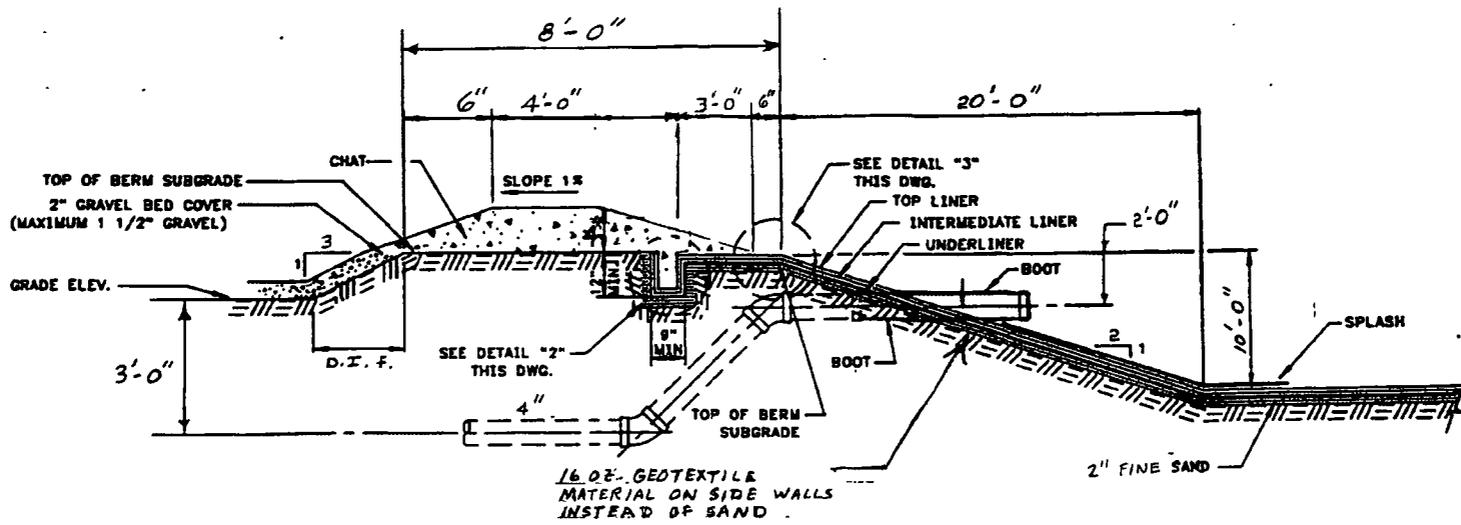
POND INLET  
SCALE: NONE

(2) 4" POND INLETS  
 COMPLETE WITH SPASH GUARD  
 INLET @ 2' BELOW TOP OF BERM  
 TIE TO BOOT - EXTEND 3'-0"  
 INTO POND BOTTOM  
 WIDTH AT BOTTOM 9'-0"

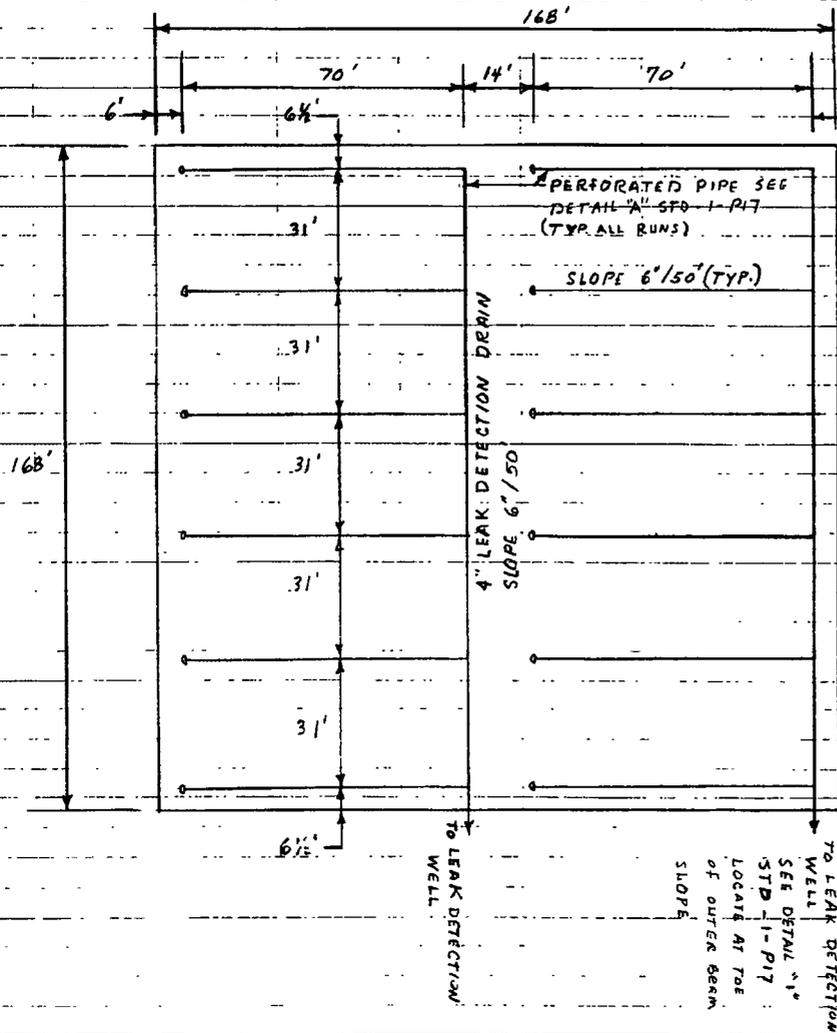
PROJECT CHACO LINED PONDS SKETCH #3  
 SUBJECT LEAK DETECTION SYSTEM  
LINER BOTTOM (2 REQUIRED)

NOTE: ALL CONNECTIONS THROUGH PRIMARY  
 LINER OR SECONDARY LINERS  
 SHALL HAVE A LINER BOOT  
 DETAIL "B" STD-1-P17

and bottom liner - 20 mil impermeable high-density polyethylene). A leak detection system was installed underlying the lined contact water pond between the intermediate and bottom liners. A copy of the construction plans and "as-builts" for the lined contact water pond are included in Appendix E.

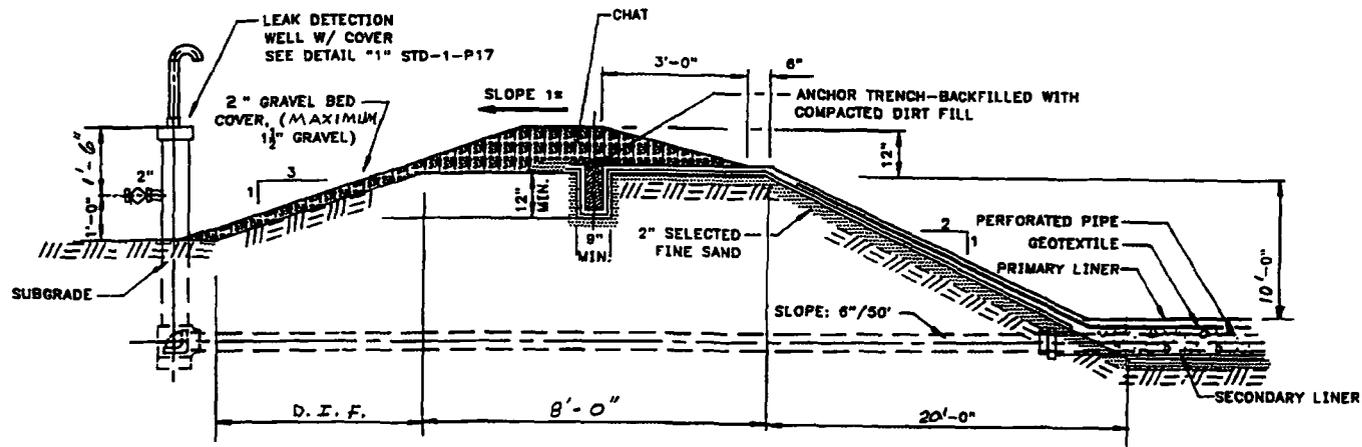
**SECTION "A-A"**  
SCALE: NONE

EVAPORATION POND  
PLANS AND SECTIONS
