ROC proposes the following as an Addendum to the Hobbs M-4 vent (1R428-76) Corrective Action Plan (CAP), submitted to the NMOCD on August 7, 2013. Page 2, Section Corrective Action Plan: text in blue lettering, below, will be added to the paragraph. Red lettering marked with a strike-through will be deleted.

**RE: Corrective Action Plan (CAP)
Rice Operating Company – Hobbs SWD System
Hobbs M-4 vent (1R428-76): UL/M sec. 4 T19S R38E**

Figure 2 – Soil Data, Proposed MW-2 and Proposed Liner

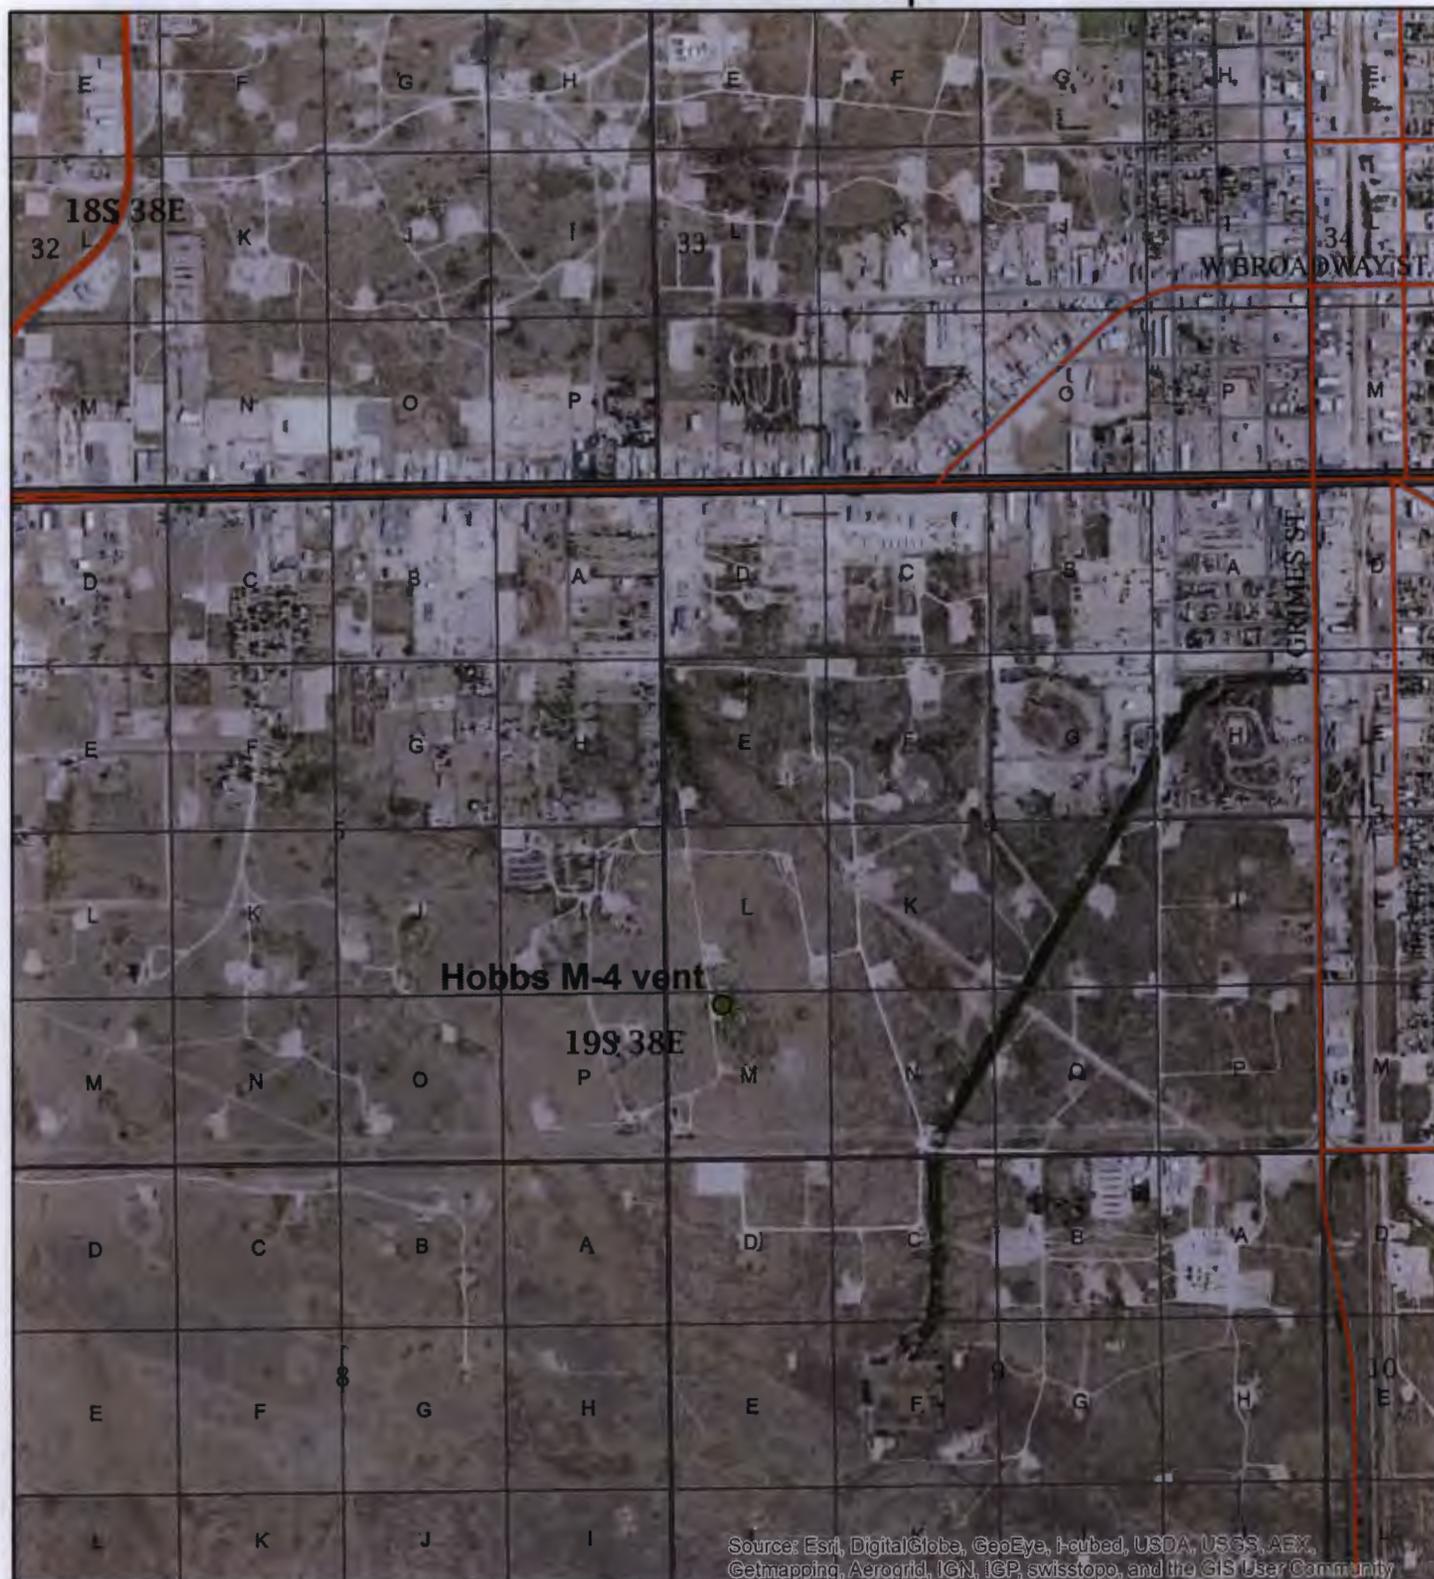
Figure 1

The site is located in Hobbs, New Mexico at UL/M sec. 4 T19S R38E as shown on the Site Location Map (Figure 1). Groundwater monitoring shows groundwater to be located at a depth of 31 feet.

Site Location Map

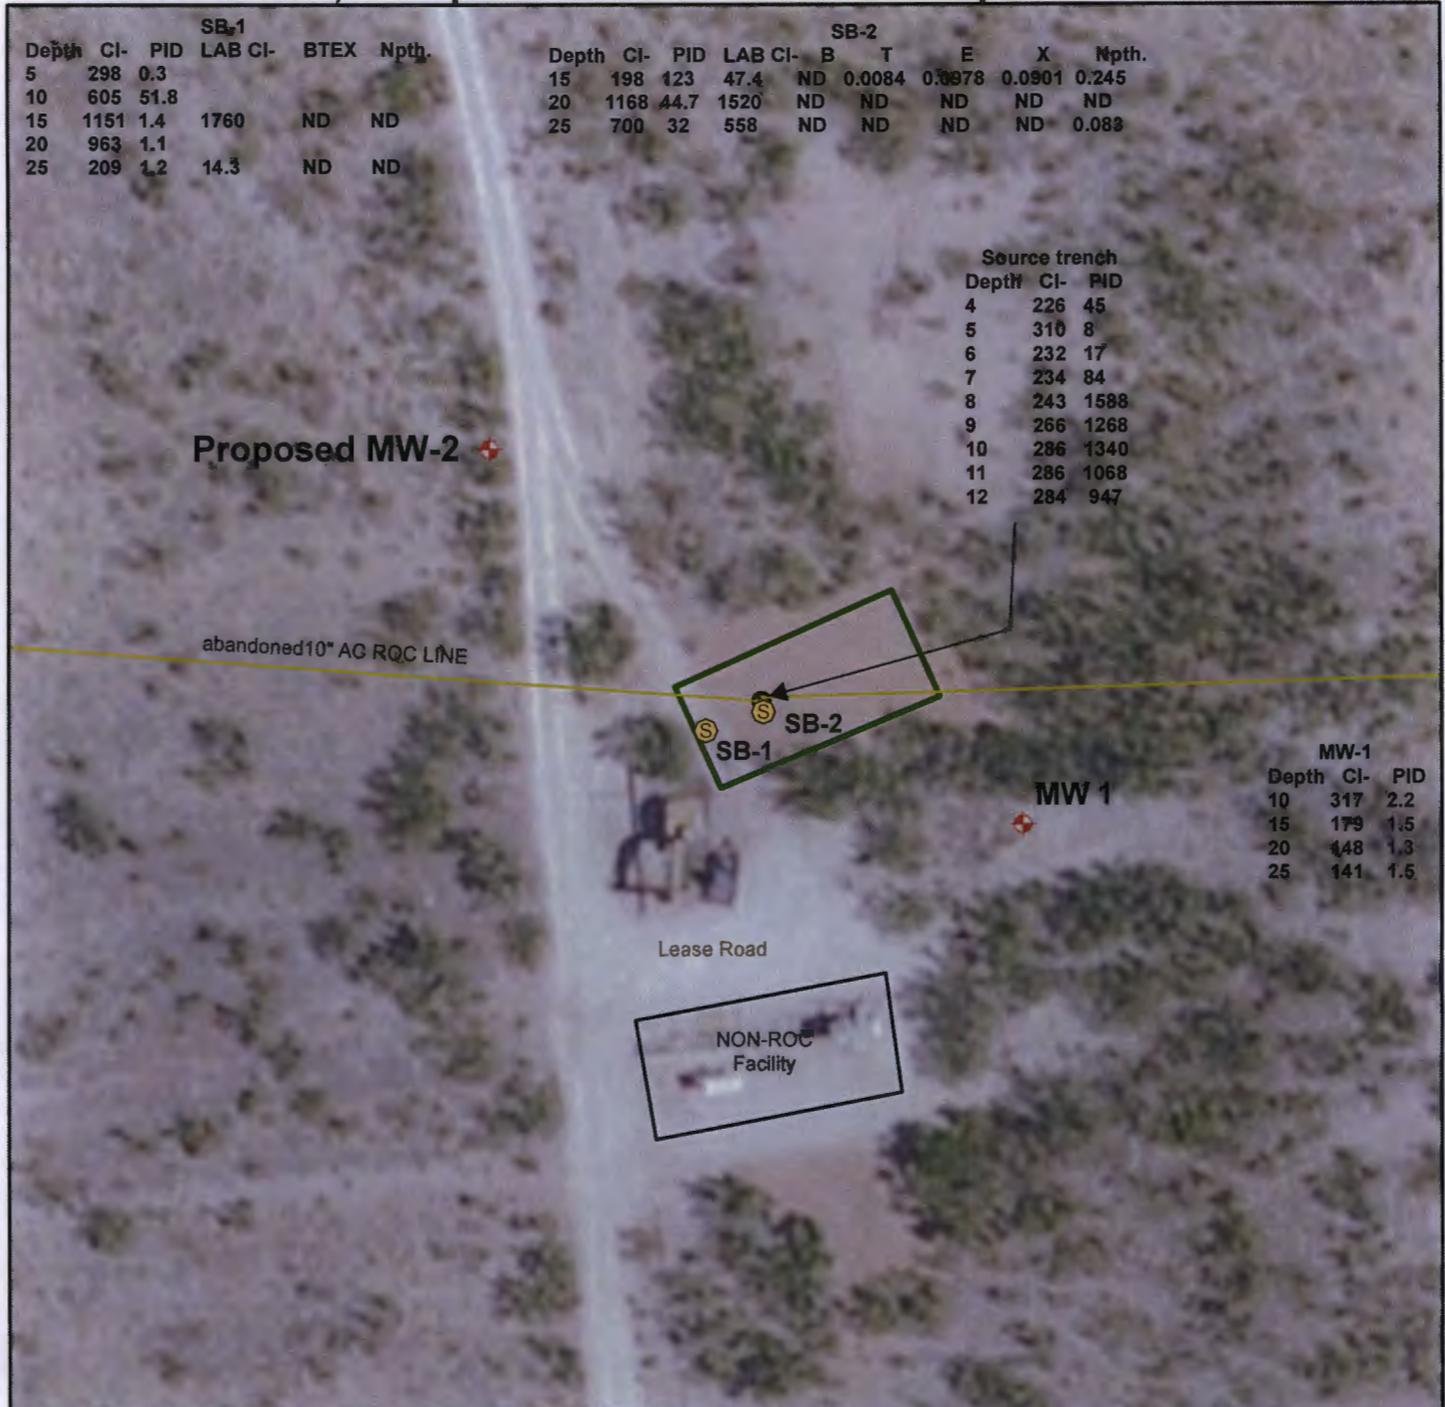
Figure 2

Soil Data, Proposed MW-2 and Proposed Liner

SB-1					
Depth	Cl-	PID	LAB	Cl-	BTEX Npth.
5	298	0.3			
10	605	51.8			
15	1151	1.4	1760	ND	ND
20	963	1.1			
25	209	1.2	14.3	ND	ND

SB-2									
Depth	Cl-	PID	LAB	Cl-	B	T	E	X	Npth.
15	198	123	47.4	ND	0.0084	0.0978	0.0901	0.245	
20	1168	44.7	1520	ND	ND	ND	ND	ND	
25	700	32	558	ND	ND	ND	ND	0.083

Source trench		
Depth	Cl-	PID
4	226	45
5	310	8
6	232	17
7	234	84
8	243	1588
9	266	1268
10	286	1340
11	286	1068
12	284	947

MW-1		
Depth	Cl-	PID
10	317	2.2
15	179	1.5
20	148	1.3
25	141	1.5

- ◆ MONITOR WELLS
- 32' x 63' PROPOSED REINFORCED POLY LINER @ 4-5' BGS

DGW = 31 FT

RECS recommends that ROC install a 20-mil reinforced poly liner measuring 32 ft x 63 ft at a depth of approximately 4-5 ft bgs (Figure 2). The liner will provide a barrier that will inhibit the downward migration of chlorides to groundwater. The soils placed above the liner will have a laboratory chloride reading no greater than 500 mg/kg and a field PID reading below 100 ppm. Excavated soil will be evaluated for use as backfill and any soils requiring disposal will be properly disposed of at a NMOCD approved facility. Upon completion of backfilling, the site will be seeded with a native vegetative mix and soil amendments will be added as necessary. Vegetation provides an infiltration barrier for the site, since plants capture water through their roots thereby reducing the amount of water traveling through the vadose zone to groundwater.

An Investigation and Characterization Plan (ICP) was submitted to NMOCD on April 13th, 2007 and approved on August 6th, 2007. As part of the ICP, ROC initiated work on the Hobbs M-4 junction box, which contained a vent. A trench was installed at the site to the depth of 12 ft bgs on September 5th, 2007. The samples were field tested for chlorides and hydrocarbons. Chloride values throughout the trench were relatively low; although, the hydrocarbon levels were elevated. To further delineate the site, two soil bores were installed on February 19th and 21st, 2008. As the bores were advanced, samples were taken every 5 ft and field tested for chlorides and hydrocarbons. Representative samples from the soil bores were taken to a commercial laboratory for analysis. In SB-1, the laboratory chloride analysis showed values of 1,760 mg/kg at 15 ft bgs and 14.3 mg/kg at 25 ft bgs. In SB-2, laboratory chloride analysis showed values of 47.4 mg/kg at 15 ft bgs, 1,520 mg/kg at 20 ft bgs and 558 mg/kg at 25 ft bgs. BTEX and Naphthalene in both soil bores at all depths were low (Figure 2).

On February 19th, 2008, MW-1 was installed approximately 63 ft down-gradient of the site. As the well was being installed, samples were taken every 5 ft and field tested for chlorides and hydrocarbons. The field samples for both chlorides and hydrocarbons were low (Figure 2). Groundwater monitoring at the site has occurred quarterly since the monitor well was installed. Since that time, the chlorides and Total Dissolved Solids (TDS) have decreased to the point where the constituents are now below the WQCC standards of 250 mg/L for chlorides and 1,000 mg/L for TDS. During the last sampling event on June 24th, 2013, the chloride value in MW-1 was 188 mg/L and the TDS value was 735 mg/L (Appendix A). One elevated sampling event occurred on December 10th, 2012, with a chloride value of 316 mg/L and a TDS value of 1,210 mg/L (Figure 3). This elevated sampling event prompted the desire to take further actions to remediate the vadose zone and delineate groundwater through a Corrective Action Plan.

In order to determine if there is an up-gradient groundwater source for contamination at the site, RECS recommends that ROC install a monitor well (MW-2) approximately 100 ft up-gradient of the site (Figure 2). The monitor well will be sampled quarterly in conjunction with MW-1. Once the monitor wells at the site have been analyzed for chloride and TPH readings, ROC will either submit a groundwater remedy to NMOCD to address groundwater quality at the site or submit a 'remediation termination' request for site closure.

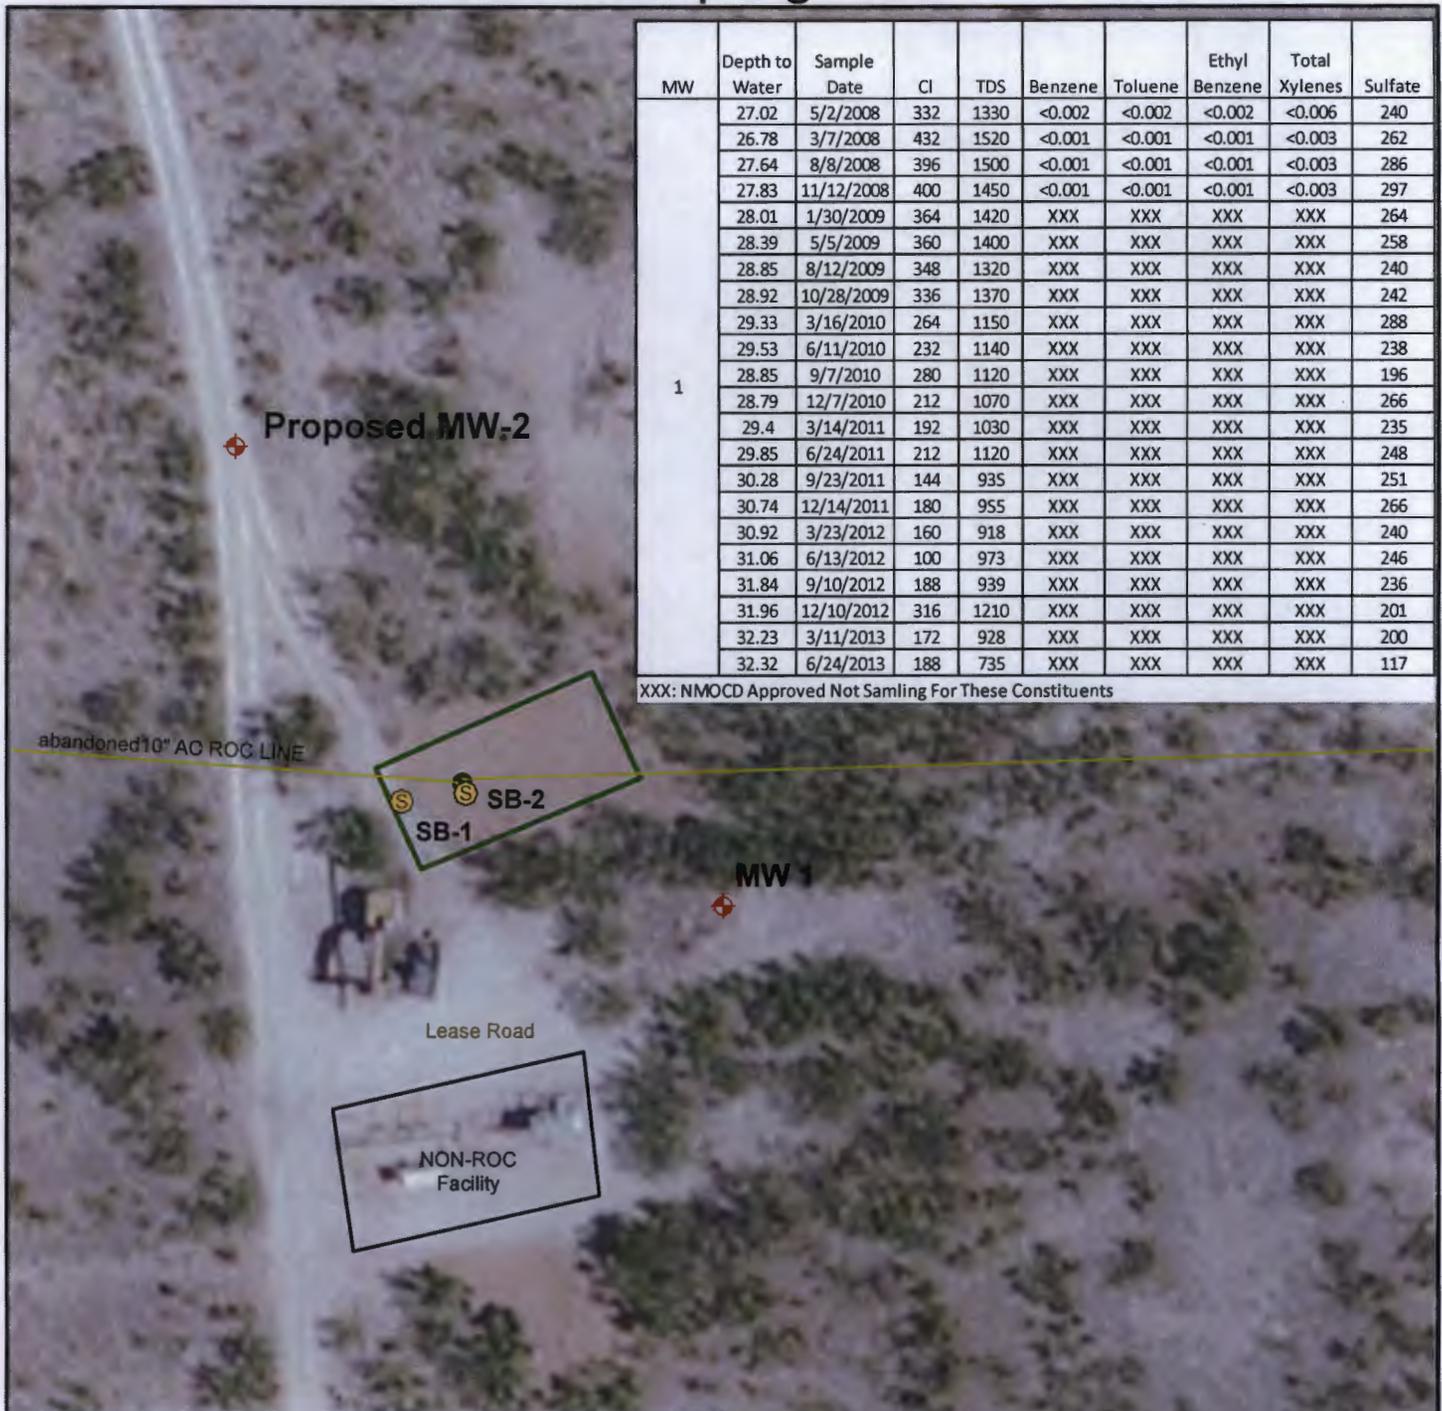
Figure 3

MW Sampling Data

MW	Depth to Water	Sample Date	Cl	TDS	Benzene	Toluene	Ethyl Benzene	Total Xylenes	Sulfate
1	27.02	5/2/2008	332	1330	<0.002	<0.002	<0.002	<0.006	240
	26.78	3/7/2008	432	1520	<0.001	<0.001	<0.001	<0.003	262

XXX: NMOCD Approved Not Sampling For These Constituents

Monitoring of the near-source well (MW-1) has shown chloride concentrations consistently near or below 250 mg/L. The two most recent quarterly samples resulted in a concentration of 172 mg/L and 188 mg/L, respectively. Based on these recent samples, ROC proposes to continue monitoring MW-1 for two additional quarters to determine if concentrations will remain below WQCC standards. After the two quarters are obtained, ROC will submit a report with recommendations. ~~In order to determine if there is an up-gradient groundwater source for contamination at the site, RECS recommends that ROC install a monitor well (MW-2) approximately 100 ft up gradient of the site (Figure 2). The monitor well will be sampled quarterly in conjunction with MW-1. Once the monitor wells at the site have been analyzed for chloride and TPH readings, ROC will either submit a groundwater remedy to NMOCD to address groundwater quality at the site or submit a ‘remediation termination’ request for site closure.”~~
