**From:** Hansen, Edward J., EMNRD  
**Sent:** Wednesday, September 11, 2013 4:40 PM  
**To:** Hack Conder (hconder@riceswd.com)  
**Cc:** Leking, Geoffrey R, EMNRD; Laura Pena (lpena@riceswd.com); Katie Jones <kjones@riceswd.com> (kjones@riceswd.com); Scott Curtis (scurtis@riceswd.com)  
**Subject:** Remediation Plan (1R427-31) Termination - ROC EME Penroc W.E.B. EOL Site

RE: Termination Request  
EME Penroc W.E.B. EOL (1R427-31): UL/C Sec. 13, T21S, R35E  
RICE Operating Company – Eunice Monument Eumont SWD System

**RICE OPERATING COMPANY  
JUNCTION BOX FINAL REPORT**

**EME W.E.B. EOL**

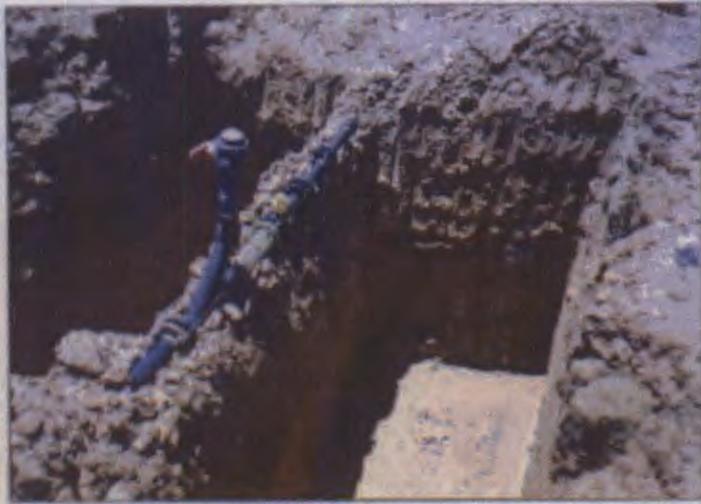
↑ Excavation ↓

General Description of Remedial Action: The junction box site was delineated vertically and laterally producing a 10 x 10 x 8 ft bgs excavation. TPH was non-detect and chloride concentrations exhibited a vertical and lateral decline. However, the bottom composite yielded 2800 ppm. The excavated soil was blended on-site (496 ppm) and then backfilled into the hole. A watertight junction box was built over the location. Due to the elevated chloride concentration in the bottom composite, a soil bore was made adjacent to the junction. Returns were continuously tested for chloride during the boring until 30 ft bgs when a conclusive declination trend was observed (see graph). The impact remaining in place does not present a threat to human health, livestock, or groundwater at 200 feet below surface. The surface is expected to re-vegetate at a normal rate.

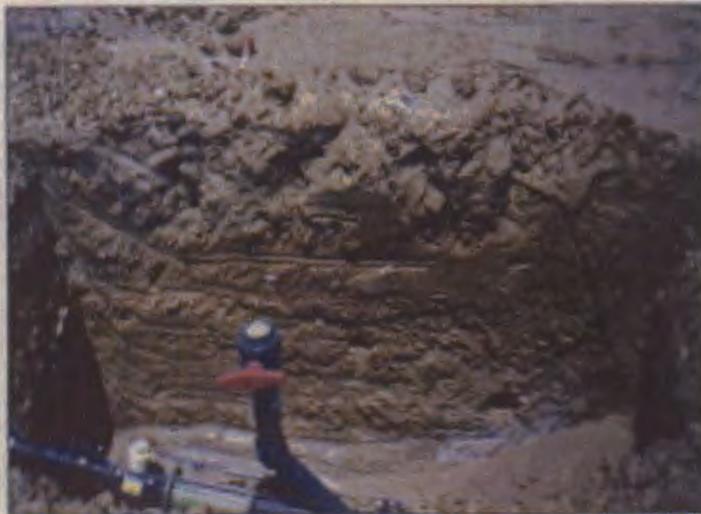
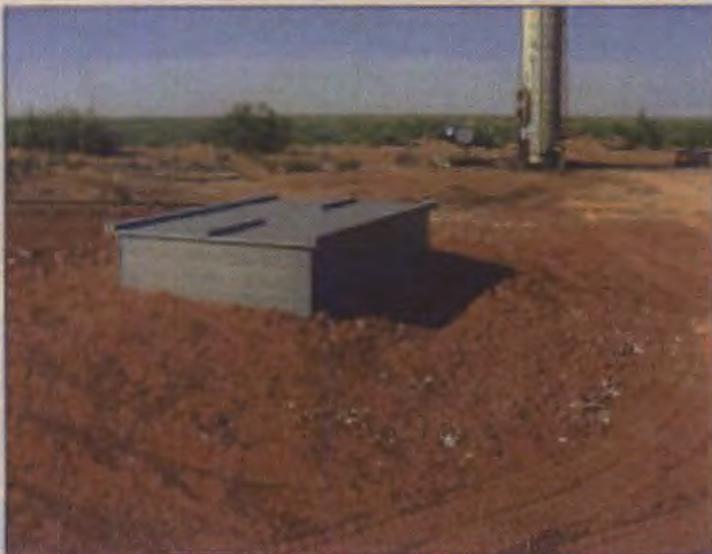
Backfilled With New Junction Box

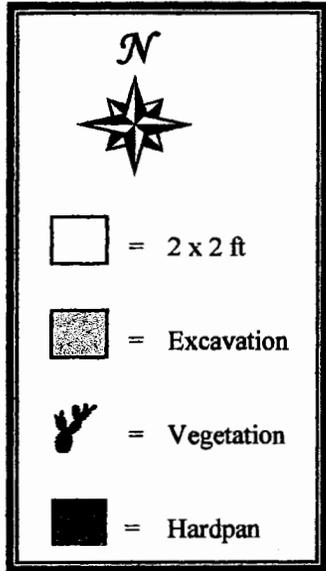
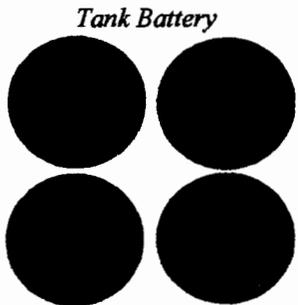
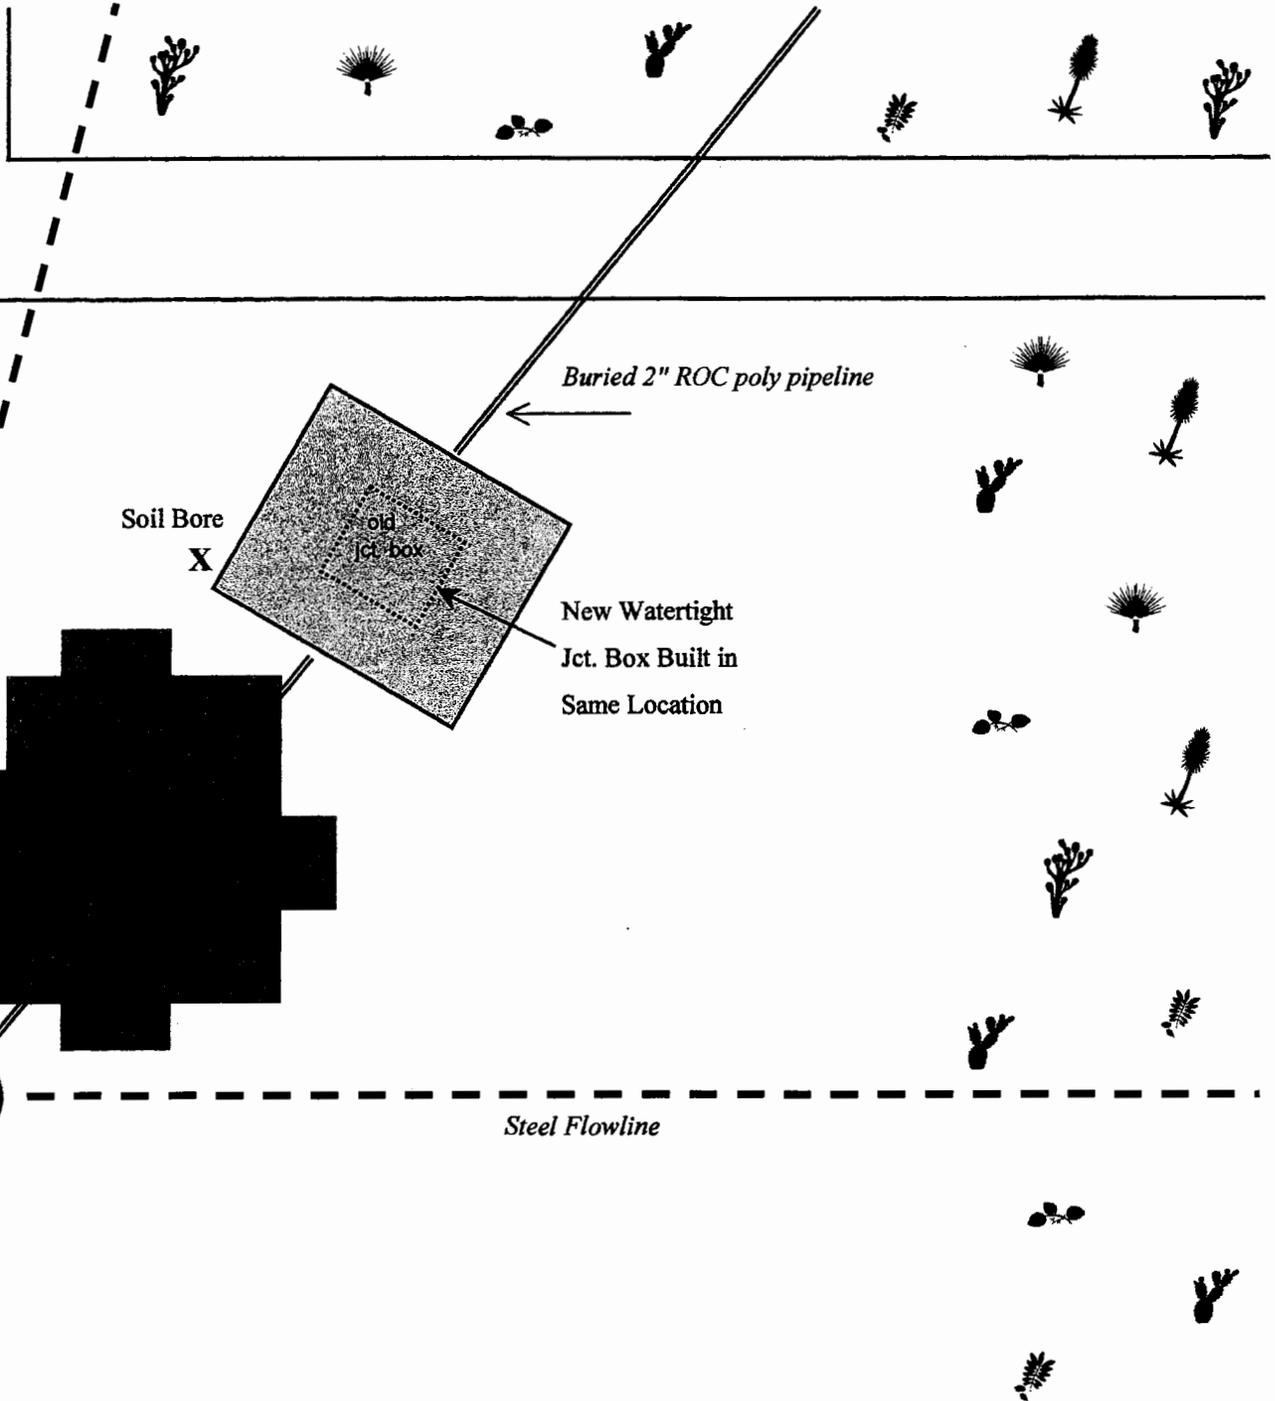
# EME W.E.B. EOL

10 x 10 x 8 ft deep Excavation

Steel Flowline

Soil Bore X

Buried 2" ROC poly pipeline

old Jct. box

New Watertight Jct. Box Built in Same Location

Heater Treaters

Tank Battery

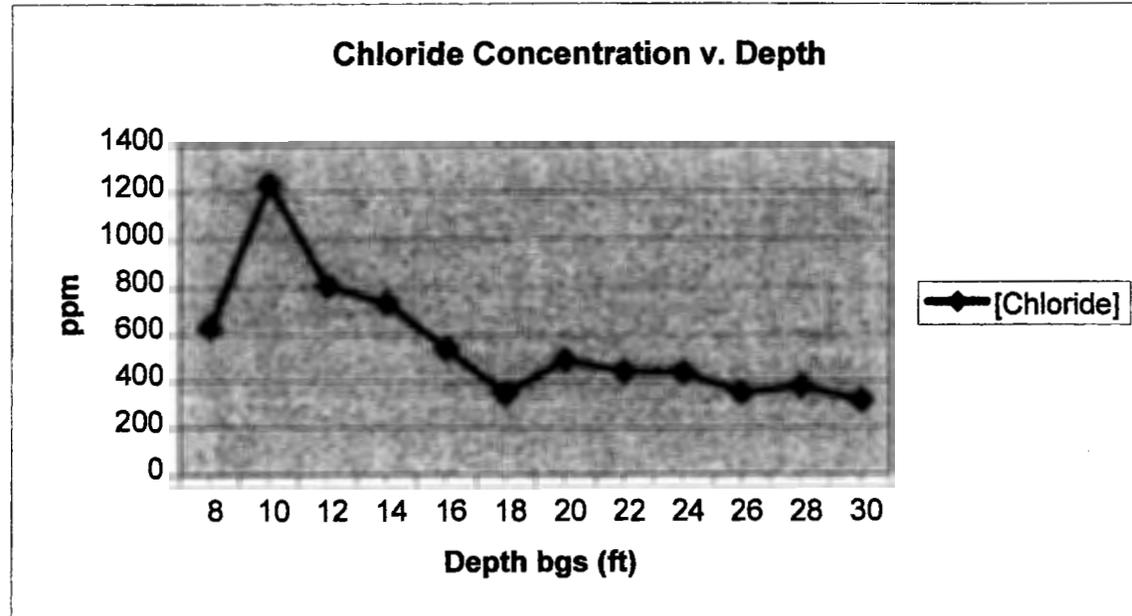
Soil Bore Next To Junction

Depth bgs (ft)	[Cl <sup>-</sup> ] ppm
8	627
10	1234
12	803
14	729
16	534
18	345
20	486
22	438
24	435
26	347
28	376
30	314

Groundwater = >200 ft

To further investigate the depth of chloride presence, one soil bore was installed at the site September 18<sup>th</sup>, 2003. As the bore was advanced, samples were taken at regular intervals for chloride field testing. A representative sample was taken to a commercial laboratory for confirmation of field numbers. SB-1 returned a laboratory chloride result of 195 mg/kg at 30 ft bgs.

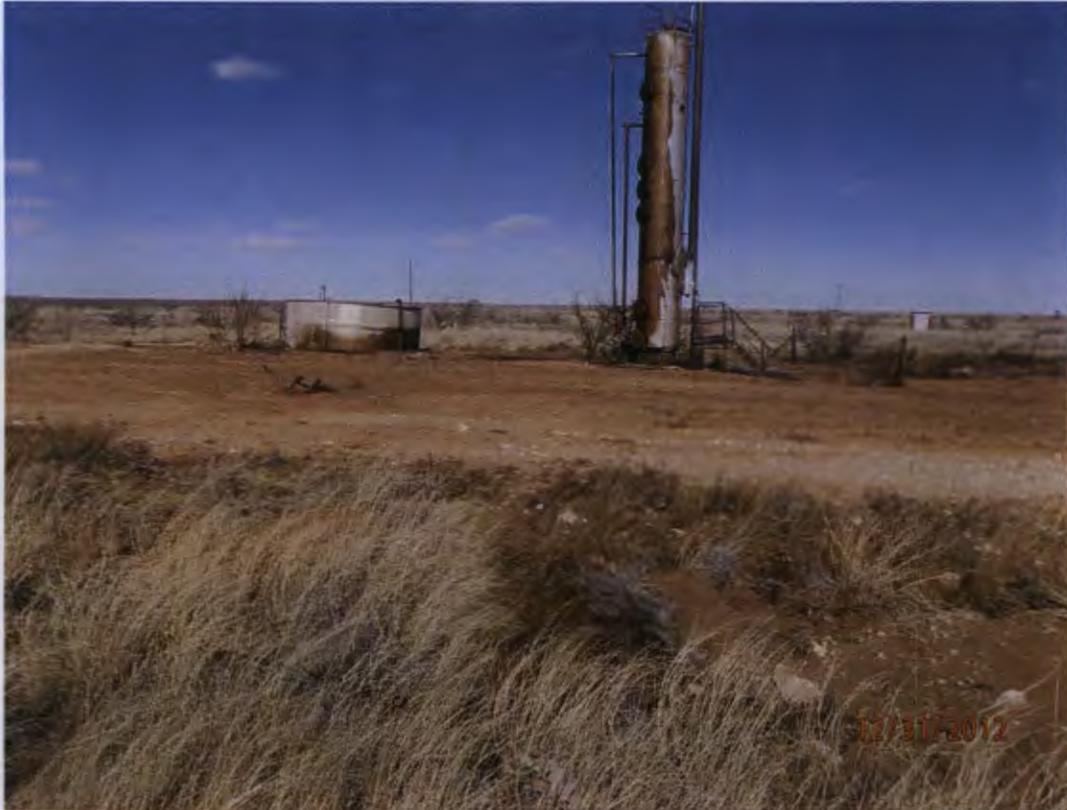
Facing North

12/31/2012

Vegetation has rebounded at this site; vegetation will act as an evapo-transpiration barrier that will also inhibit the downward migration of chlorides and hydrocarbons. Plants capture water through their roots and so reduce the amount of water infiltrating below the root zone. A junction box is no longer needed at the site.

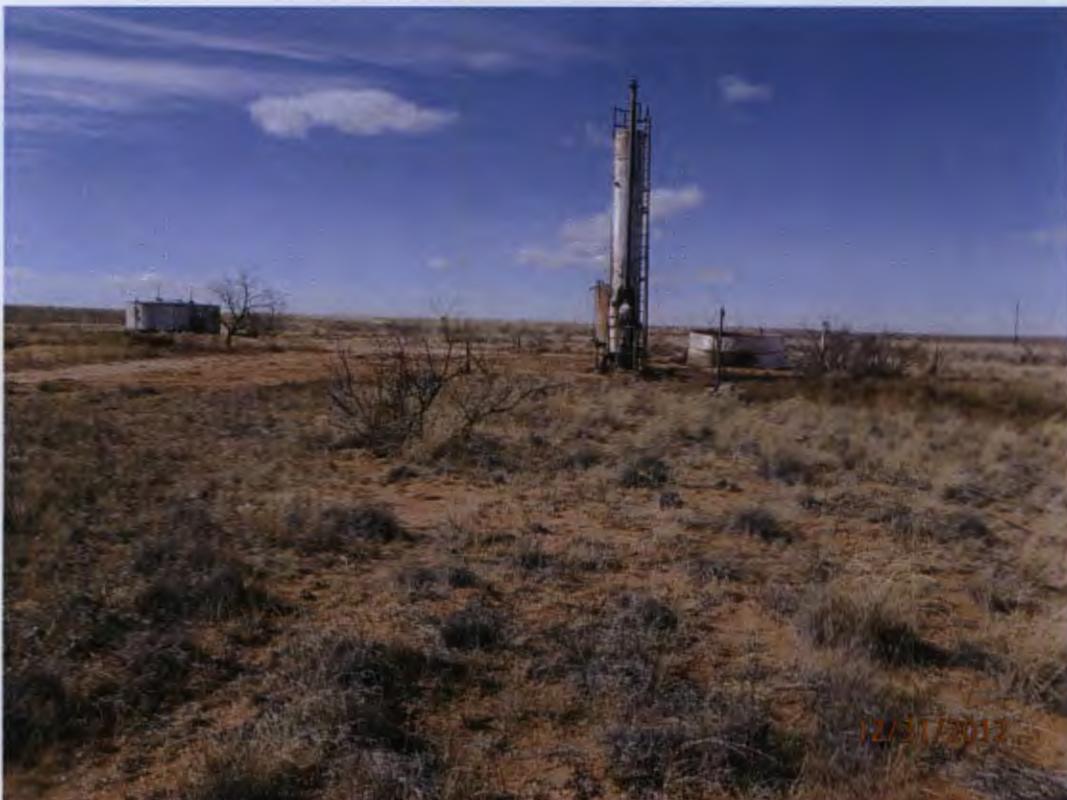
Facing West

12/31/2012
