**From:** Hansen, Edward J., EMNRD  
**Sent:** Tuesday, September 17, 2013 10:18 AM  
**To:** Hack Conder (hconder@riceswd.com)  
**Cc:** Leking, Geoffrey R, EMNRD; Laura Pena (lpena@riceswd.com); Katie Jones <kjones@riceswd.com> (kjones@riceswd.com); Scott Curtis (scurtis@riceswd.com)  
**Subject:** Remediation Plan (1R427-99) Termination - ROC EME K-36 Site

**RE: Termination Request  
for the Rice Operating Company's  
EME K-36 Site  
Unit Letter K, Section 36, T20S, R36E, NMPM, Lea County, New Mexico  
Remediation Plan (1R427-99) Termination**

RE: Termination Request  
EME K-36 (1R427-99): UL/K, Sec. 36, T20S, R36E  
RICE Operating Company – Eunice Monument Eumont SWD System

RE: Further Investigation & Termination Request  
EME K-36 (1R427-99): UL/K, Sec. 36, T20S, R36E  
RICE Operating Company – Eunice Monument Eumont SWD System

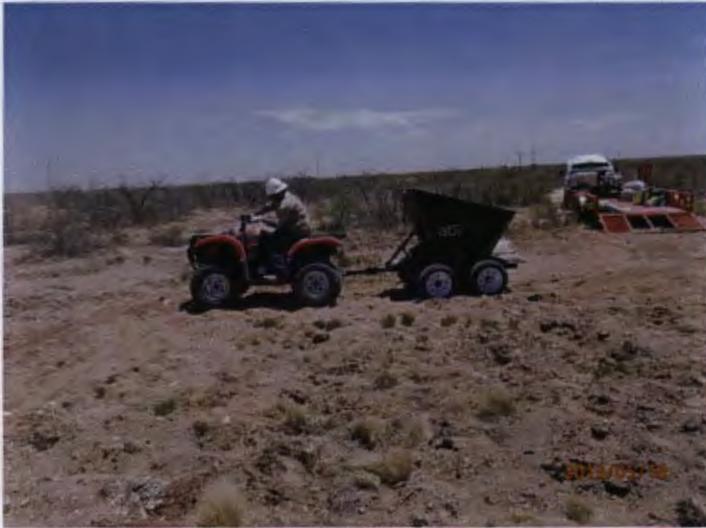
Spreading amendments, facing east

5/16/2013

On 5/16/2013, soil amendments were added to the site and the site was seeded with a blend of native vegetation. Vegetation will act as an evapo-transpiration barrier that will also inhibit the downward migration of chlorides and hydrocarbons. Plants capture water through their roots and so reduce the amount of water infiltrating below the root zone.

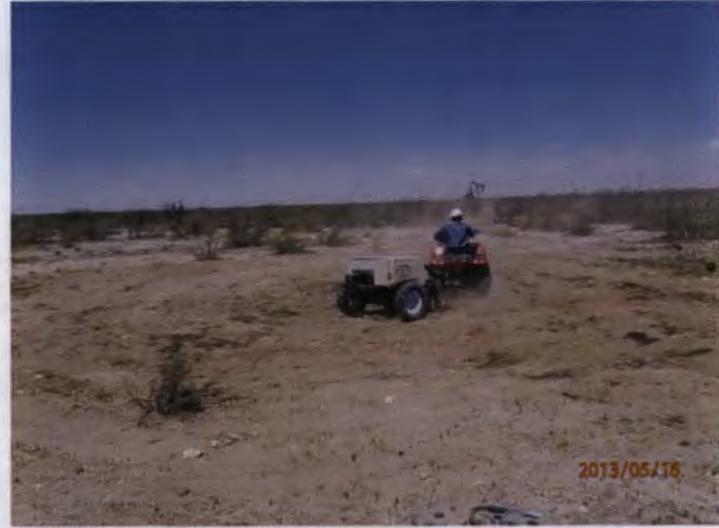
Seeding and tilling site, facing north

5/16/2013

Custom seed mix <input checked="" type="checkbox"/>	Prescribed mix <input type="checkbox"/>	Seed mix name: 3 Lbs. Lea Co. Mix, 3 Boyd Johnston Lbs. Race Horse Oats and Mix ½ lbs. 3 Lbs. Sudan Grass	Seeding date: 5/16/2013
Broadcast <input checked="" type="checkbox"/>			
Method: Mechanical Seeder			
Soil conditions during seeding: Dry <input checked="" type="checkbox"/> Damp <input type="checkbox"/> Wet <input type="checkbox"/>			
Photos attached <input type="checkbox"/>	Observations: The seed was tilled into the site.		
Number of photos:

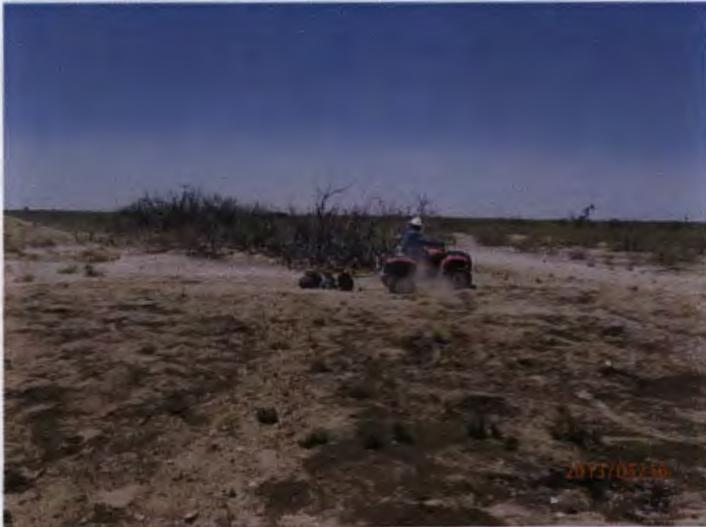
Tilling site, facing west

5/16/2013

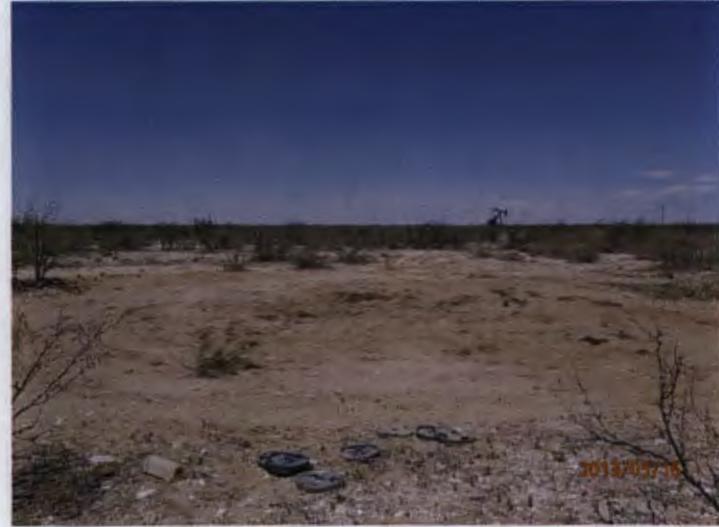
Site completed, facing north

5/16/2013

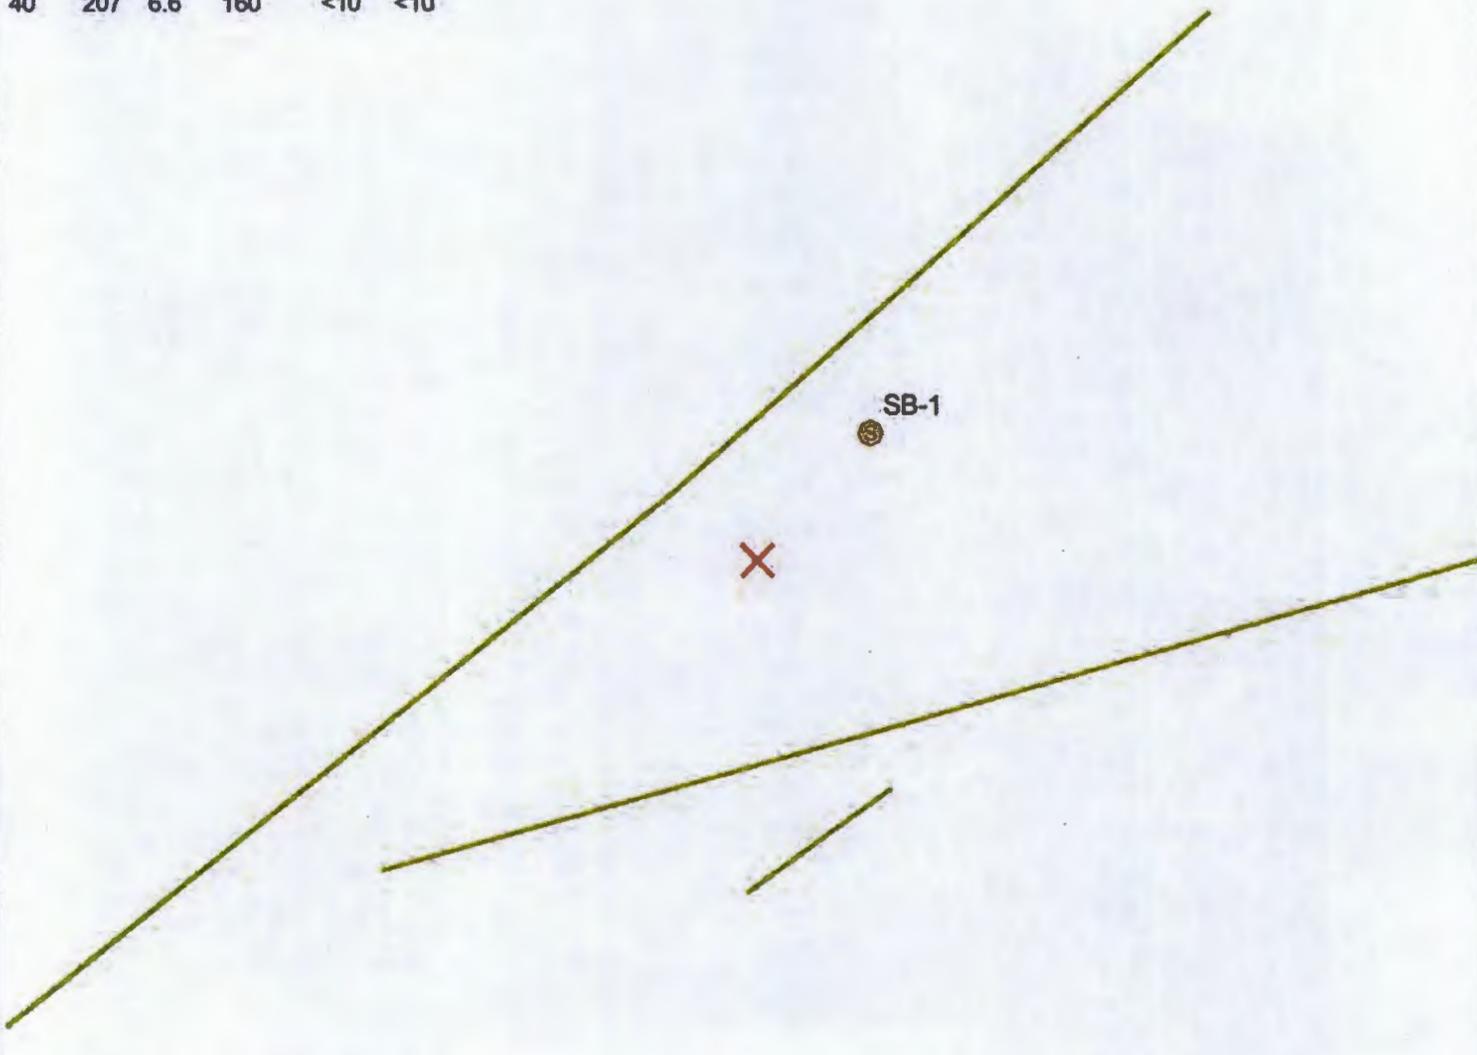
# Soil Bore Installation

Depth	Cl-	PID	LAB Cl-	GRO	DRO
SS	146	0.1			
5	394	0.2			
10	178	0.1			
15	451	0.2			
20	543	0.2			
25	626	0.5	688	<10	<10
30	478	0.3			
35	289	0.3			
40	207	6.6	160	<10	<10

DGW = 115

To further investigate the depth of chloride presence, a soil bore was initiated on July 25, 2013 at 12 ft northeast of the former junction box site. The boring was advanced to a depth of 40 ft below ground surface (bgs) with soil samples collected every 5 ft. Each sample was field titrated for chlorides and field screened using a PID for hydrocarbons, resulting in concentrations that did not change with depth. The 25 ft and 40 ft samples were sent to a commercial laboratory for analysis. The 25 ft samples resulted in a chloride concentration of 688 mg/kg and concentrations of GRO and DRO below detectable limits. The 40 ft sample resulted in a chloride concentration of 160 mg/kg and concentrations of GRO and DRO below detectable limits. The entire bore hole was plugged with bentonite to ground surface.

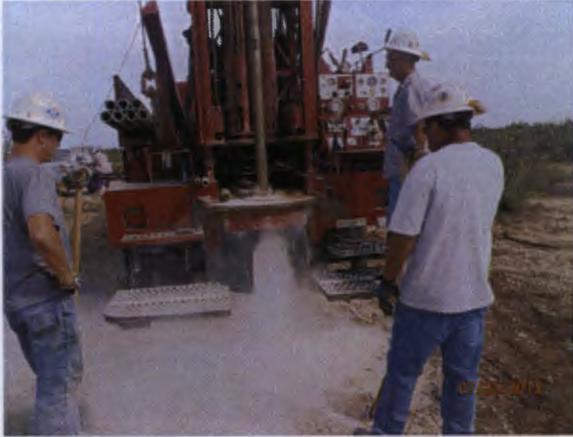
Drilling SB-1, facing west

7/25/13

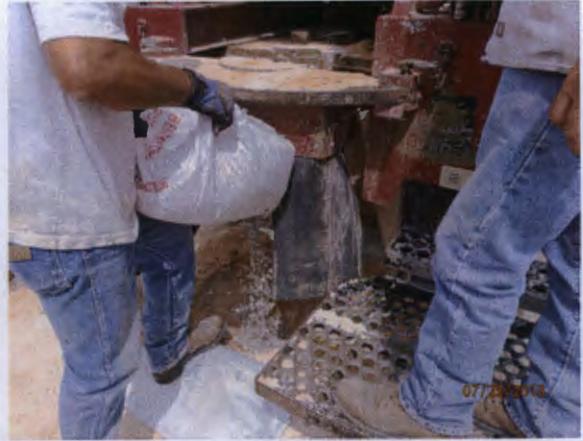
Plugging SB-1 in total with bentonite

7/25/13
