**From:** Hansen, Edward J., EMNRD  
**Sent:** Monday, September 23, 2013 4:02 PM  
**To:** Hack Conder (hconder@riceswd.com)  
**Cc:** Leking, Geoffrey R, EMNRD; Laura Pena (lpena@riceswd.com); Katie Jones <kjones@riceswd.com> (kjones@riceswd.com); Scott Curtis (scurtis@riceswd.com)  
**Subject:** Remediation Plan (1R427-48) Termination - ROC EME H-29 Site

RE: Termination Request  
EME H-29 (1R427-48): UL/H, Sec. 29, T21S, R36E  
RICE Operating Company – Eunice Monument Eumont (EME) SWD System

**EME H-29  
(1R427-48)**

**RICE OPERATING COMPANY  
JUNCTION BOX FINAL REPORT**

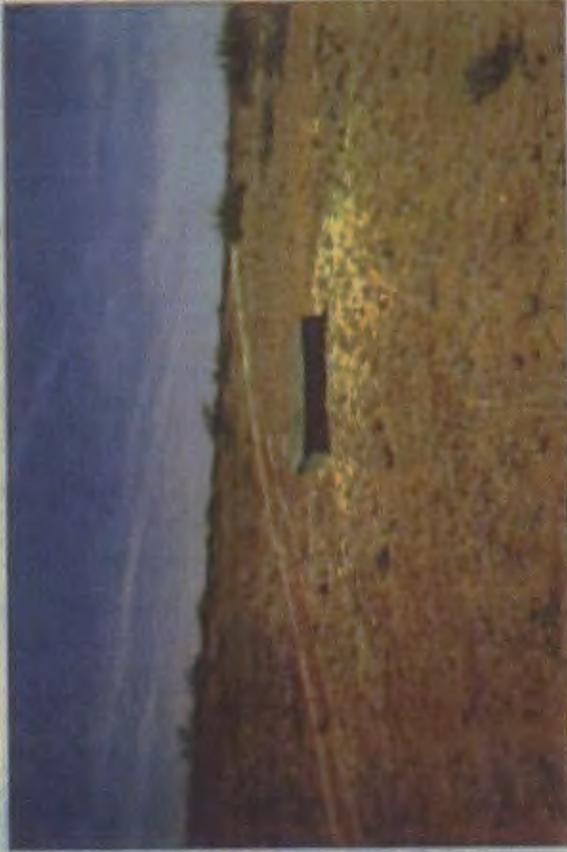
Undisturbed box prior to NORM removal

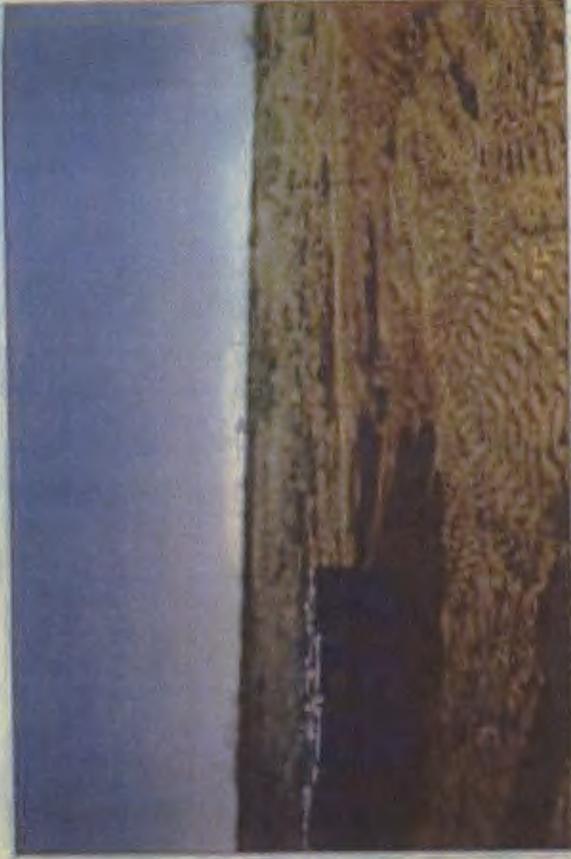
NORM Excavation

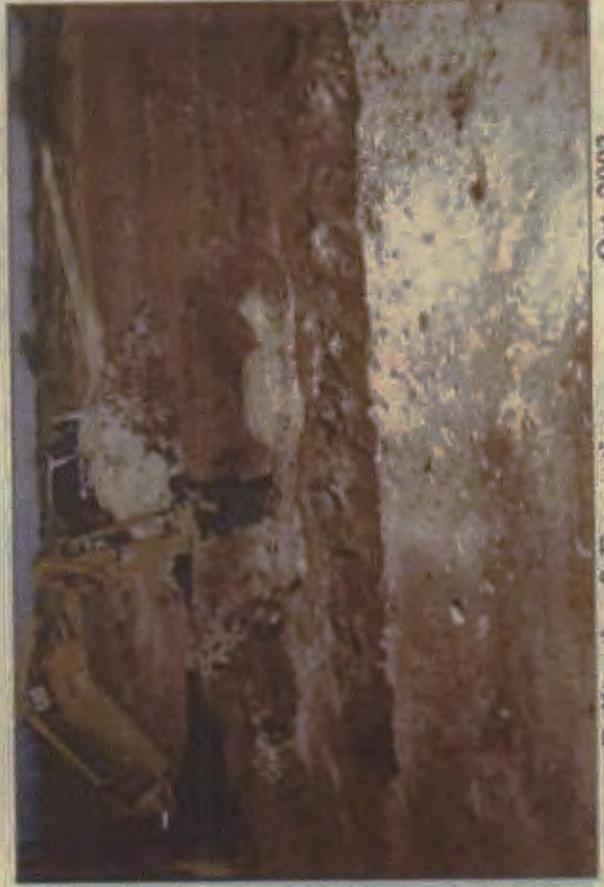
Oct. 2003

Delineation & Excavation

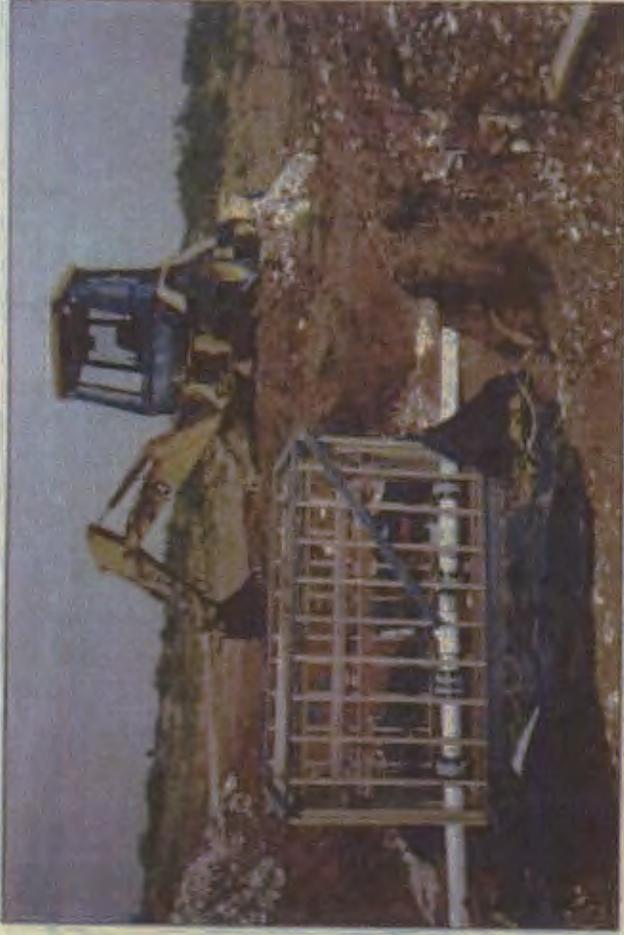
Construction of New Junction Box 50 ft East

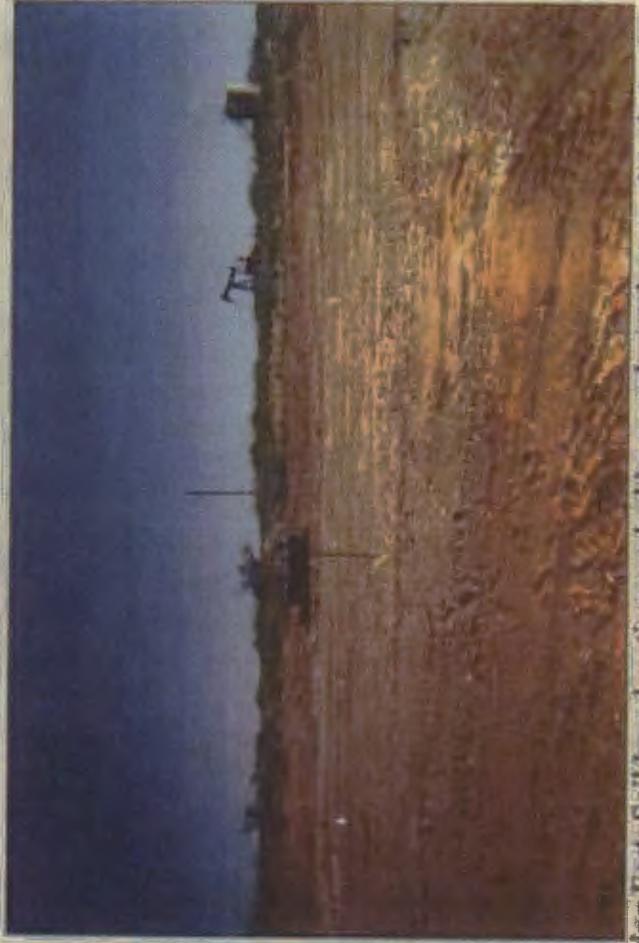
Looking East: Soil bore location marked by wooden stake; new box in background

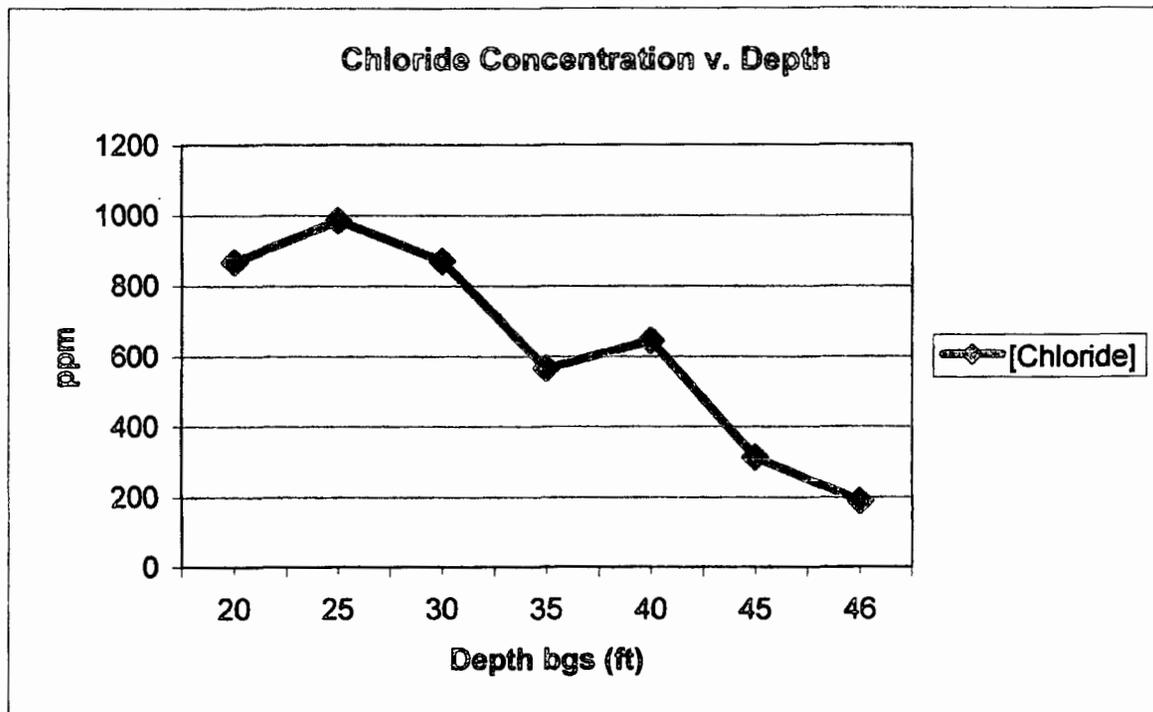
**CHLORIDE CONCENTRATION CURVE**

Depth bgs (ft)	[Cl <sup>-</sup> ] ppm
20	868
25	986
30	871
35	566
40	645
45	314
46	189

Groundwater = 174 ft

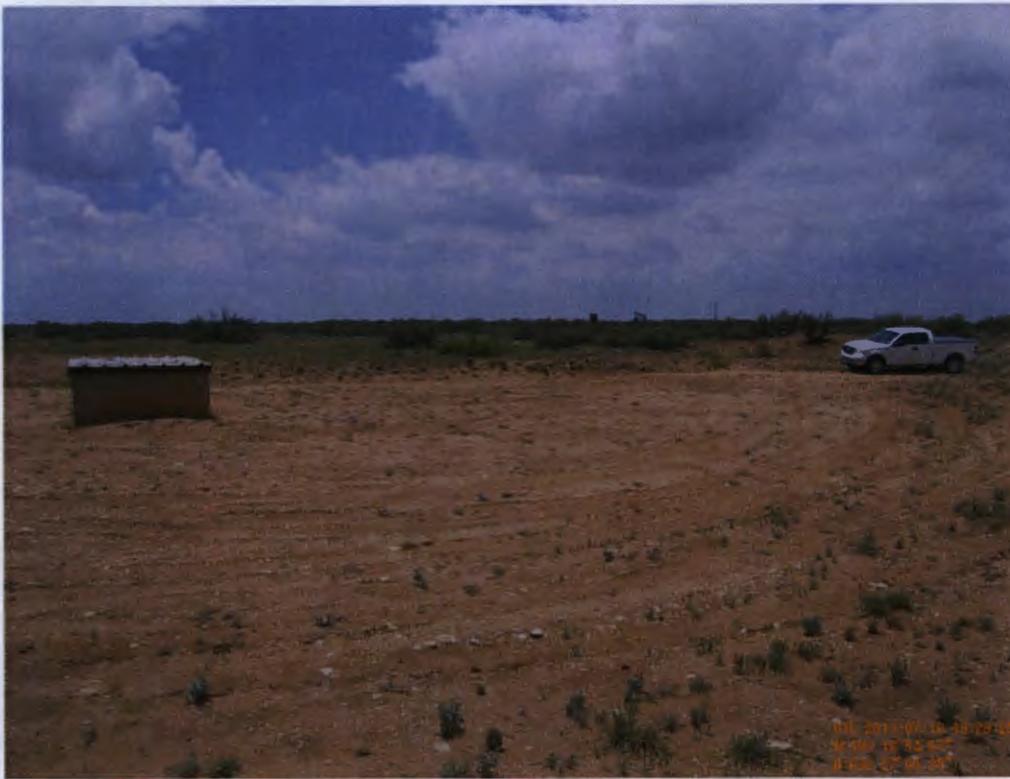
7/16/2013

Facing west

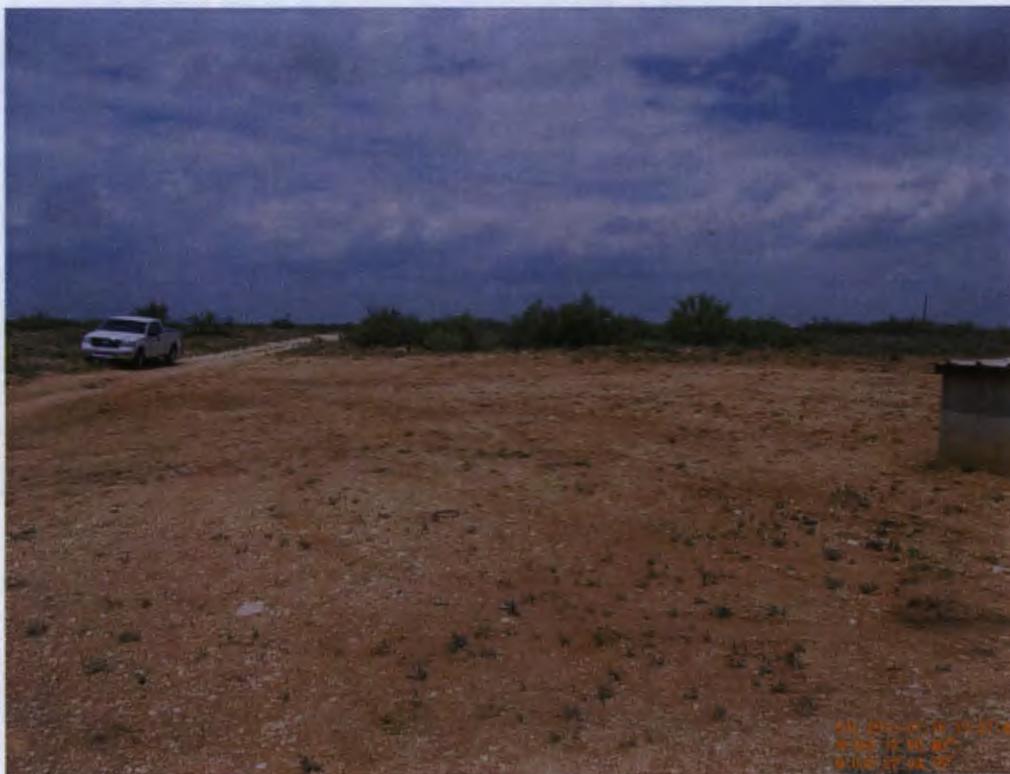
7/16/2013

Facing north
