**RE: CAP Report and Termination Request
Rice Operating Company – BD SWD System
BD Jct. C-23-1 (1R426-279): UL/C sec. 23 T22S R37E**

CAP Report

**BD jct. C-23-1 (1R426-279)
Unit Letter C, Section 23, T-22-S, R-37-E**

BD Jct. C-23-1 (1R426-279)
Unit Letter C, Section 23, T22S, R37E

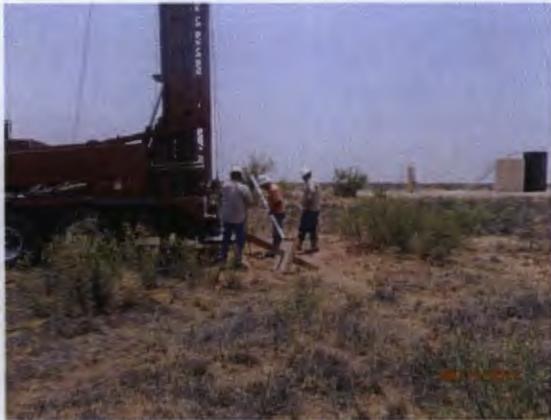
Pulling MW-1, facing south 6/19/13

The two monitor wells (MW-1 and MW-2) were plugged and abandoned on June 19th, 2013. They were plugged with a 1-3% bentonite/concrete slurry with a 3 foot concrete cap. Documentation of these activities will be found in Appendix A.

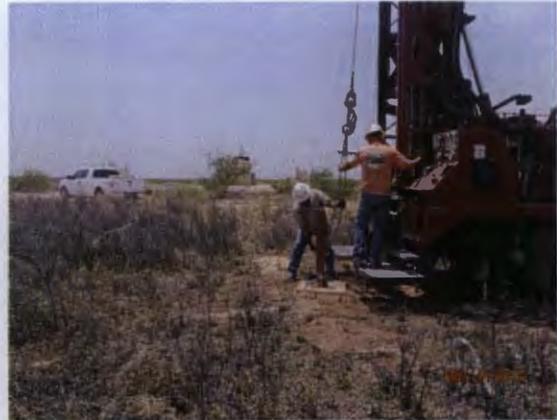
Pulling MW-2, facing west 6/19/13

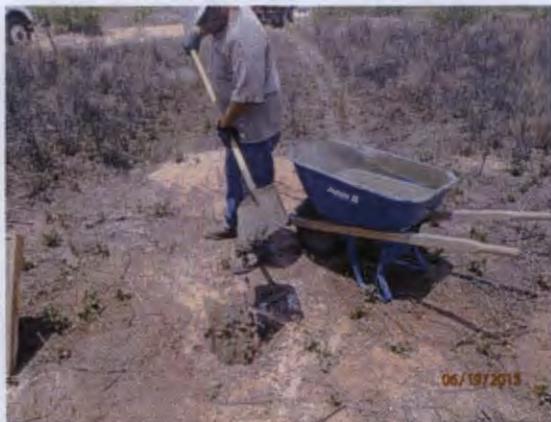
Plugging MW-2 with a 1-3% bentonite/concrete slurry and 3 ft concrete cap, facing north 6/19/13

Client	Rice Operating
Contractor	Harrison & Cooper
Date Completed	6/19/2013
Site	Jct. C-23-1
Well ID	MW-2
Casing Diameter	2"
Well Depth	73'
Casing Material	PVC
Plugging Material	Portland/Bentonite Slurry
Slurry Interval	3'-73'
Cement Interval	0'-3'

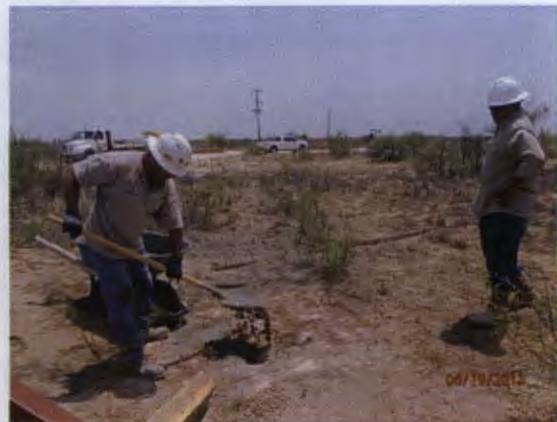
Plugging MW-1 with a 1-3% bentonite/concrete slurry and 3 ft concrete cap, facing north 6/19/13

Client	Rice Operating
Contractor	Harrison & Cooper
Date Completed	6/19/2013
Site	Jct. C-23-1
Well ID	MW-1
Casing Diameter	2"
Well Depth	72'
Casing Material	PVC
Plugging Material	Portland/Bentonite Slurry
Slurry Interval	3'-72'
Cement Interval	0'-3'

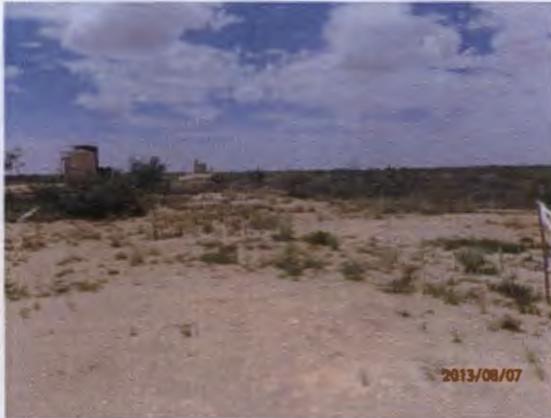
8/7/2013

site prior,
facing west

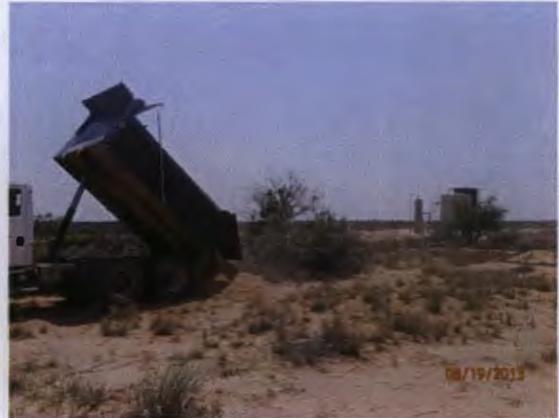
8/19/2013

importing blow sand,
facing southwest

Beginning on August 19th, 2013, RECS personnel were on site to prepare the site for seeding. A total of 24 yards of top soil was imported to the site to serve as a seed bed. A sample of this top soil was field tested for hydrocarbons and returned a result of 0 ppm. The sample was then taken to a commercial laboratory for analysis and returned a chloride reading of non-detect. On August 26th, 2013, soil amendments were added to the soil and the site was seeded with a blend of native vegetation. A silt net fence was placed around the site to retard erosion and maintain seed integrity. Seeding documentation will be found in Appendix B.

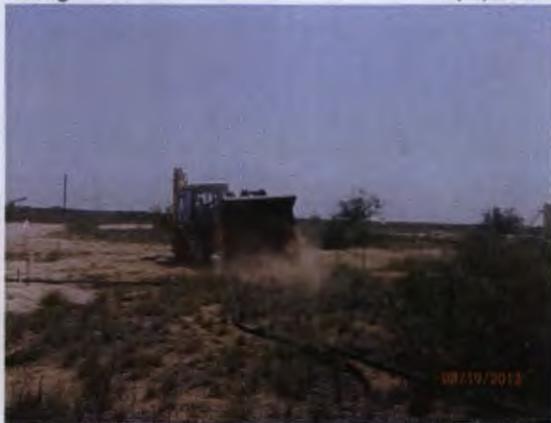
8/19/2013

spreading blow sand,
facing south

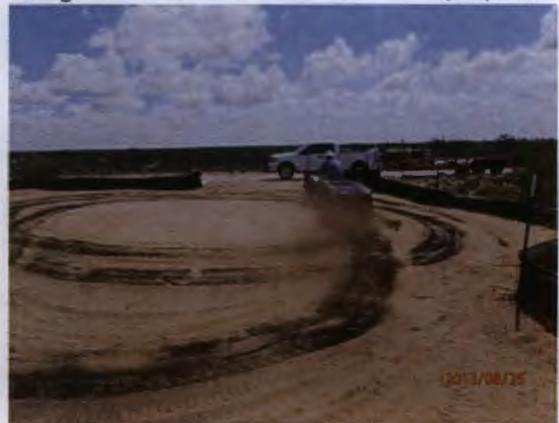
8/26/2013

spreading amendments,
facing south

Fertilizer <input checked="" type="checkbox"/>	Hay <input type="checkbox"/>	Other <input checked="" type="checkbox"/>
Type: BIO NHANCE		Describe: 3 BAGS POTTING MIX 1 BAG OF MANURE
Lbs/acre: 6 BAGS

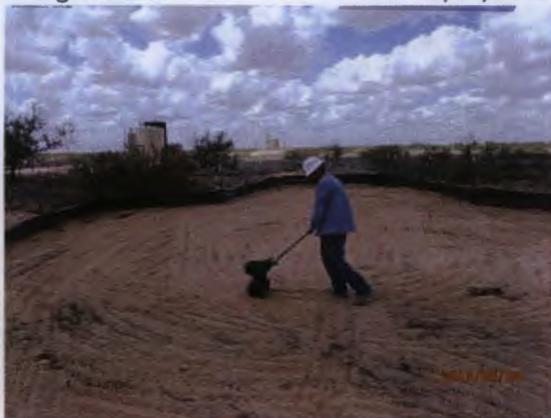
8/26/2013

seeding the site,
facing west

Custom seed mix <input checked="" type="checkbox"/>	Prescribed mix <input type="checkbox"/>	Seed mix name: 5LBS. BLUE GRAMA, 5LBS. SUMMMER WHEAT, 5 LBS SIDE OATS Seeding date: 8-26-13
Broadcast <input checked="" type="checkbox"/>		
Method: broadcast seeder		
Soil conditions during seeding: Dry <input checked="" type="checkbox"/> Damp <input type="checkbox"/> Wet <input type="checkbox"/>		
Photos attached <input type="checkbox"/>	Observations:	
Number of photos:

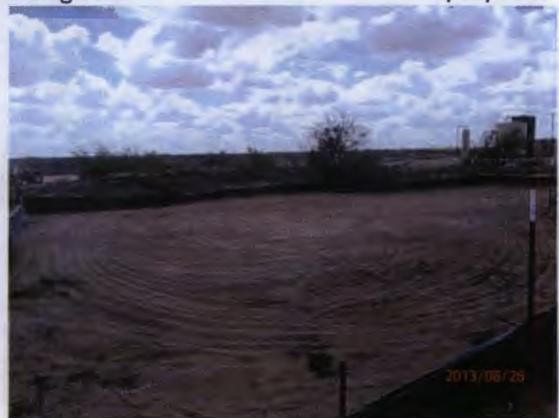
8/26/2013

site complete,
facing southwest
