1R - 423-07

RE: CAP Report and Termination Request
Justis E-26 (1R423-07): Unit Letter E, Section 26, T24S, R37E
RICE Operating Company – Justis SWD System

Justis E-26

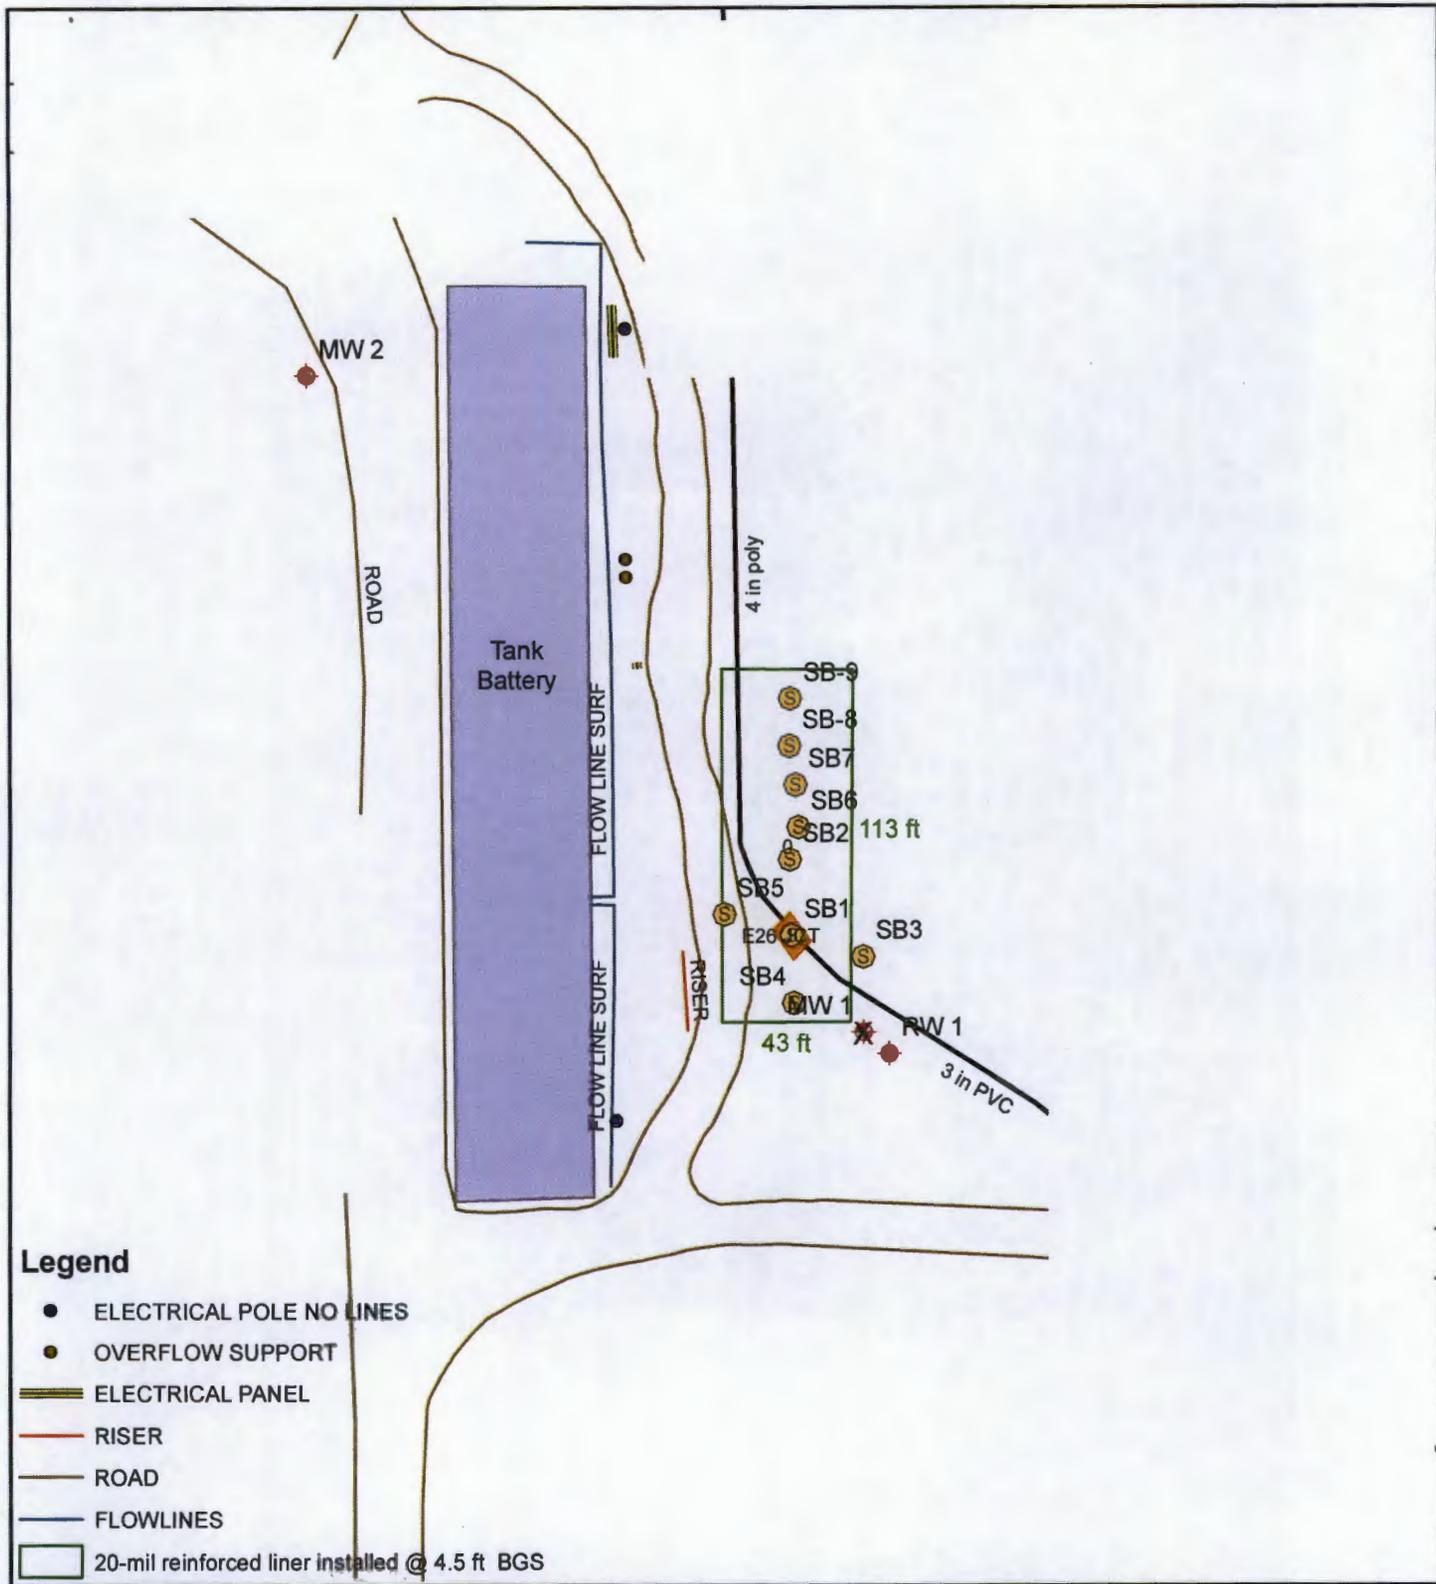
Figure 2

Beginning March 6, 2013, field personnel were onsite to excavate this site to dimensions of 113 ft by 43 ft, to a depth of 5 ft bgs, as shown on the attached Figure 2. Approximately 1,376 yards of excavated soil was properly disposed of at a NMOCD approved facility, and approximately 164 yards of blow sand was imported to serve as padding for the liner. A composite sample of the imported blow sand was field tested for hydrocarbons, resulting in a PID reading of 0.0 ppm. The sample was subsequently sent to commercial laboratory for analysis of chloride, resulting in a chloride concentration of 48 mg/kg. Six inches of blow sand were placed in the bottom of the excavation to serve as padding, and a 20-mil reinforced liner was properly seated at a depth of 4.5 ft bgs. An additional six inches of blow sand were placed above the liner. Approximately 936 yards of top soil were imported to serve as backfill for the excavation. A composite sample of the imported topsoil was field tested for hydrocarbons, resulting in a PID reading of 0.0 ppm. The sample was sent to commercial laboratory for analysis of chloride, resulting in a concentration of <16 mg/kg. The excavation was backfilled to ground surface, contoured to the surrounding area, and silt net fencing was placed around the site. On May 30, 2013, amendments were added to the soil, and the site was seeded with a blend of native vegetation. Lab results and a PID sheet for the imported soil, revegetation form, and photographs are attached in Appendix A.

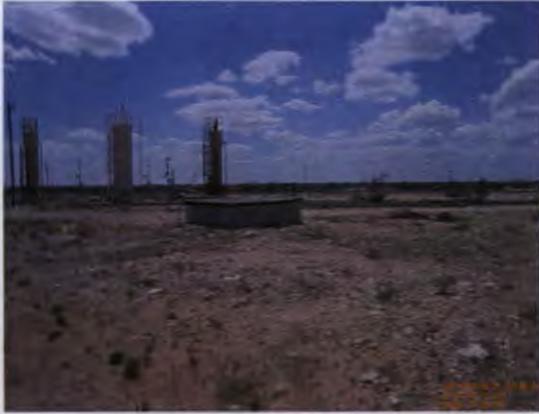
Site prior, facing west 6/21/2012

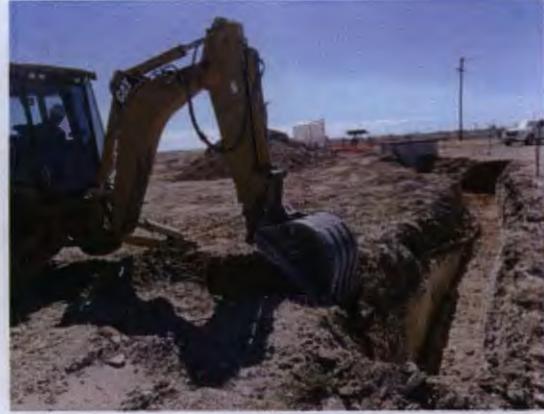
Excavating, facing south 3/8/2013

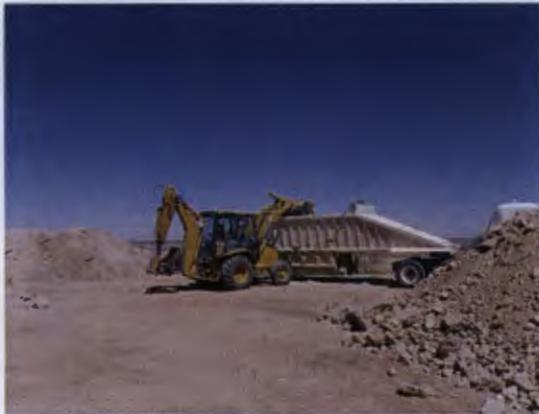
Hauling off spoil pile, facing east 3/13/2013

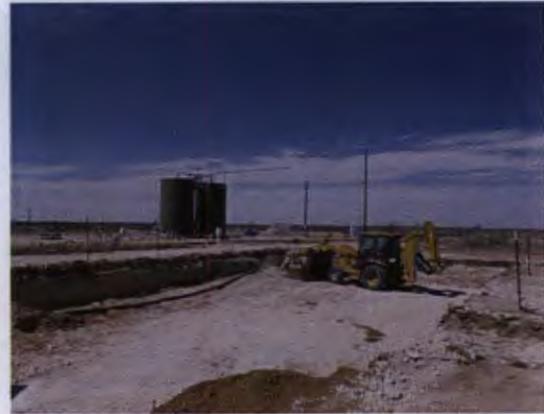
Padding the completed excavation, facing northwest 3/21/2013

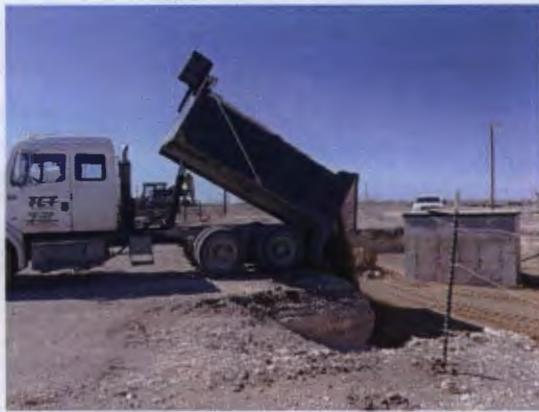
Hauling in blow sand, facing south 3/25/2013

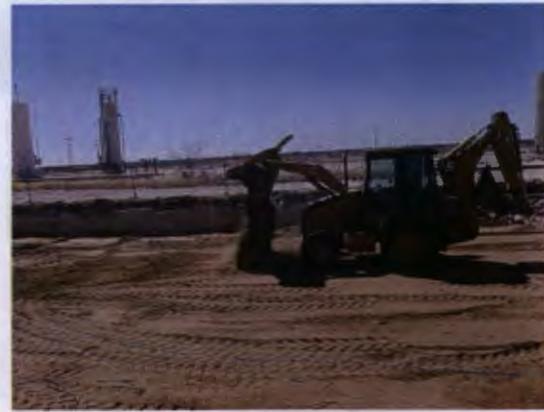
Padding excavation, facing west 3/25/2013

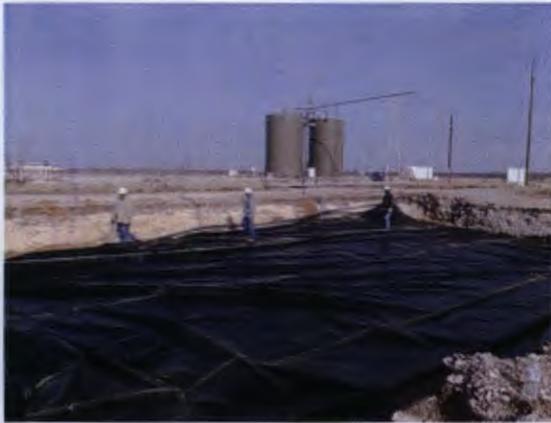
Installing the 20-mil, reinforced liner at approximately 4.5 ft bgs, facing northwest
3/27/2013

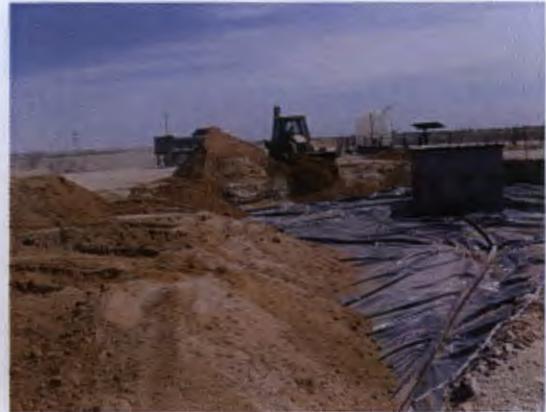
Backfilling, facing east
3/27/2013

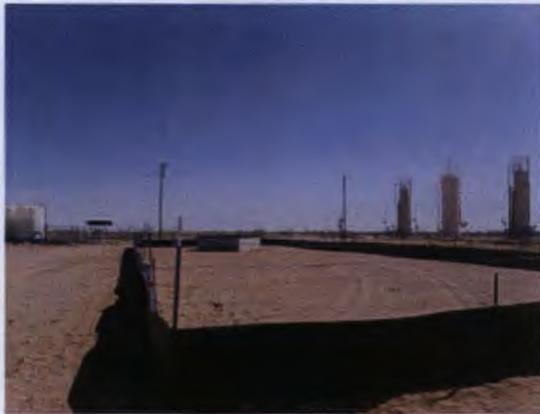
Silt net installed, facing south
4/11/2013

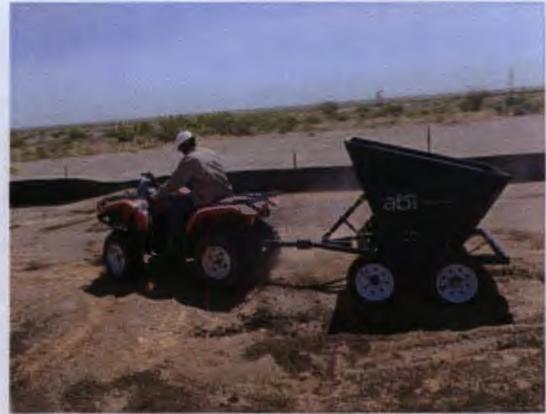
Spreading amendments, facing north
5/30/2013

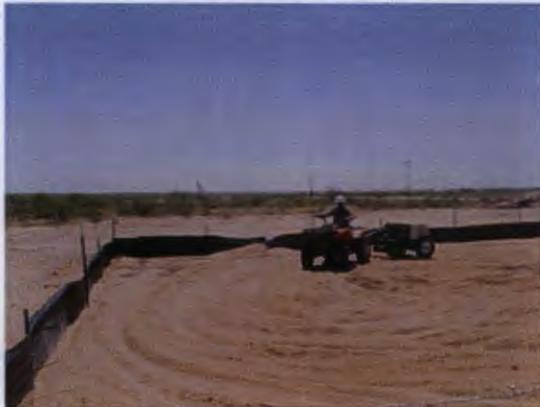
Seeding, facing north
5/30/2013

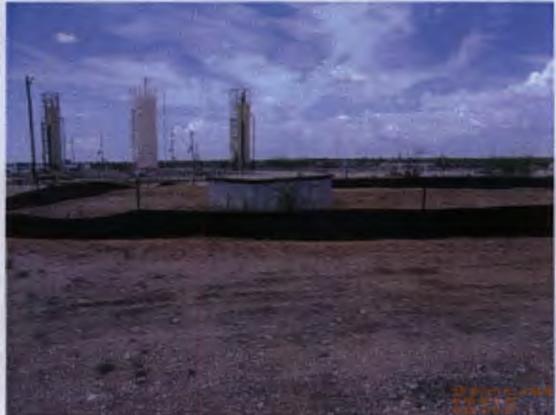
Site complete with vegetation starting to grow, facing west
7/31/2013
