**RICE OPERATING COMPANY  
JUNCTION BOX DISCLOSURE\* REPORT**

SWD SYSTEM	JUNCTION	UNIT	SECTION	TOWNSHIP	RANGE	COUNTY	BOX DIMENSIONS - FEET		
Blinebry-Drinkard (BD)	O-29-1 vent	O	29	22S	38E	Lea	Length 4'	Width 4'	Height 2'
							Eliminated

**General Description of Remedial Action:** This junction box was eliminated during the pipeline replacement/upgrade program. After the former junction box was removed, an investigation was conducted using a backhoe to collect soil samples at regular intervals producing a 30x30x12 ft deep excavation. Chloride field tests performed on each sample resulted in concentrations that did not relent with depth. Organic vapors were measured using a PID which yielded low concentrations. Representative composite samples from the bottom of the excavation and the excavation walls were sent to a commercial laboratory for analysis of chloride and TPH. A total of 648 yards of excavated soil was transported to a NMOCD approved disposal facility. Clean, imported blow sand was used to pad the excavation and prepare for the liner. A 20-mil reinforced liner was properly seated at approximately 11.5 ft bgs. An additional 6 inches of the imported blow sand was placed

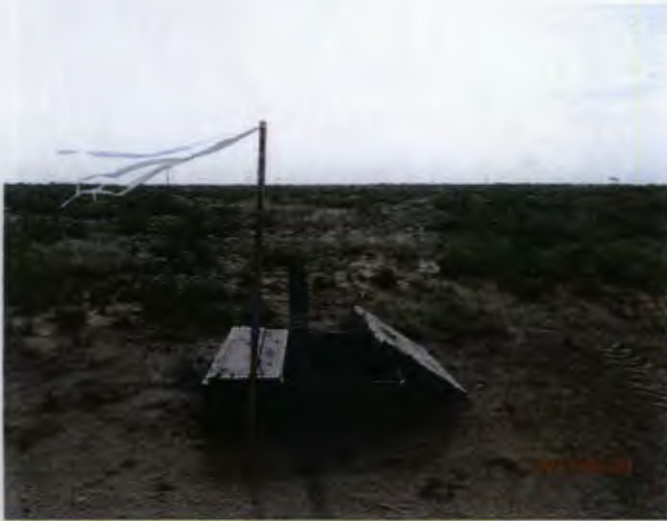
Site prior to excavation, facing east 6.20.13

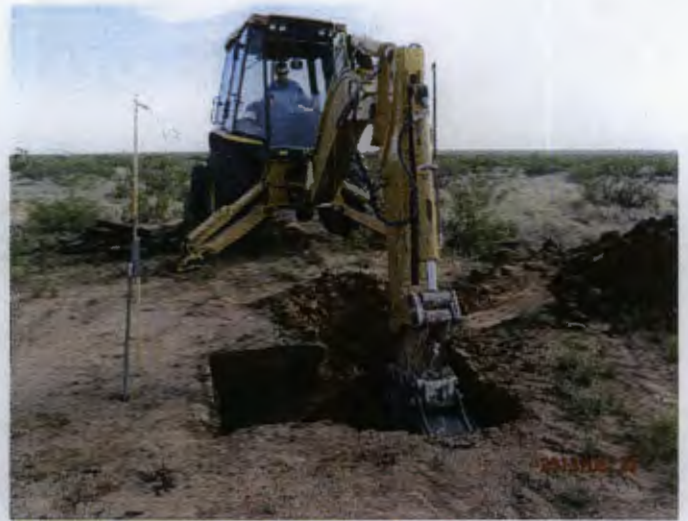
Digging Vertical, facing north 6.20.13

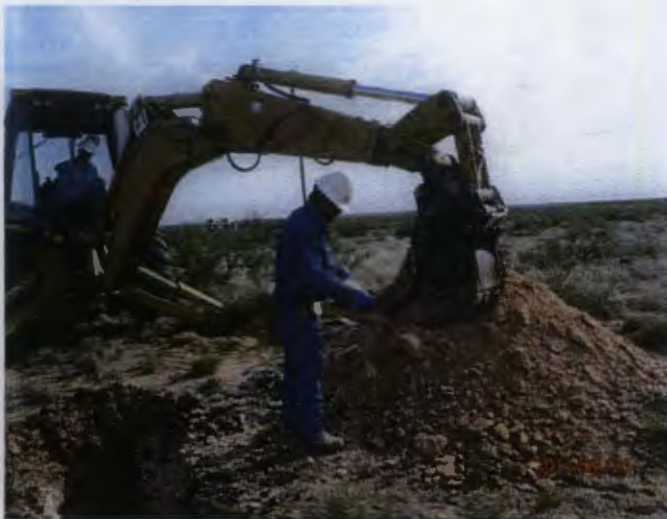
Collecting sample, facing northeast 6.20.13

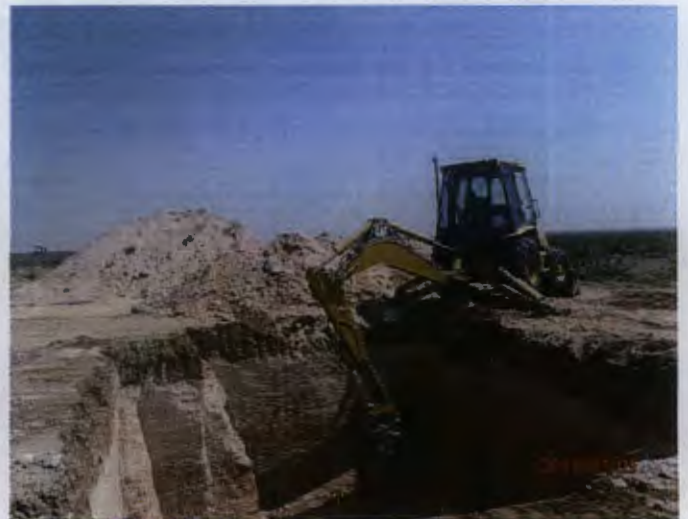
Cleaning out excavation, facing north 7.3.13

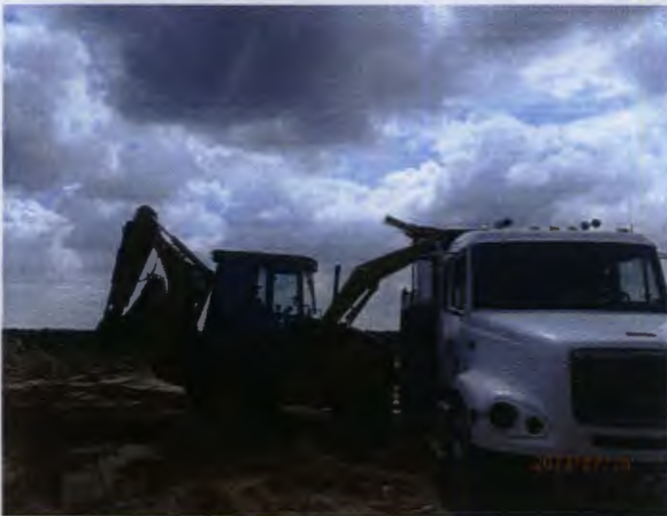
Exporting Soil, facing east 7.16.13

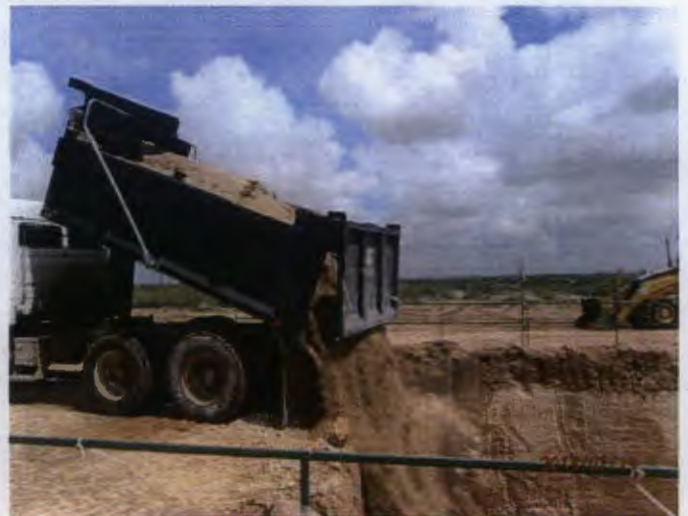
Importing in blow sand, facing north 7.19.13

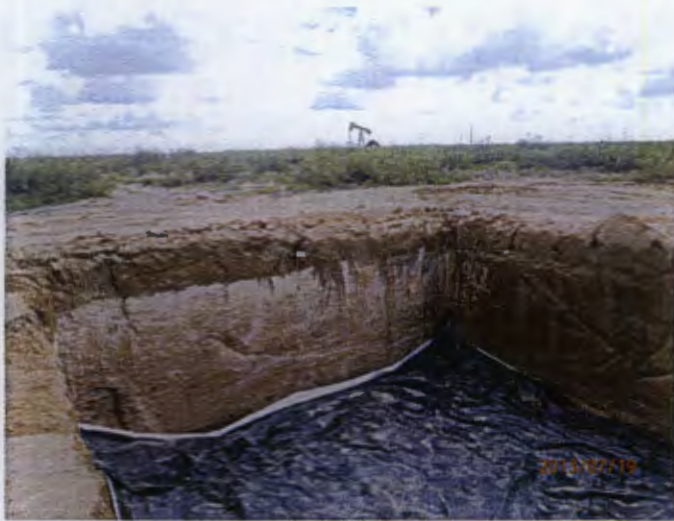
Installed 30' x 30', 20 mil reinforced poly, facing southeast 7.19.13

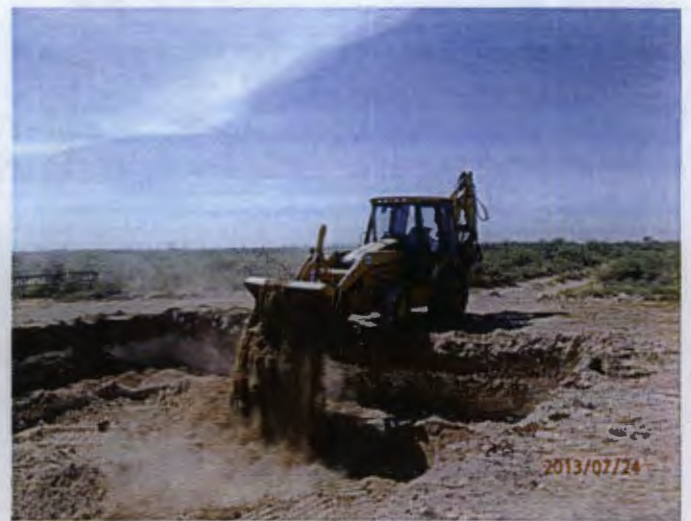
Backfilling excavation, facing southeast 7.24.13

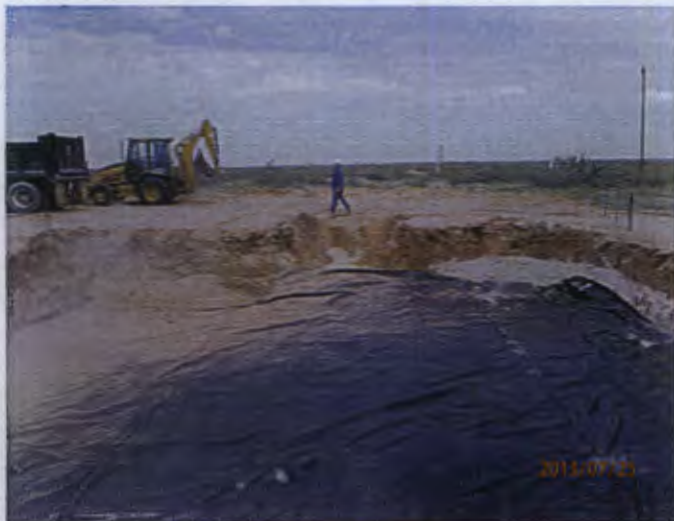
Padding above 2<sup>nd</sup> 20 mil reinforced Liner, facing North 7.25.13

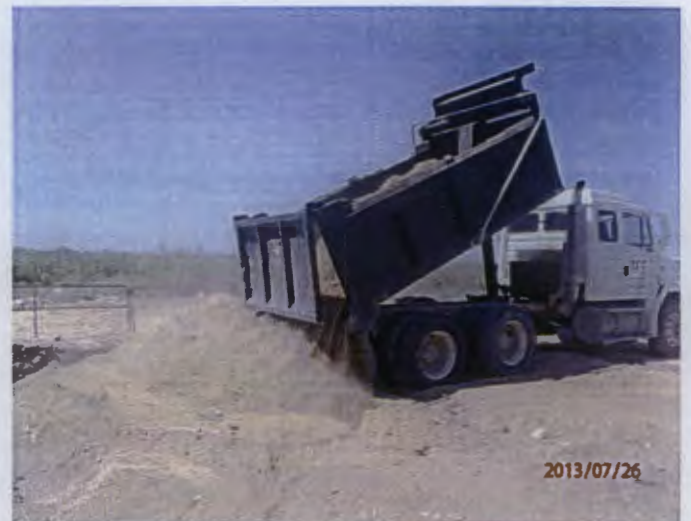
Importing Top Soil, facing south 7.26.13

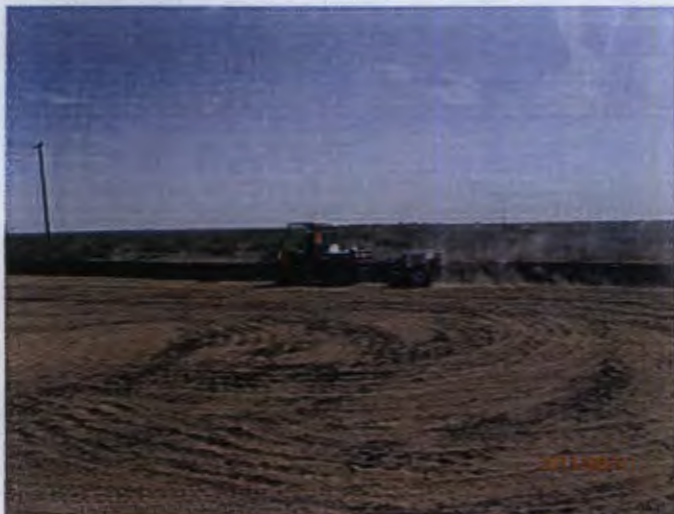
Seeding site, facing east 8.1.13

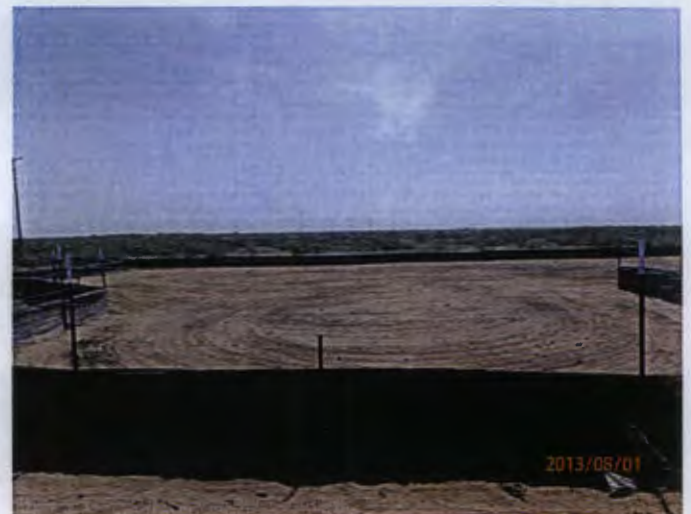
Final photo, facing east 8.1.13

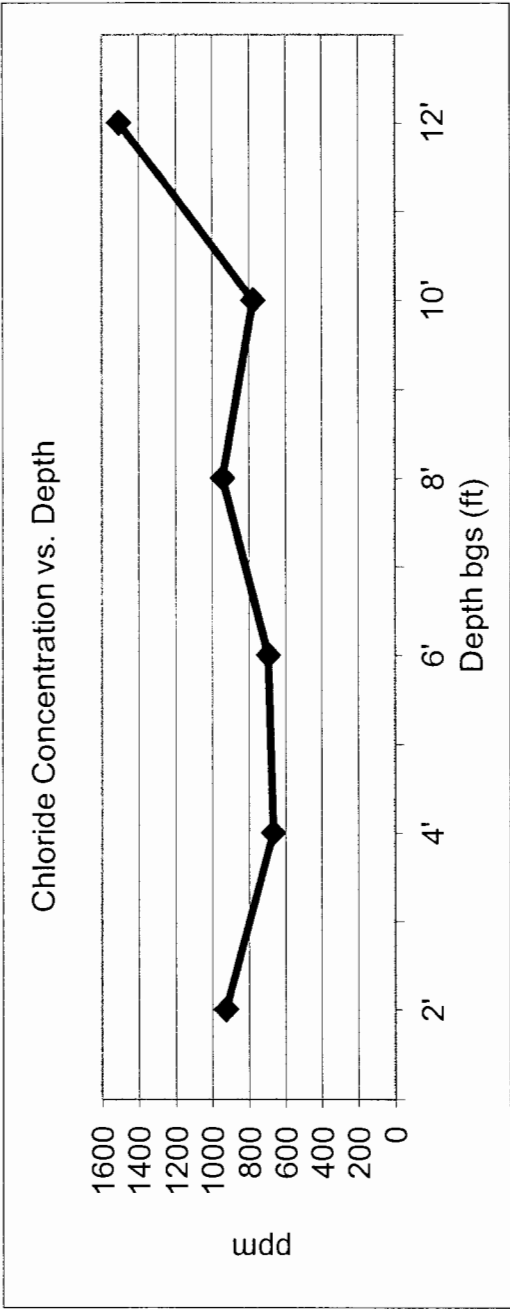
**BD O-29-1 vent**

Backhoe samples at 15 ft. east of the junction (source)

Depth bgs (ft)	[Cl] ppm
2'	928
4'	669
6'	696
8'	945
10'	778
12'	1509

Groundwater = 124 ft

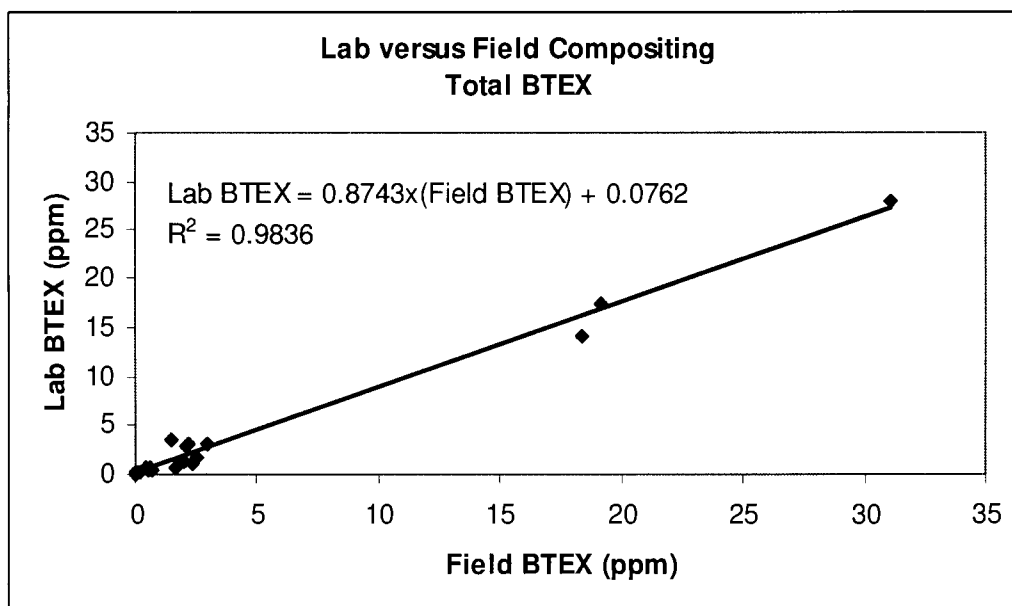
A comparison of lab-composited soil samples versus field-composited soil samples revealed a close correspondence for total BTEX between the two methods (Figure 1).

**Figure 1** - Laboratory versus field-composited soil samples analyzed for BTEX.

The high  $R^2$  value (0.9836) of the best-fit statistical regression line indicates a high degree of reliability in using the field-compositing method over the range of values observed. Below a “field-composited BTEX” value of 0.61 ppm the “lab-composited BTEX” values are slightly lower. However, above a field-composited BTEX value of 0.61 the lab-composited values run slightly lower. In other words, the field-composited values tended to produce slightly higher BTEX numbers above the point at which BTEX concentrations become significant.

There is a reason for this. BTEX is volatile and quickly biodegradable. The compositing and “packaging” of soil samples in the field minimize the handling and aeration that occur in the laboratory. Thus, field-composited soil samples lose less BTEX to evaporation and/or biodegradation prior to laboratory analysis. In other words, the field compositing and packaging of soil samples better preserves sample integrity, and for this reasons would appear to represent the better method of procuring soil samples for subsequent analysis of BTEX.

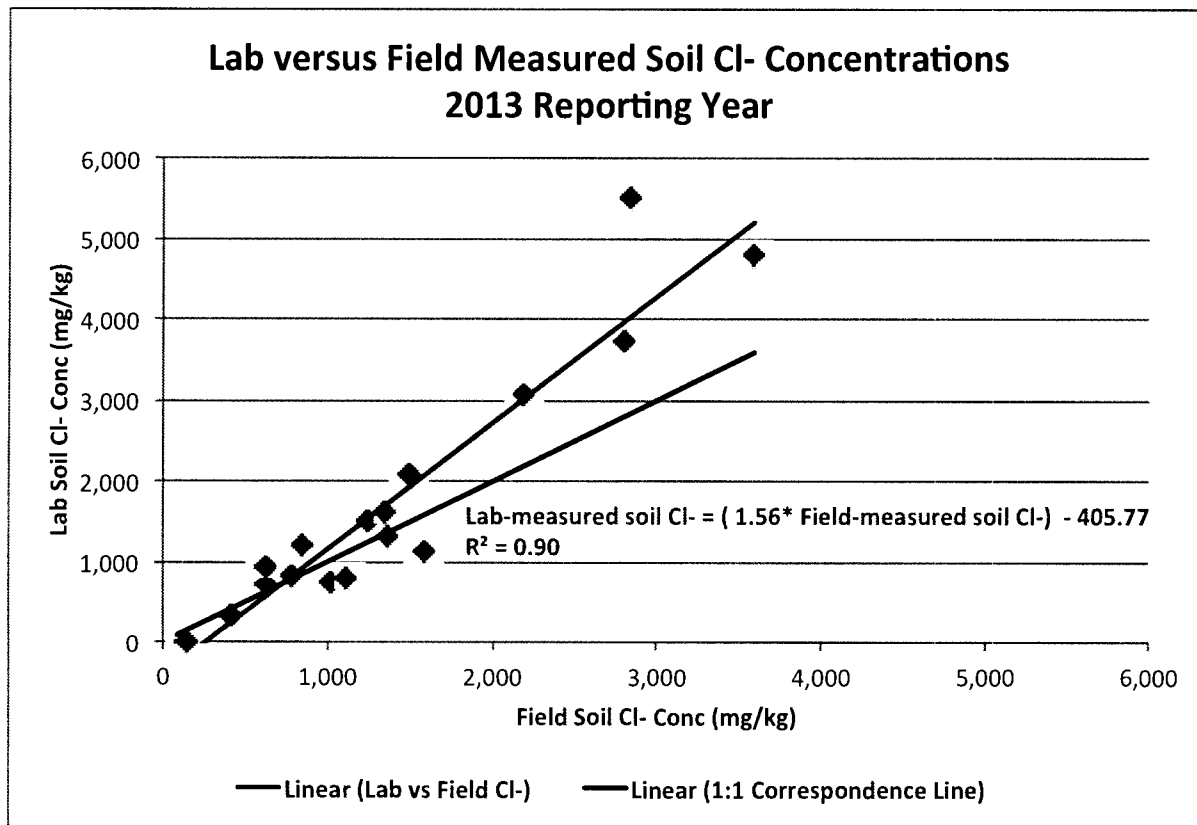
A representative sample of 29 pairs of laboratory versus field measured soil chloride values was compared to determine how well field measurements matched laboratory measurements. It is assumed that laboratory measurements better represent the “true” values due to the controlled environment that a laboratory provides. A simple plot of the laboratory versus field measured soil chloride values is given below (Figure 1).

**Figure 1** – Laboratory versus field measured soil chloride measurements (n = 29 paired sets).

A straight line fit to the data confirms a general linear trend over a wide range of soil chloride concentrations, and the  $R^2$  value (0.90) indicates that field measurements provide a reliable approximation of laboratory-measured values. Based on the best-fit line of lab vs field measured values, field measured values overestimate lab measure values below a field measured value of 723 mg/kg and above this underestimate the lab-measured values. This is indicated in the graph where the (blue) best-fit line of lab vs field measured chlorides crosses the (black) line which would indicate a 1:1 correspondence.
