IR-421-411

EME Jct. I-9

RE: Termination Request

# RICE OPERATING COMPANY JUNCTION BOX FINAL REPORT

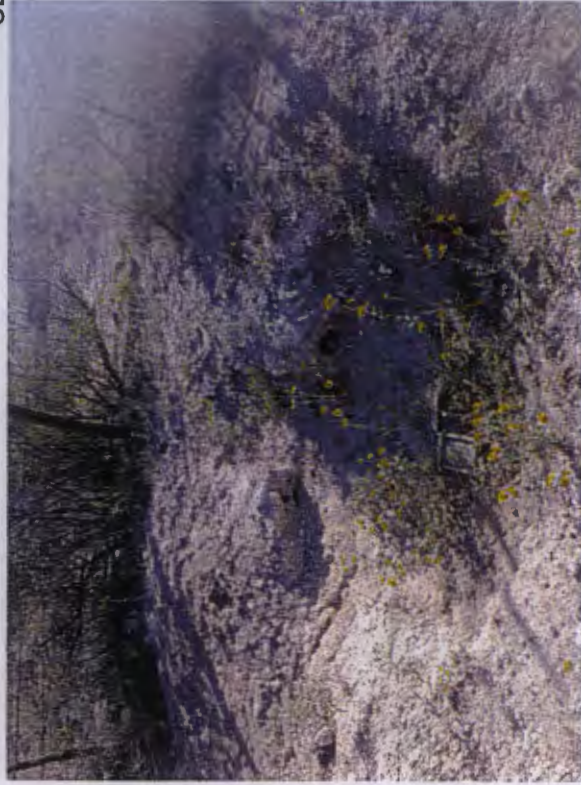
Site prior, facing east

10/26/2012

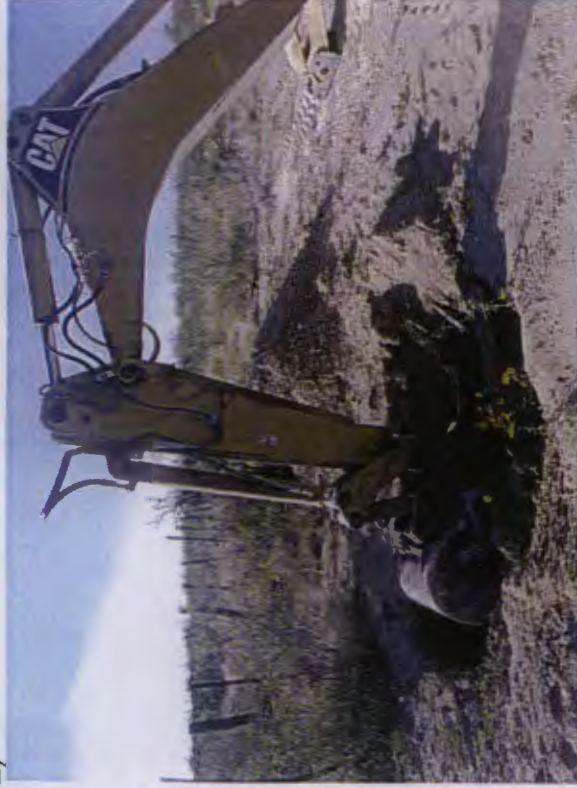
Excavating site, facing south

10/26/2012

**General Description of Remedial Action:** This junction and line were eliminated during the pipeline replacement/upgrade program. After the former junction box was removed, an investigation was conducted using a backhoe to collect soil samples at regular intervals, creating a 7x3x7 ft. deep excavation. Chloride field tests performed on each sample yielded concentrations that decreased with depth. Organic vapors were measured using a PID, which yielded low concentrations. The deepest sample, 7 ft. below ground surface (BGS) was sent to a commercial laboratory for analysis of chloride and TPH, which confirmed low concentrations of each. The excavation was backfilled with imported blow sand to ground surface and contoured to the surrounding area. The blow sand was sent to a commercial laboratory for analysis of chloride and TPH, which confirmed low concentrations of each. On 6/7/2013, the site was seeded with a blend of native vegetation and is expected to return to a productive capacity at a normal rate.

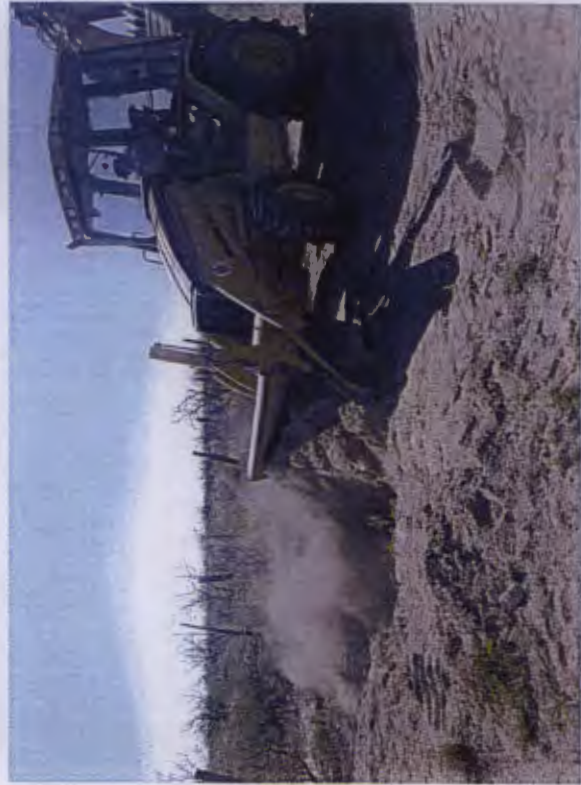
Backfilling excavation

10/26/2012

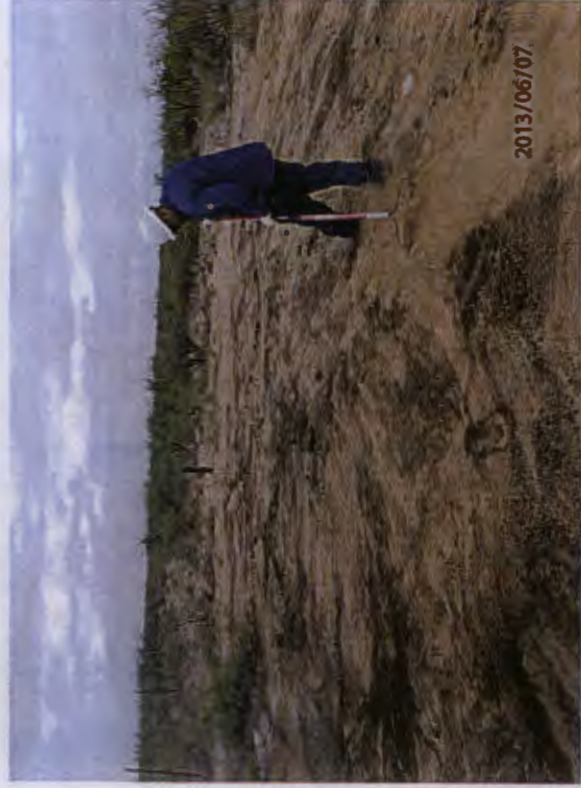
Seeding site, facing south

6/7/2013

| Custom Seed Mix | <input checked="" type="checkbox"/> | Prescribed Mix | <input type="checkbox"/> | Seed Mix Name: | 7.5 lbs of blue gramma, 7.5 lbs of side oats | Date: | 6/7/2013 |
| Broadcast | <input checked="" type="checkbox"/> | Method: | Portable Seeder | | | | |

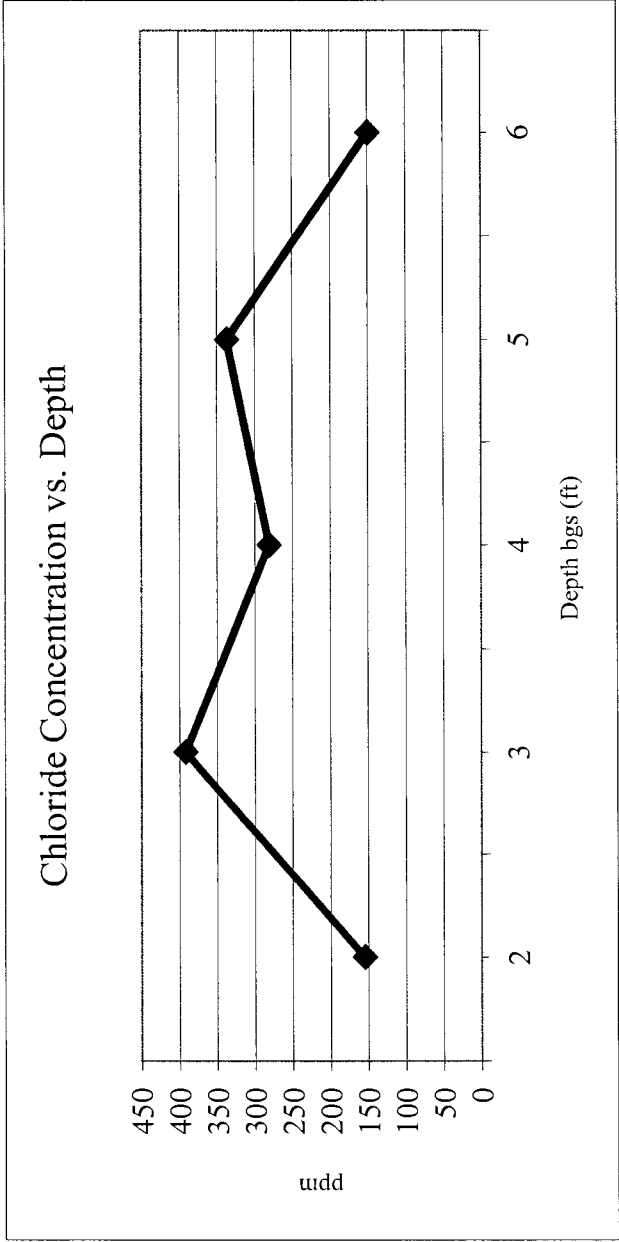
EME Jct. I-9

Unit 'I', Sec. 9, T20S, R36E

Backhoe samples at junction (source)

Groundwater = 32 ft

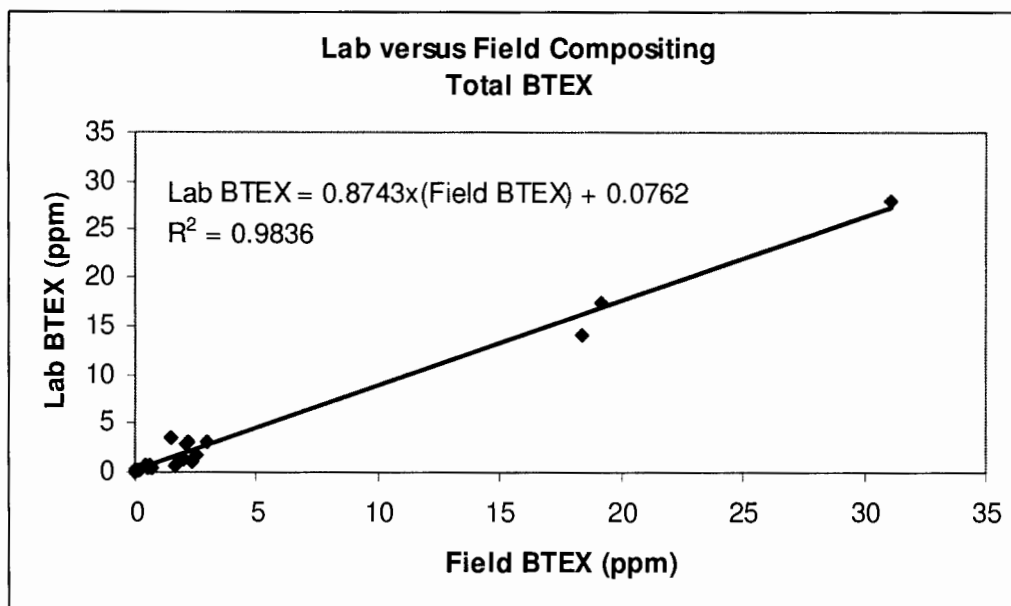
A comparison of lab-composited soil samples versus field-composited soil samples revealed a close correspondence for total BTEX between the two methods (Figure 1).

**Figure 1** - Laboratory versus field-composited soil samples analyzed for BTEX.

The high  $R^2$  value (0.9836) of the best-fit statistical regression line indicates a high degree of reliability in using the field-compositing method over the range of values observed. Below a “field-composited BTEX” value of 0.61 ppm the “lab-composited BTEX” values are slightly lower. However, above a field-composited BTEX value of 0.61 the lab-composited values run slightly lower. In other words, the field-composited values tended to produce slightly higher BTEX numbers above the point at which BTEX concentrations become significant.

There is a reason for this. BTEX is volatile and quickly biodegradable. The compositing and “packaging” of soil samples in the field minimize the handling and aeration that occur in the laboratory. Thus, field-composited soil samples lose less BTEX to evaporation and/or biodegradation prior to laboratory analysis. In other words, the field compositing and packaging of soil samples better preserves sample integrity, and for this reasons would appear to represent the better method of procuring soil samples for subsequent analysis of BTEX.

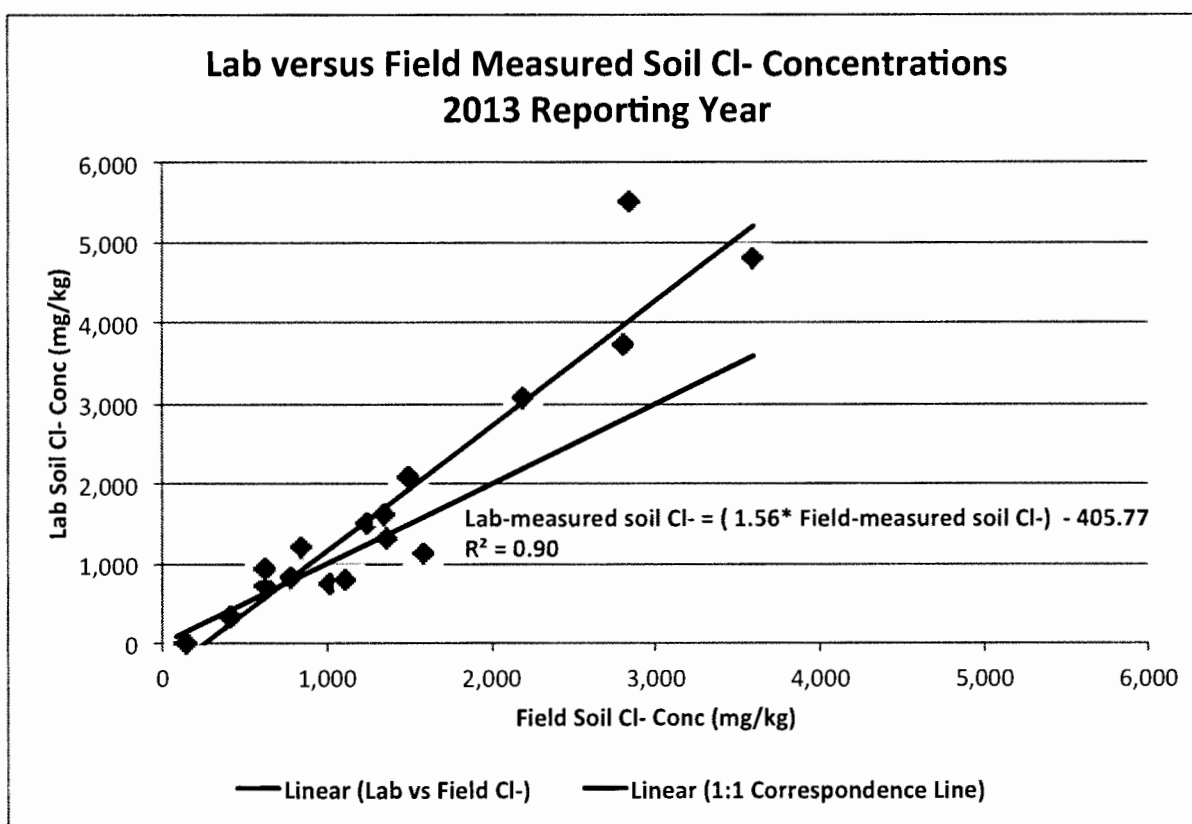
A representative sample of 29 pairs of laboratory versus field measured soil chloride values was compared to determine how well field measurements matched laboratory measurements. It is assumed that laboratory measurements better represent the “true” values due to the controlled environment that a laboratory provides. A simple plot of the laboratory versus field measured soil chloride values is given below (Figure 1).

**Figure 1** – Laboratory versus field measured soil chloride measurements (n = 29 paired sets).

A straight line fit to the data confirms a general linear trend over a wide range of soil chloride concentrations, and the  $R^2$  value (0.90) indicates that field measurements provide a reliable approximation of laboratory-measured values. Based on the best-fit line of lab vs field measured values, field measured values overestimate lab measure values below a field measured value of 723 mg/kg and above this underestimate the lab-measured values. This is indicated in the graph where the (blue) best-fit line of lab vs field measured chlorides crosses the (black) line which would indicate a 1:1 correspondence.
