**3R - 438**

Groundwater Investigation  
Report  
Enterprise Products Company  
Lateral 6C September 2011  
Pipeline Release  
NE¼ SW¼ Section 26, T28N, R11W  
San Juan County, New Mexico

October 31, 2012

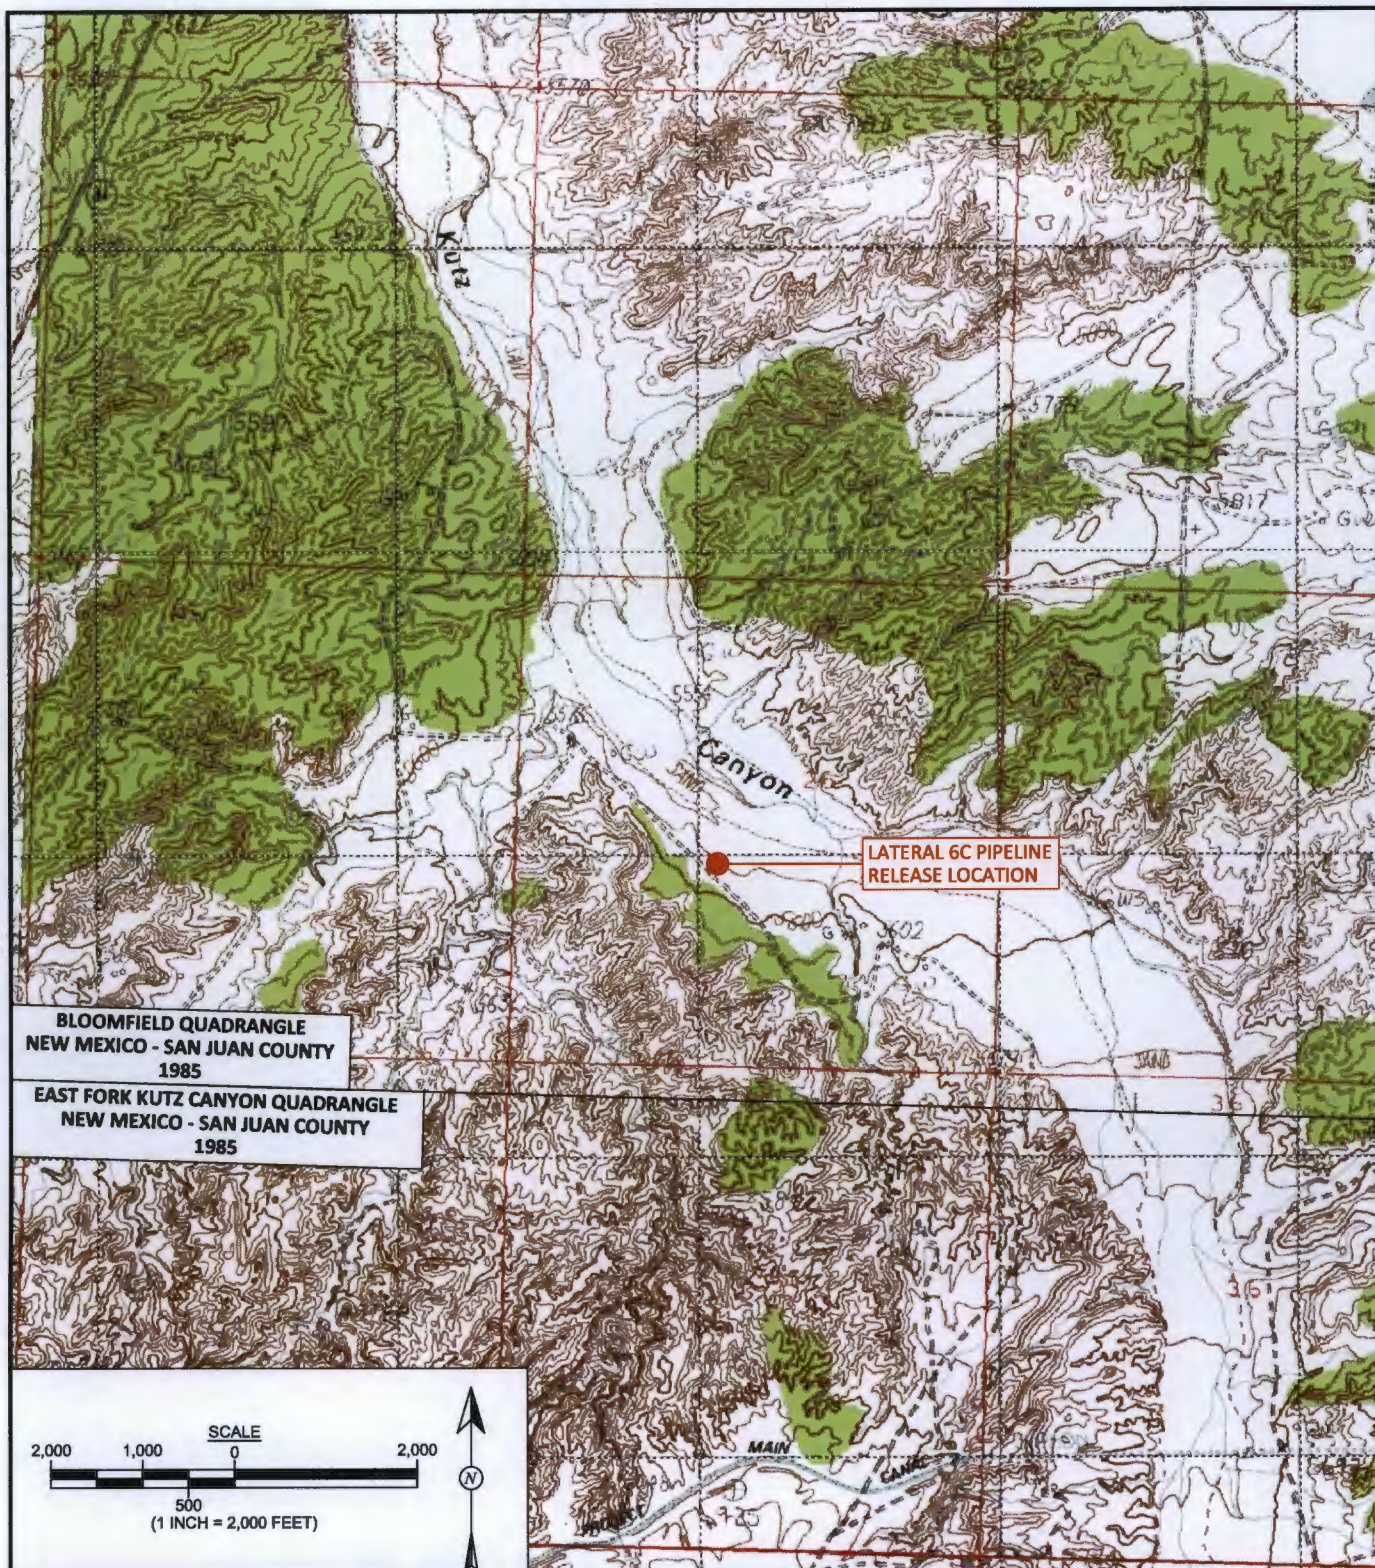
The release area is located on Federal land under jurisdiction of the Bureau of Land Management (BLM) within the NE¼ SW¼, Section 26, T28N, R11W, San Juan County, New Mexico. Latitude and longitude of the release were recorded as N36.63202 and W107.97400, respectively. The release location is within the floodplain of Kutz Wash, which is located 165 feet to the northeast. Kutz Wash flows north and ultimately discharges into the San Juan River. Based on measurements from the site investigation, depth to groundwater is approximately 14 to 16 feet below ground surface (bgs). A topographic site location map is included as Figure 1, and an aerial map showing the release location is included as Figure 2.

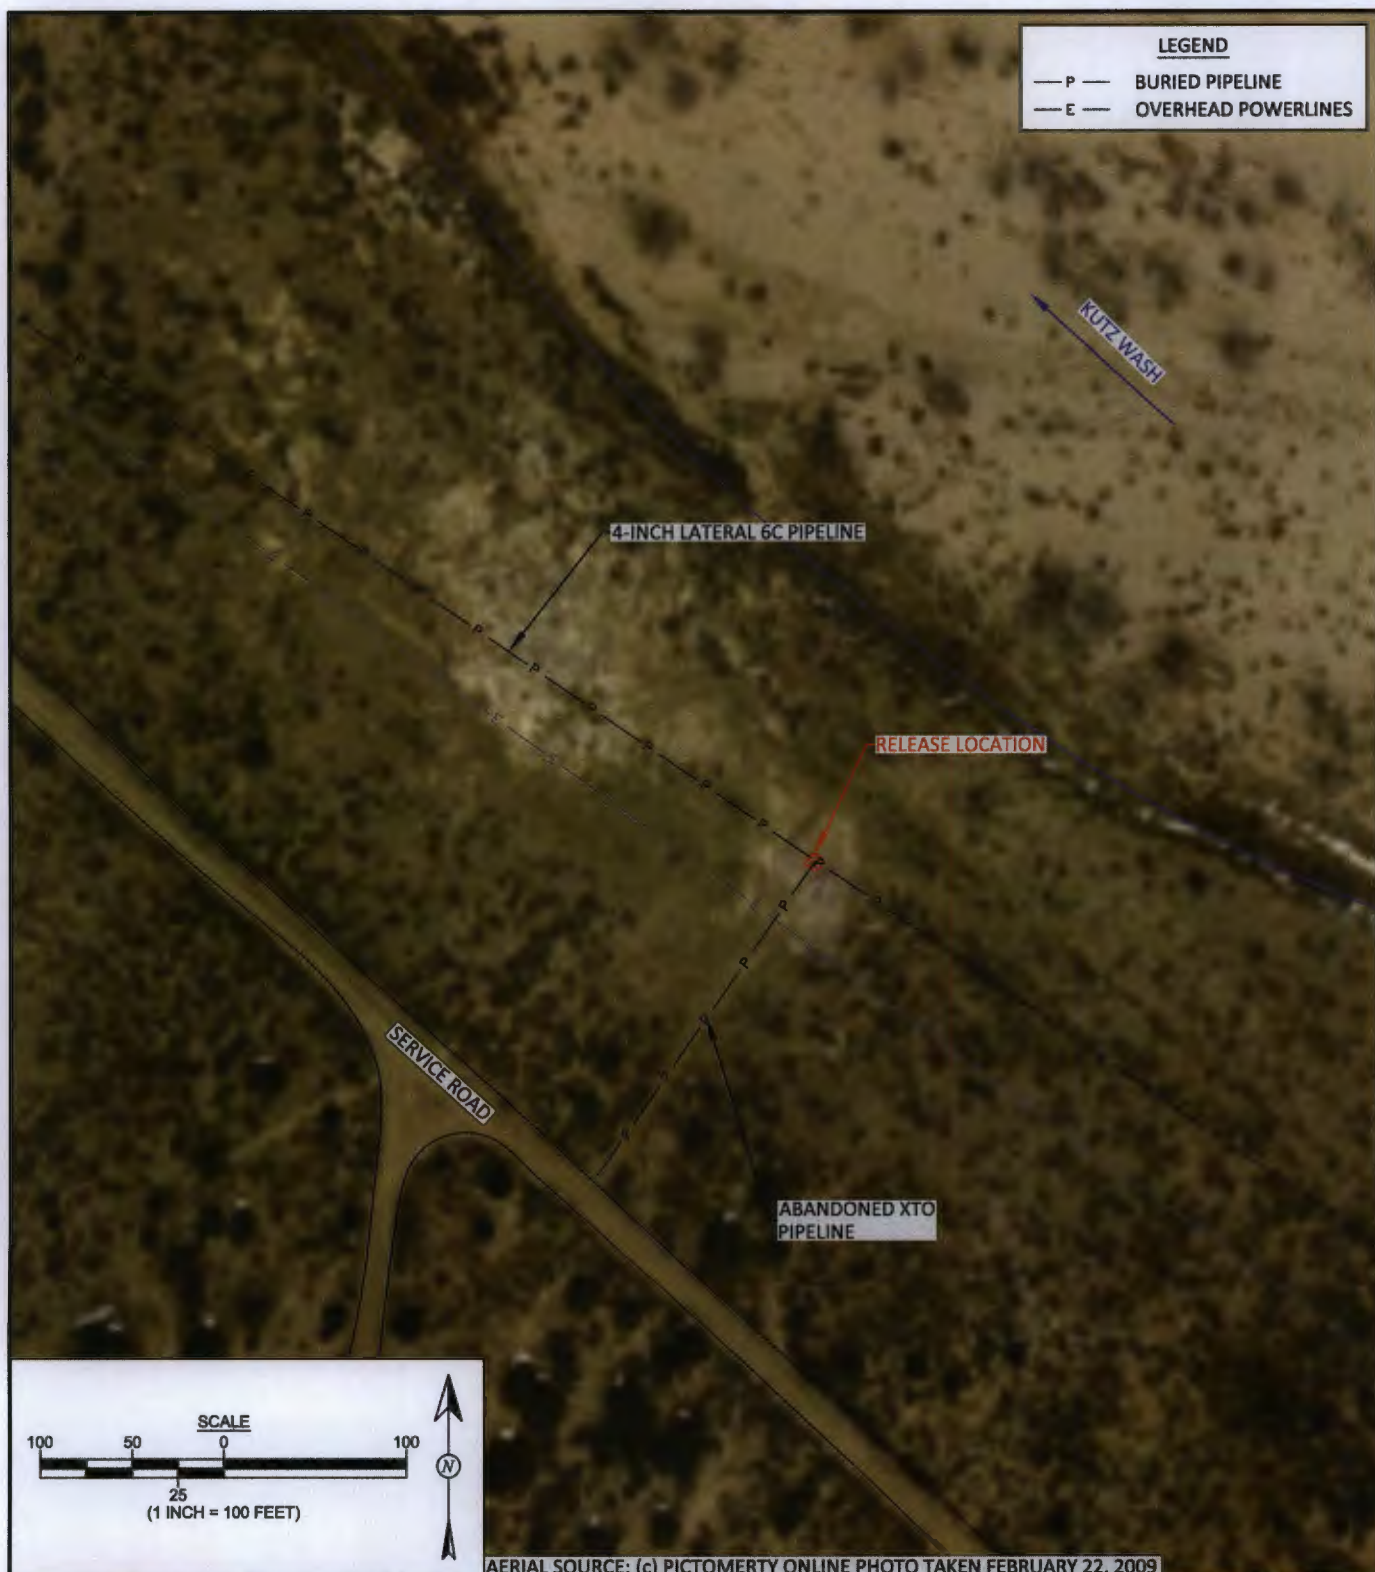
**FIGURE 2**

**AERIAL SITE MAP**  
 ENTERPRISE PRODUCTS COMPANY  
 LATERAL 6C PIPELINE RELEASE  
 GROUNDWATER INVESTIGATION  
 SAN JUAN COUNTY, NEW MEXICO  
 NE¼ SW¼, SECTION 26, T28N, R11W  
 N36.63202, W107.97400

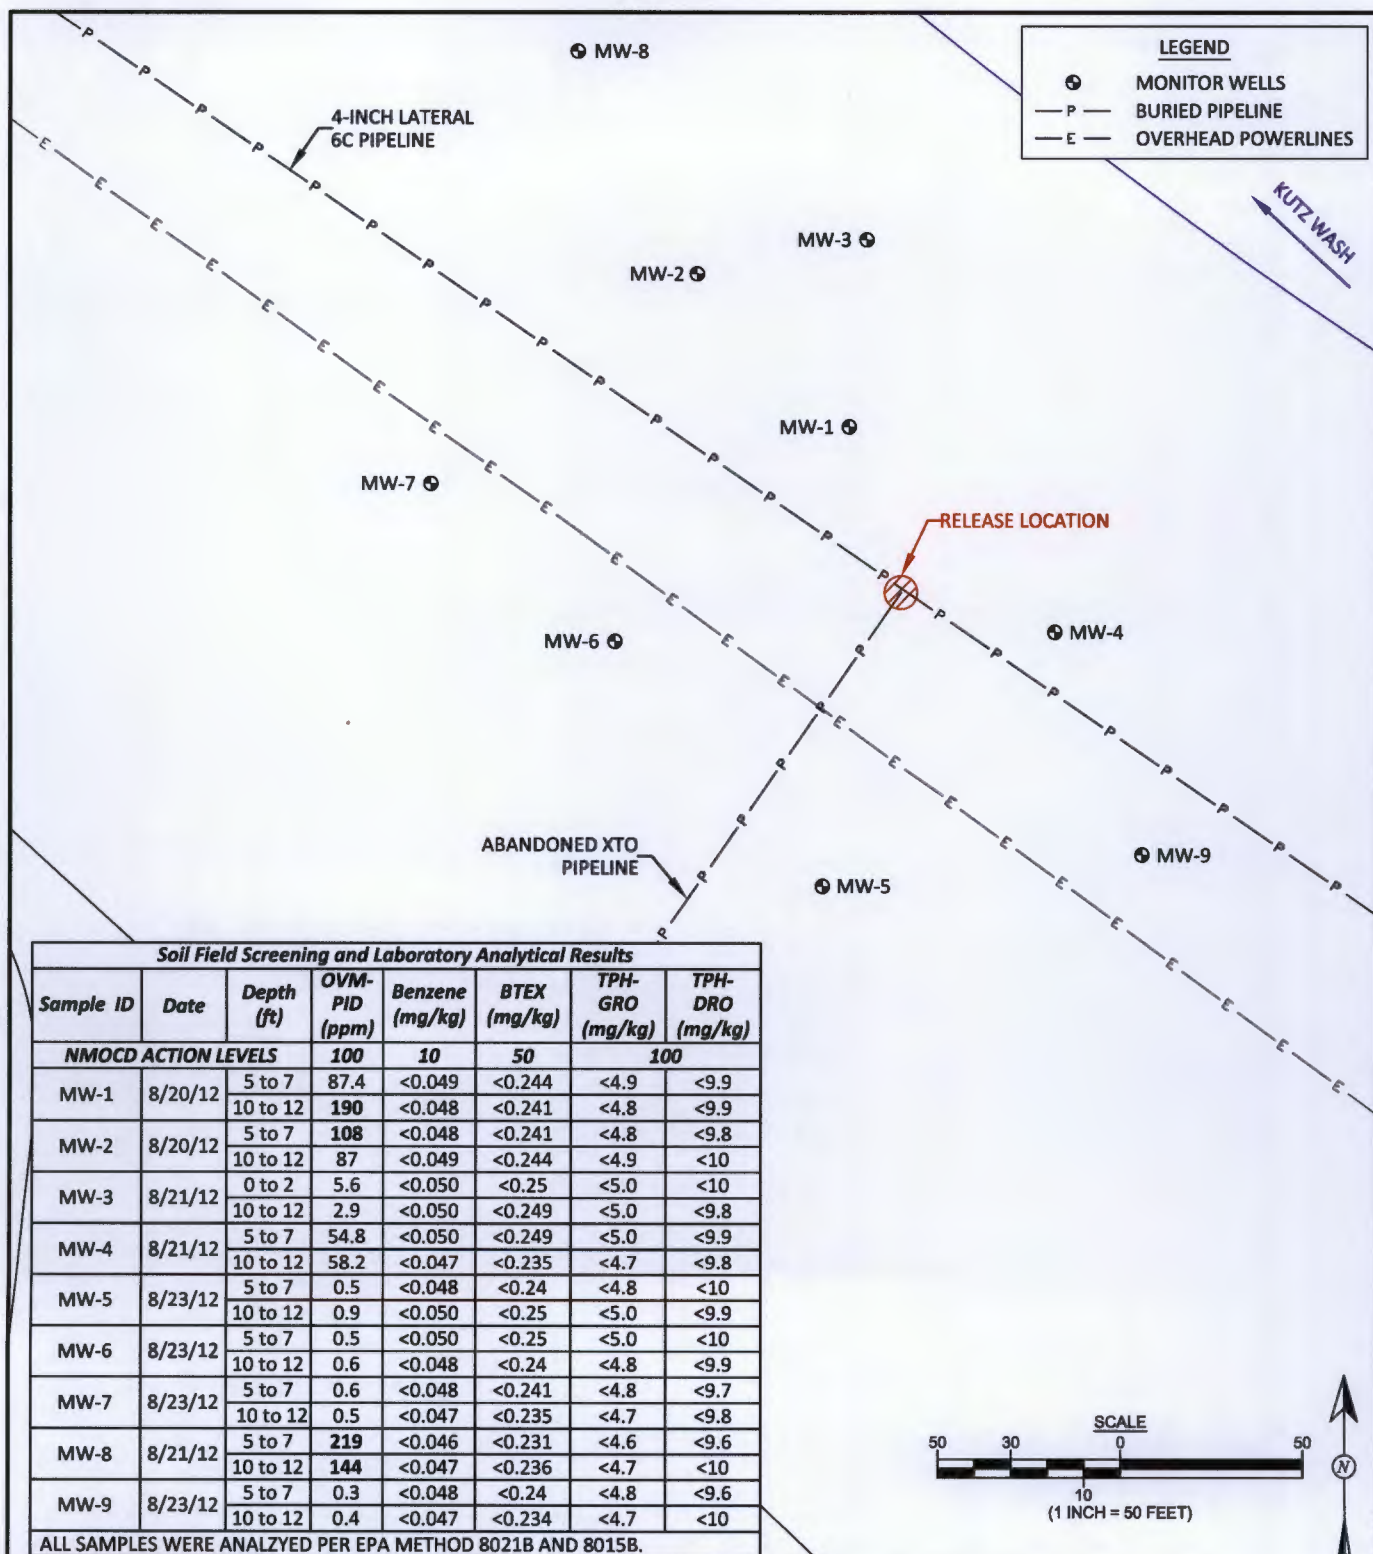
**FIGURE 3**

On August 20 through 23, 2012, AES installed nine soil borings within and adjacent to the September 2011 release area in order to delineate the extent of the groundwater hydrocarbon contamination. The soil borings were each advanced to a total depth of 25 feet bgs and completed as monitor wells (MW-1 through MW-9). The locations of monitor wells are presented on Figure 3.

During the August 2012 site investigation, field screening readings showed VOC concentrations ranging from 0.3 ppm in MW-9 at 5 feet bgs up to 219 ppm in MW-8 at 5 to 7 feet bgs. Soil laboratory analytical results for benzene, total BTEX and TPH were below laboratory detection limits in each sample. Tabulated field screening and laboratory analytical results are presented in Table 1. Soil laboratory analytical reports are provided in Appendix C.

**SOIL ANALYTICAL RESULTS**  
**AUGUST 2012**  
ENTERPRISE PRODUCTS COMPANY  
LATERAL 6C PIPELINE RELEASE  
GROUNDWATER INVESTIGATION  
SAN JUAN COUNTY, NEW MEXICO  
NE¼ SW¼, SECTION 26, T28N, R11W  
N36.63202, W107.97400

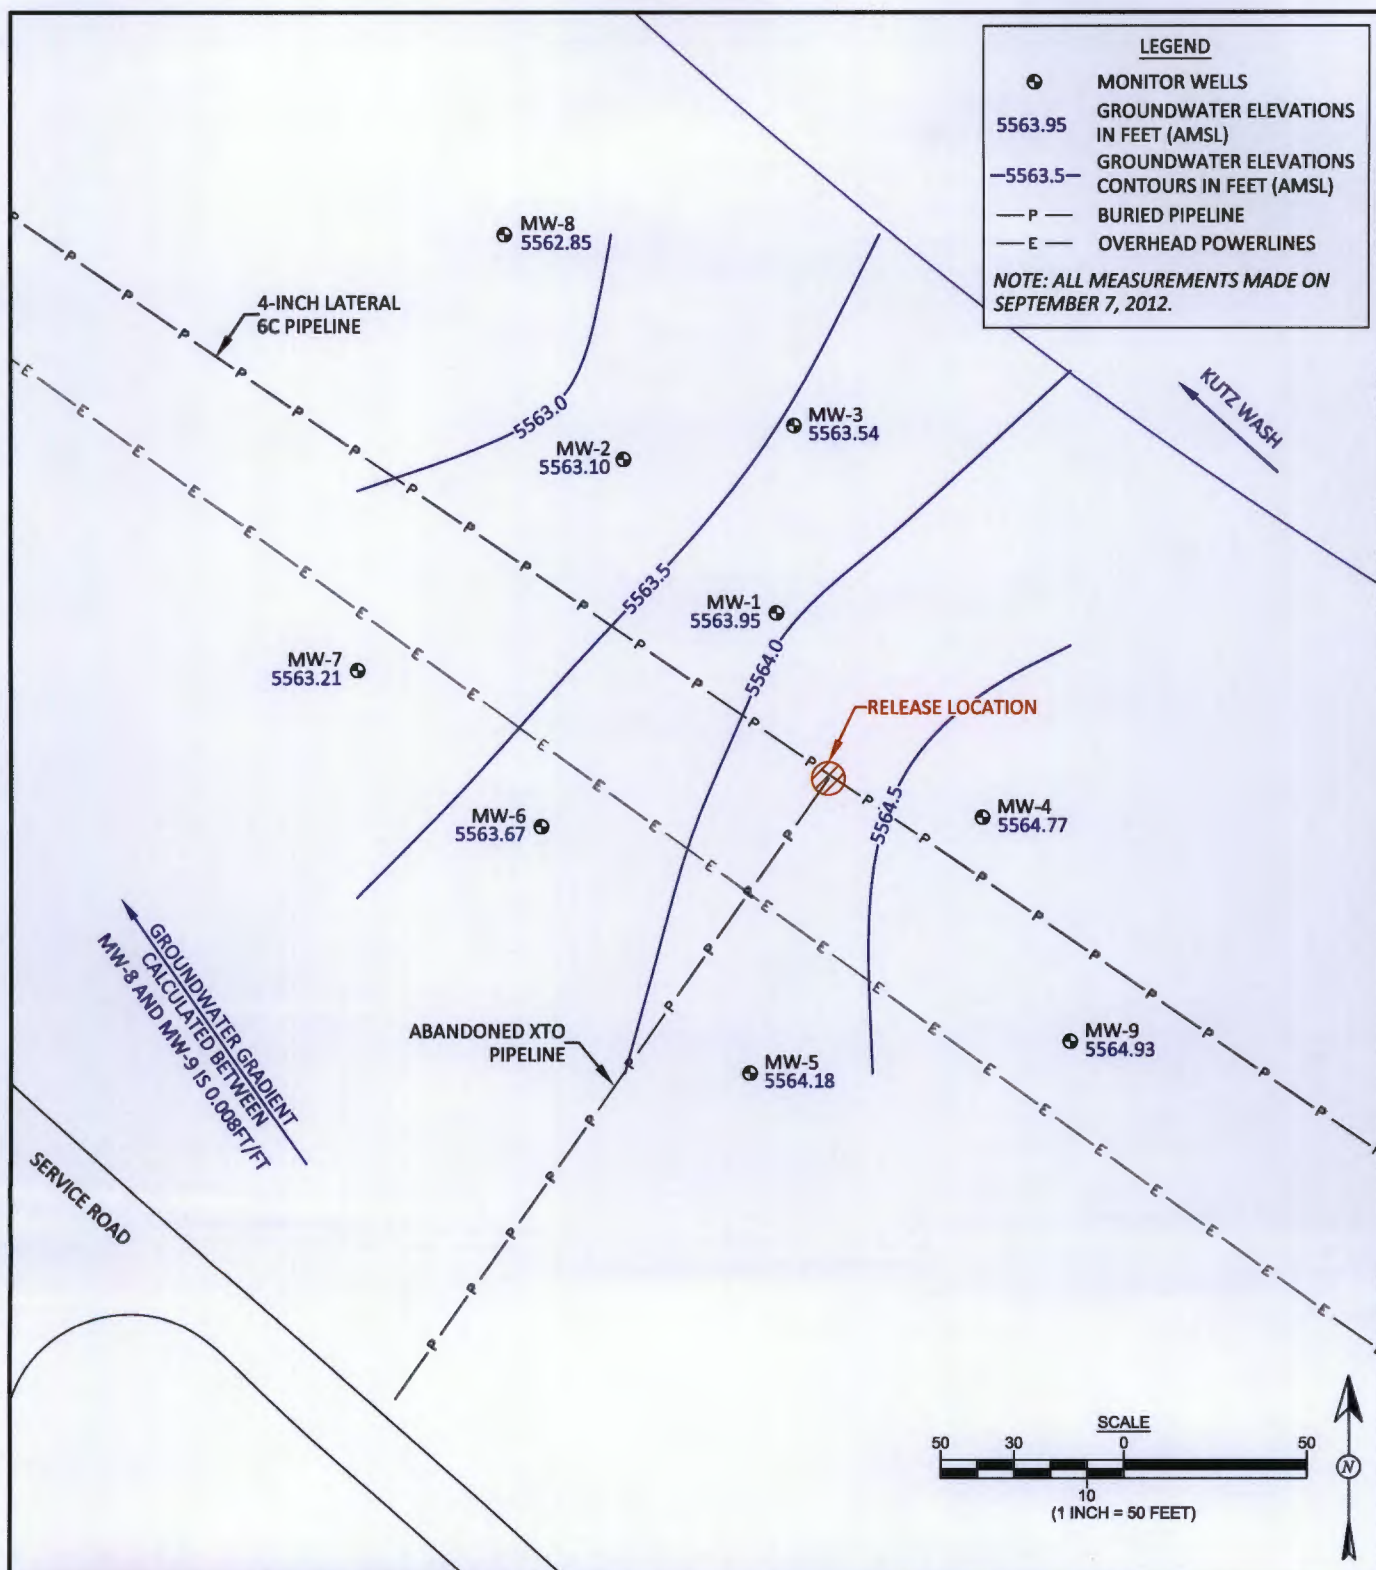
## FIGURE 4

The site investigation revealed a hydraulic gradient to the northwest at an incline of 0.008 foot/foot. Depth to water was gauged, and water quality measurements were recorded prior to sample collection. Depth to water ranged from 14.96 feet bgs in MW-8 to 19.35 feet bgs in MW-5, and groundwater elevations ranged from 5562.85 feet above mean sea level (amsl) in MW-8 to 5564.93 feet amsl in MW-9.

**GROUNDWATER ELEVATION CONTOURS  
SEPTEMBER 2012**  
ENTERPRISE PRODUCTS COMPANY  
LATERAL 6C PIPELINE RELEASE  
GROUNDWATER INVESTIGATION  
SAN JUAN COUNTY, NEW MEXICO  
NE¼ SW¼, SECTION 26, T28N, R11W  
N36.63202, W107.97400

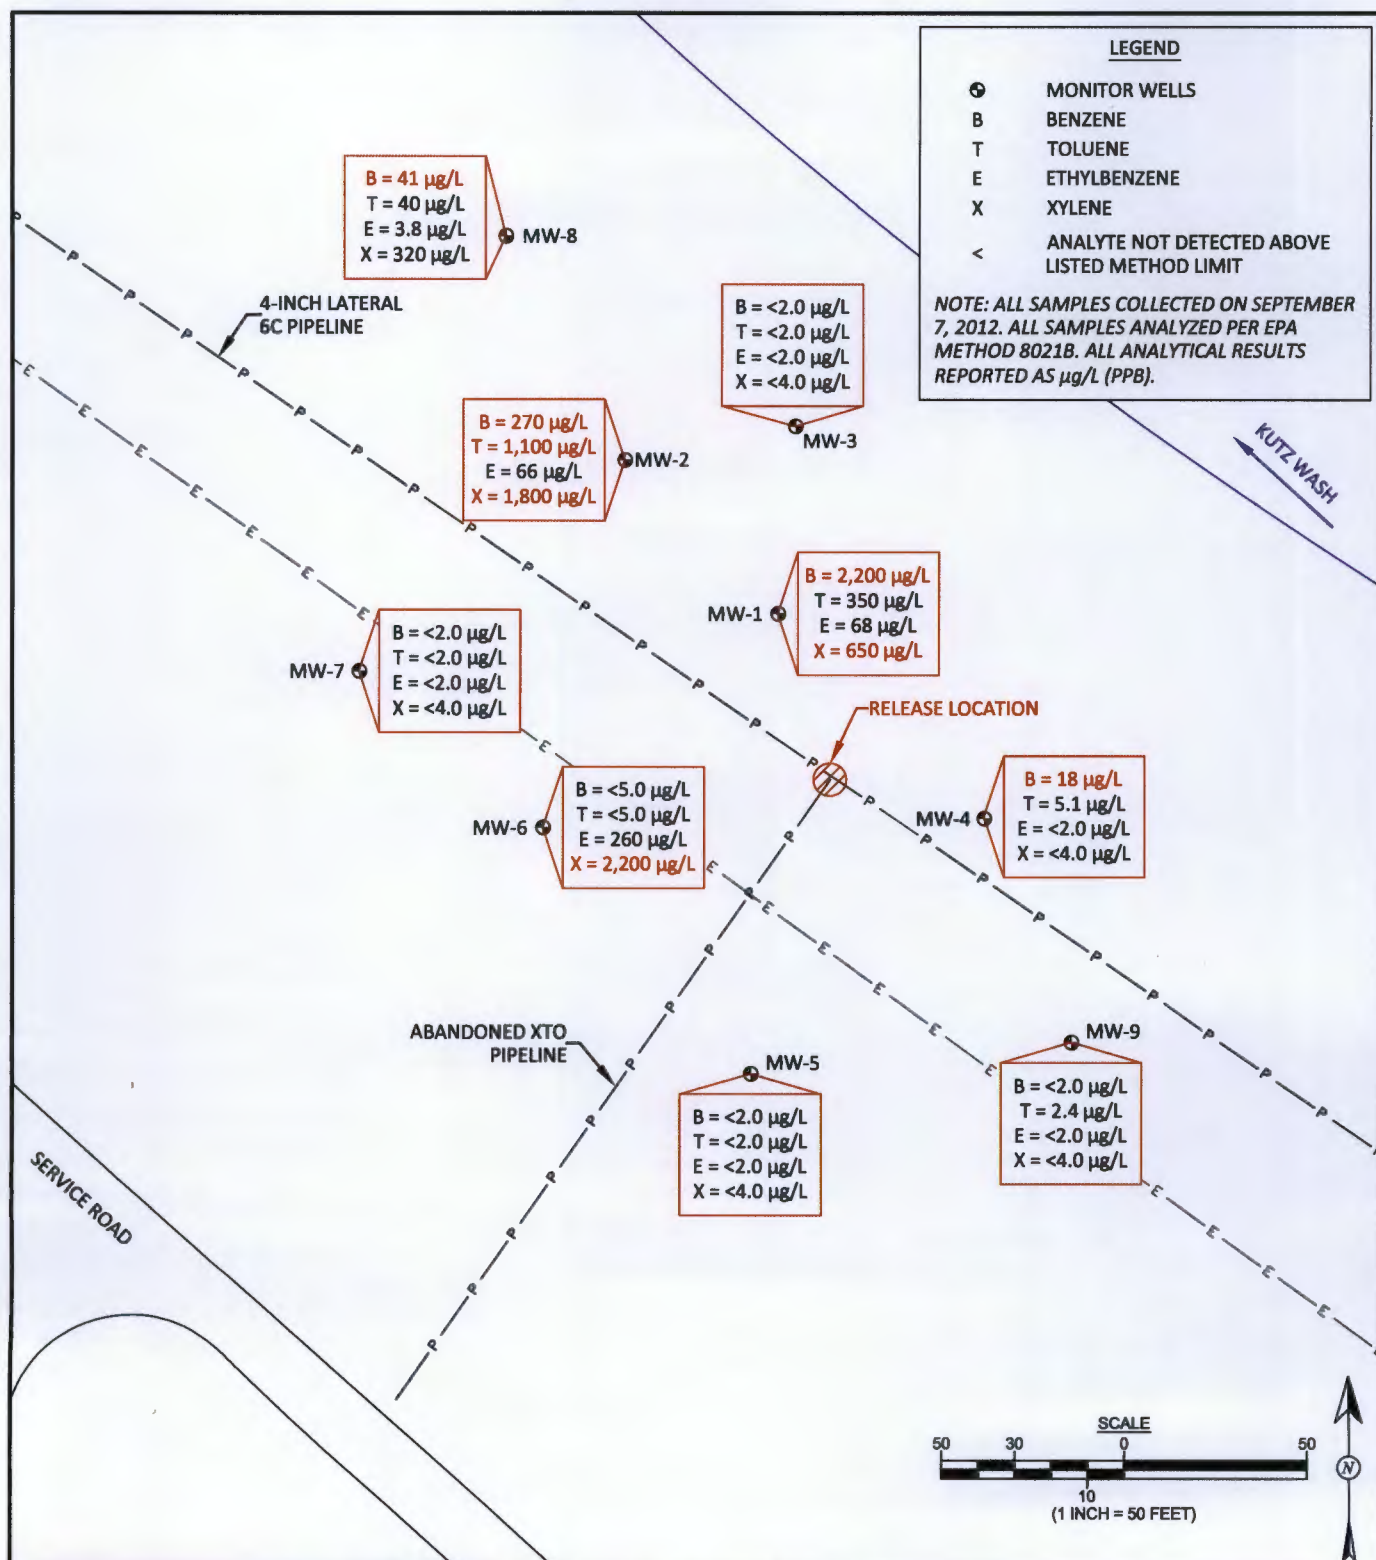
**FIGURE 5**

Groundwater laboratory analytical results showed that dissolved phase benzene concentrations were above WQCC standard of 10 µg/L in MW-1 (2,200 µg/L), MW-2 (270 µg/L), MW-4 (18 µg/L), and MW-8 (41 µg/L). Dissolved phase toluene concentrations above the WQCC standard of 750 µg/L were reported in MW-2 (1,100 µg/L), and ethylbenzene concentrations were below the WQCC standard of 750 µg/L in all wells. Dissolved phase xylene concentrations above the WQCC standard of 620 µg/L in three wells, including MW-1 (650 µg/L), MW-2 (1,800 µg/L), and MW-6 (2,200 µg/L). Tabulated groundwater analytical results are presented in Table 3 and on Figure 5. Dissolved phase benzene, toluene, and xylene concentration contours are presented on Figures 6 through 8, respectively. Groundwater laboratory analytical reports are presented in Appendix D.

**GROUNDWATER CONTAMINANT  
CONCENTRATIONS, SEPTEMBER 2012**  
ENTERPRISE PRODUCTS COMPANY  
LATERAL 6C PIPELINE RELEASE  
GROUNDWATER INVESTIGATION  
SAN JUAN COUNTY, NEW MEXICO  
NE¼ SW¼, SECTION 26, T28N, R11W  
N36.63202, W107.97400

Based on laboratory analytical results from the August and September 2012 investigation, groundwater continues to be impacted above WQCC standards in the vicinity of the September 2011 release. Additionally, the lateral extent of the dissolved phase benzene has not been fully defined in the downgradient direction (near MW-8). Therefore, AES recommends installation of an additional monitor well northwest of MW-8. Additionally, this site may be appropriate for consideration of an application of an oxygen release compound to enhance bioremediation of residual contaminants. Details will be included within the corrective action plan, which will be submitted under separate cover.

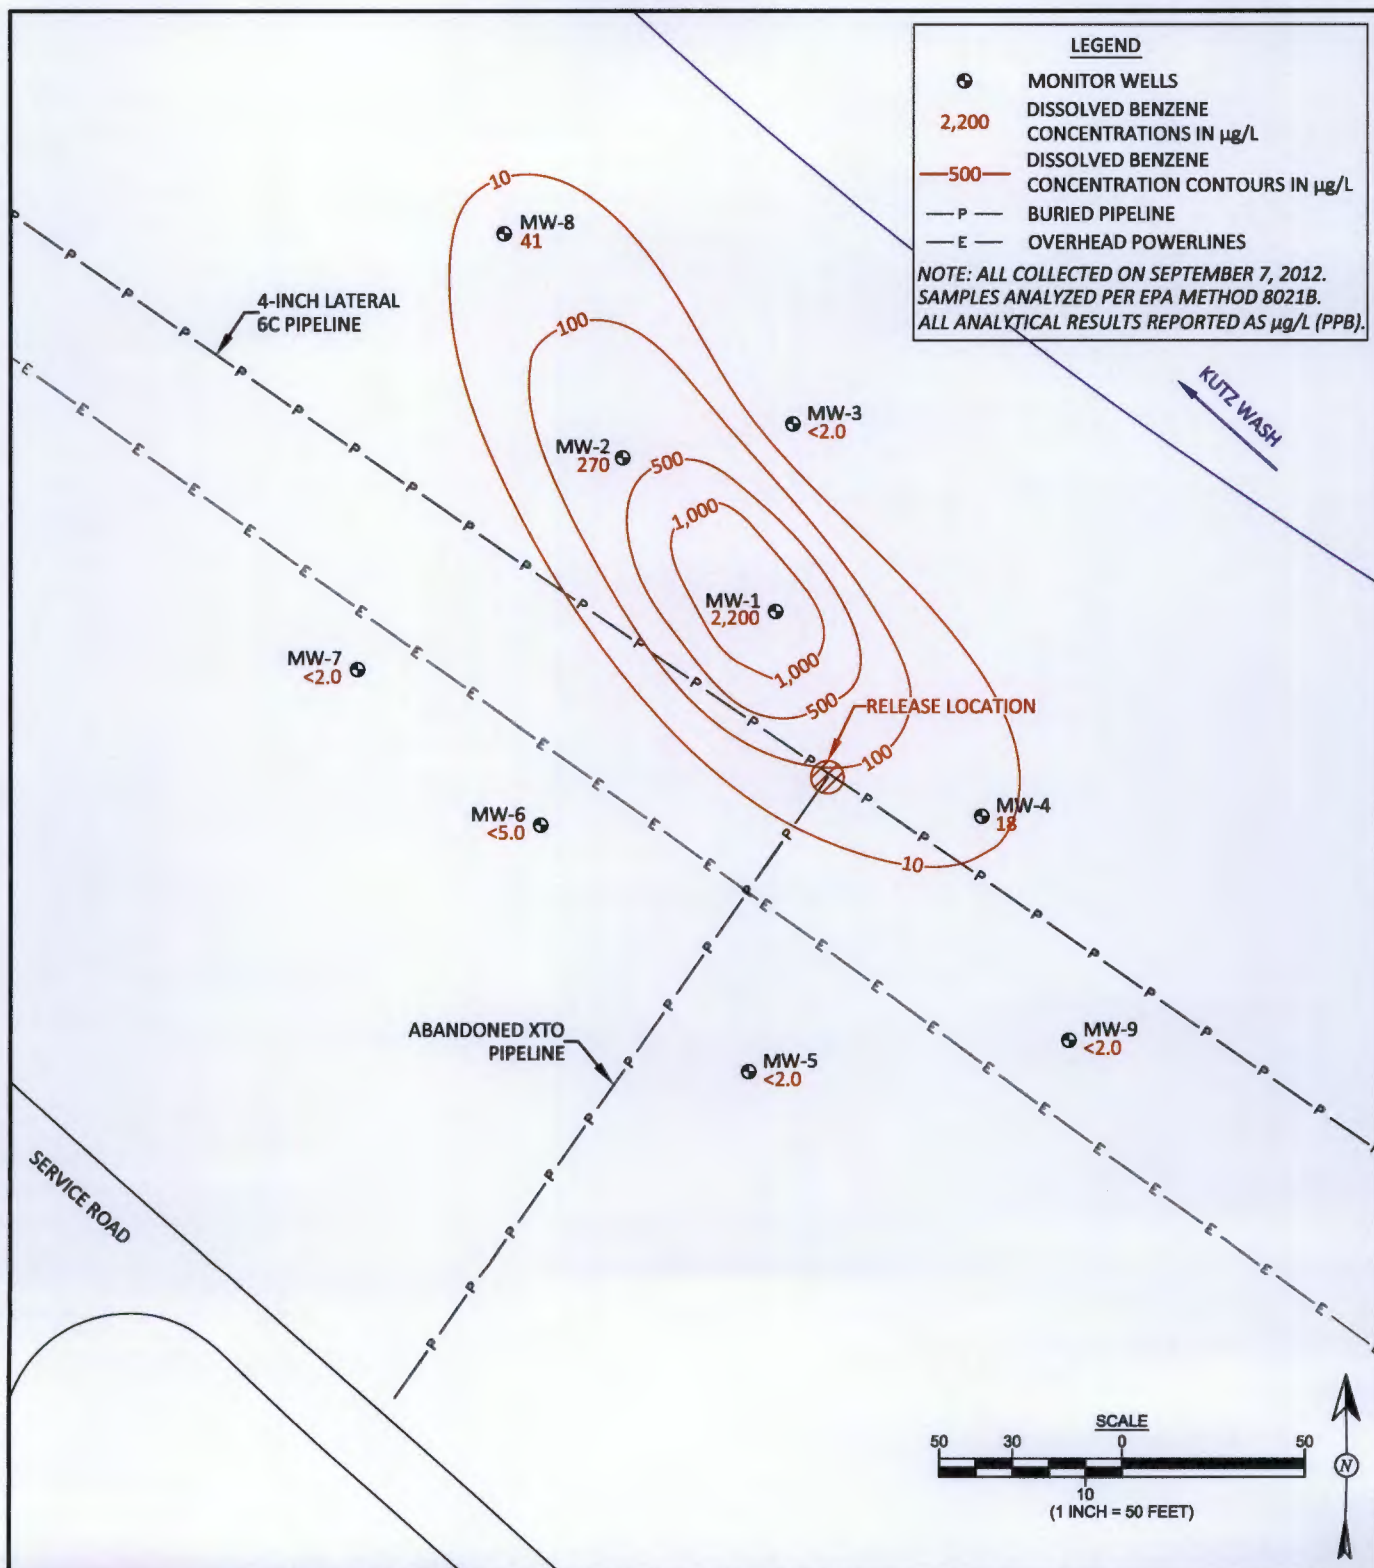
**FIGURE 6**

**DISSOLVED BENZENE CONCENTRATION CONTOURS, SEPTEMBER 2012**

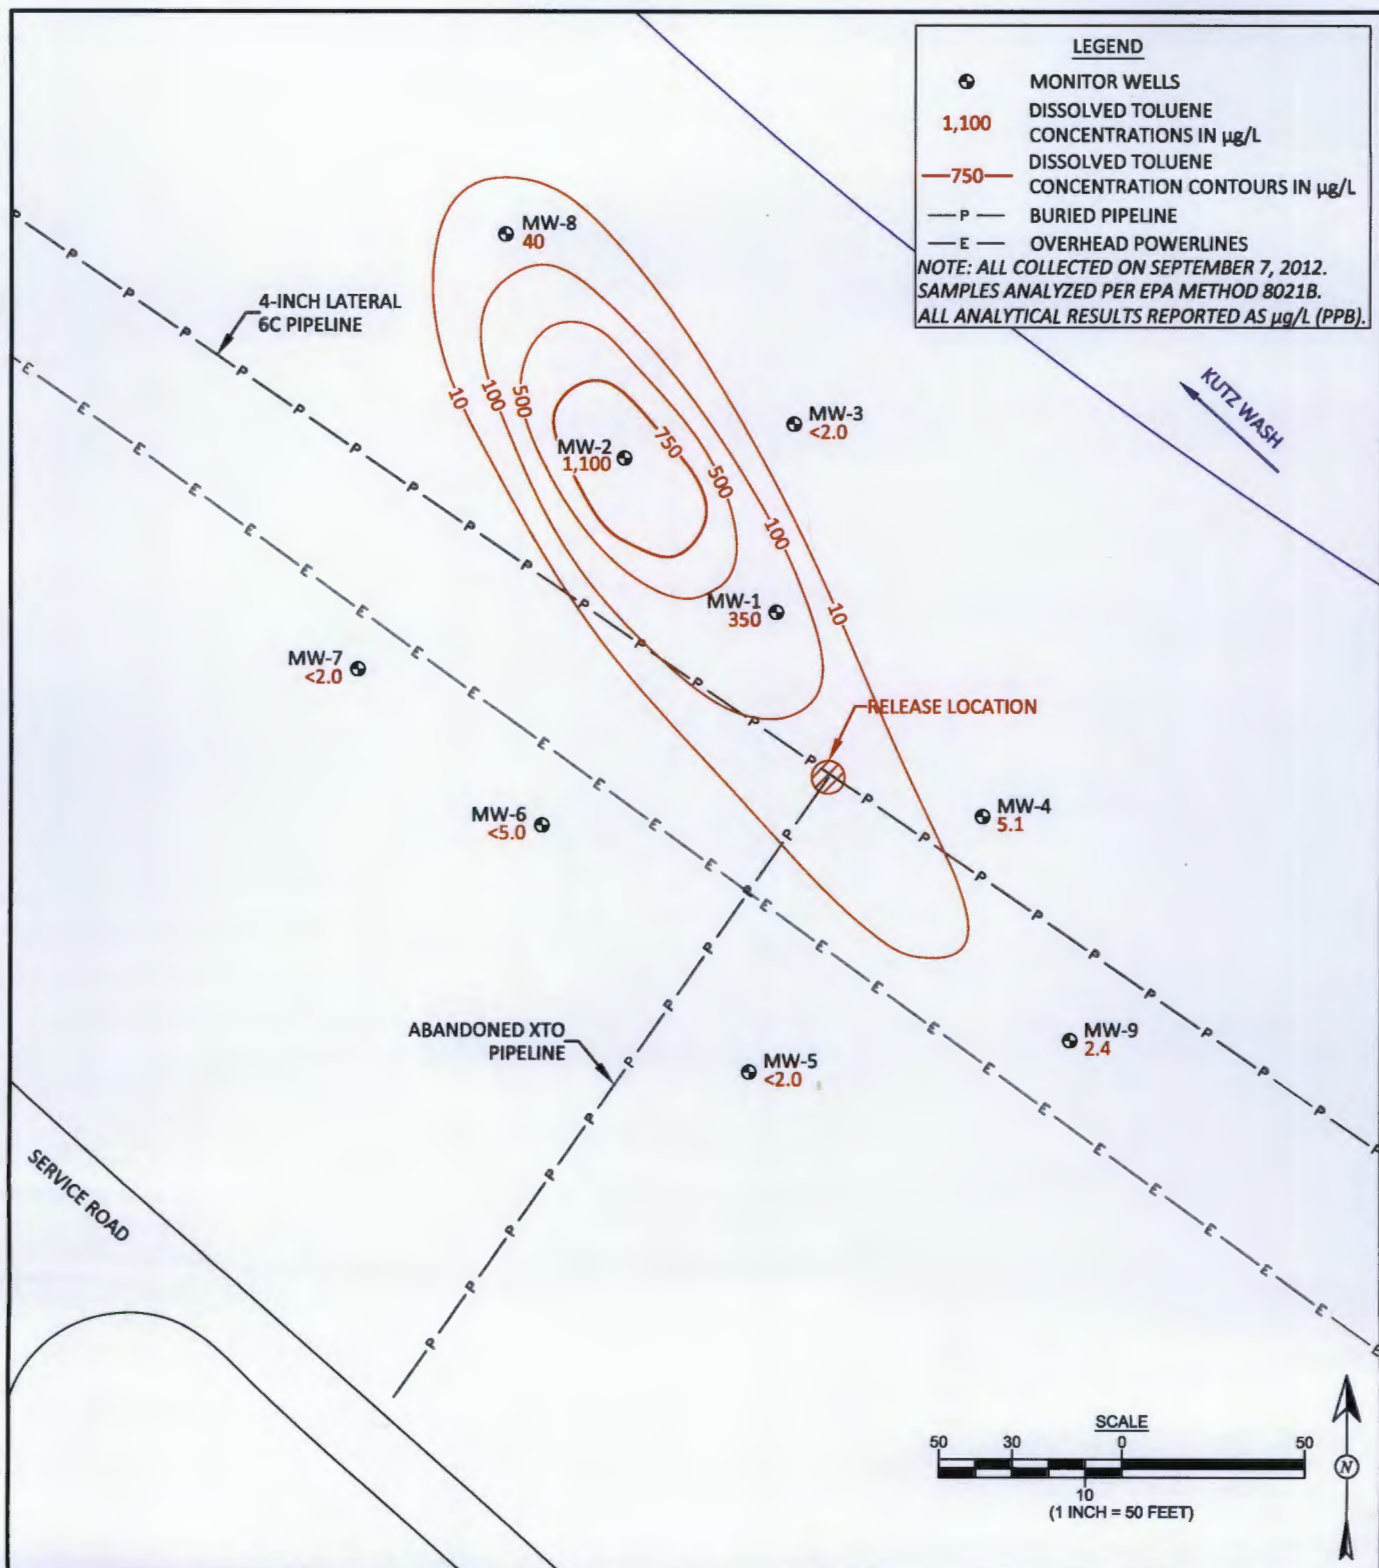
**FIGURE 7**

**DISSOLVED TOLUENE CONCENTRATION  
 CONTOURS, SEPTEMBER 2012**  
 ENTERPRISE PRODUCTS COMPANY  
 LATERAL 6C PIPELINE RELEASE  
 GROUNDWATER INVESTIGATION  
 SAN JUAN COUNTY, NEW MEXICO  
 NE¼ SW¼, SECTION 26, T28N, R11W  
 N36.63202, W107.97400

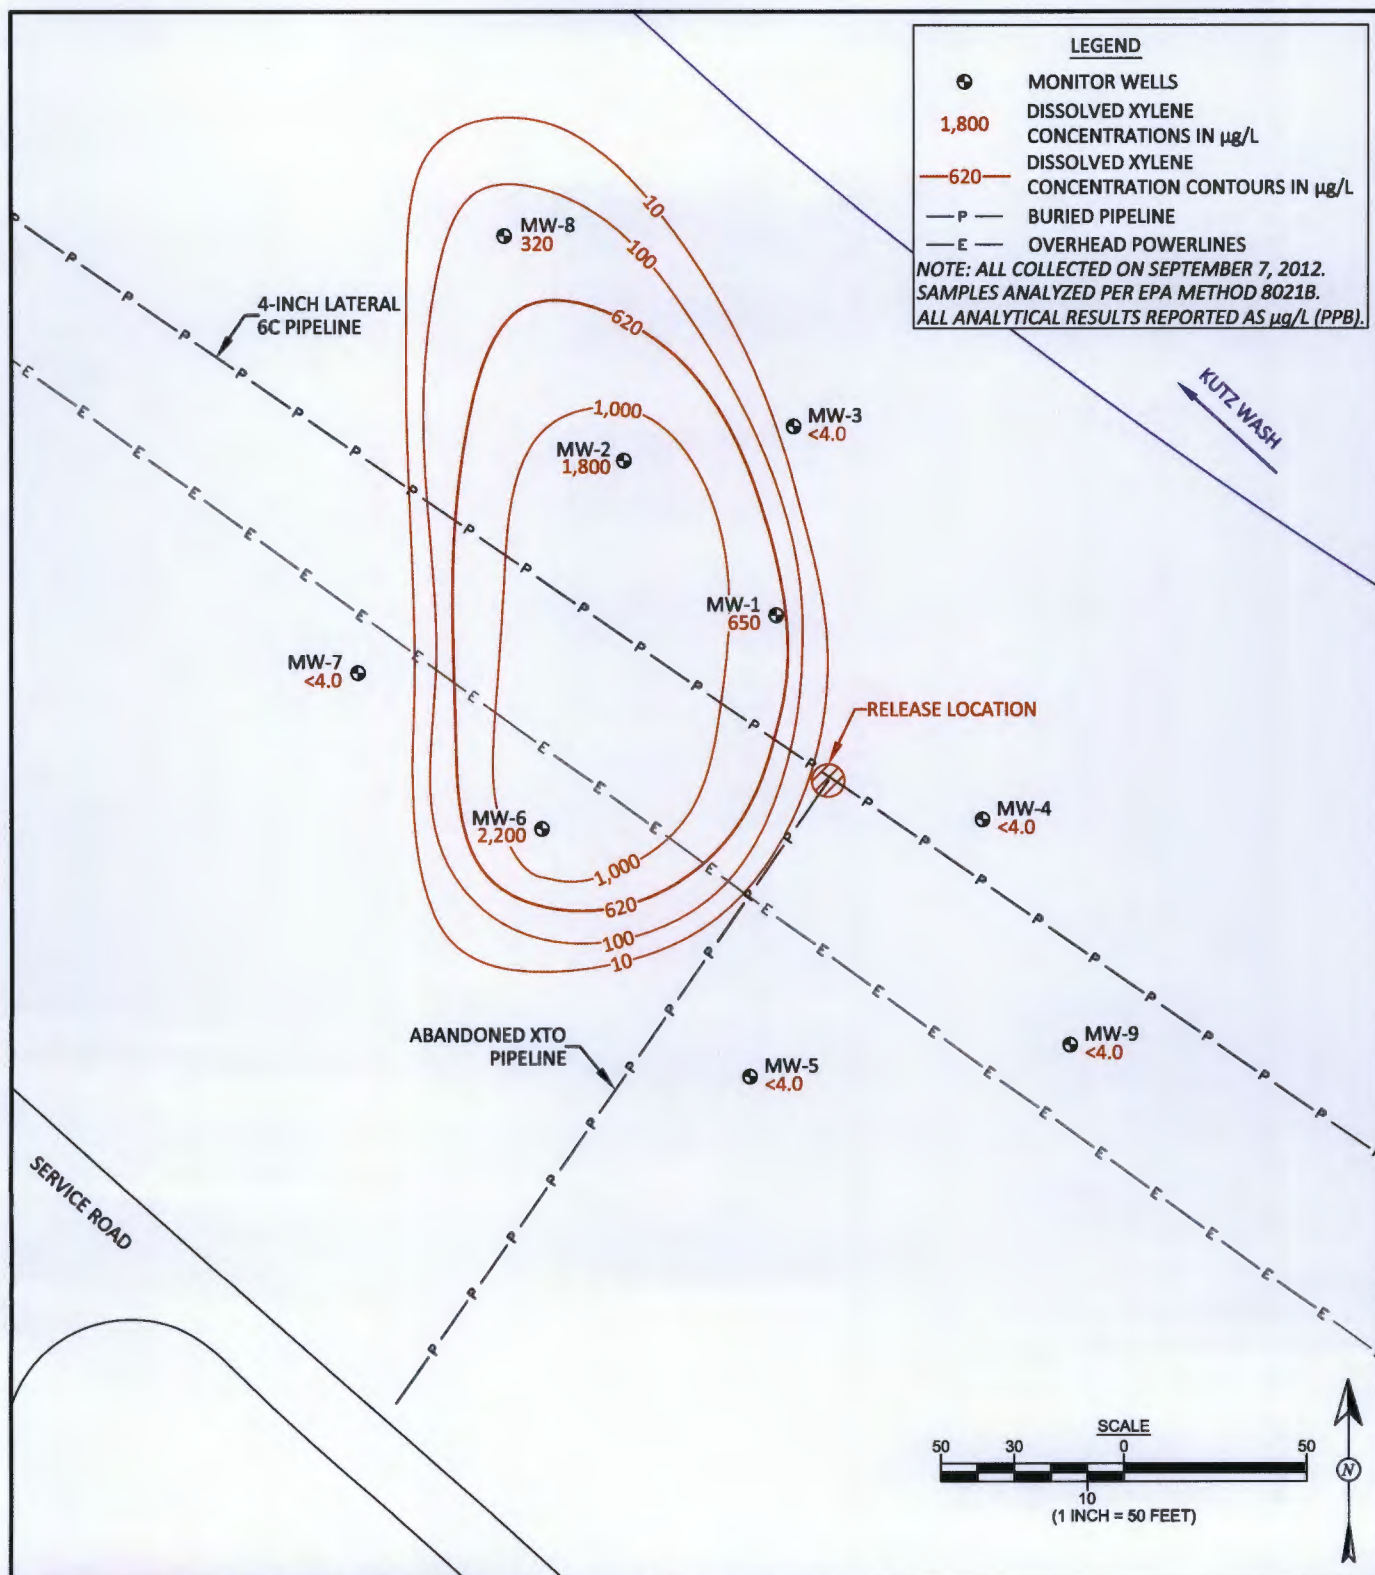
**FIGURE 8**

Hydraulic gradient was calculated to have a magnitude of 0.008 foot/foot in a northwest direction. Laboratory analytical results confirmed groundwater contaminant concentrations above the WQCC standard of 10 µg/L for benzene in MW-1 (2,200 µg/L), MW-2 (270 µg/L), MW-4 (18 µg/L), and MW-8 (41 µg/L). Additionally, dissolved phase toluene above the WQCC standard of 750 µg/L was reported in MW-2 with 1,100 µg/L, and xylene above the WQCC standard of 620 µg/L was reported in MW-1 (650 µg/L), MW-2 (1,800 µg/L), and MW-6 (2,200 µg/L).

**DISSOLVED XYLENE CONCENTRATION  
 CONTOURS, SEPTEMBER 2012**  
 ENTERPRISE PRODUCTS COMPANY  
 LATERAL 6C PIPELINE RELEASE  
 GROUNDWATER INVESTIGATION  
 SAN JUAN COUNTY, NEW MEXICO  
 NE¼ SW¼, SECTION 26, T28N, R11W  
 N36.63202, W107.97400

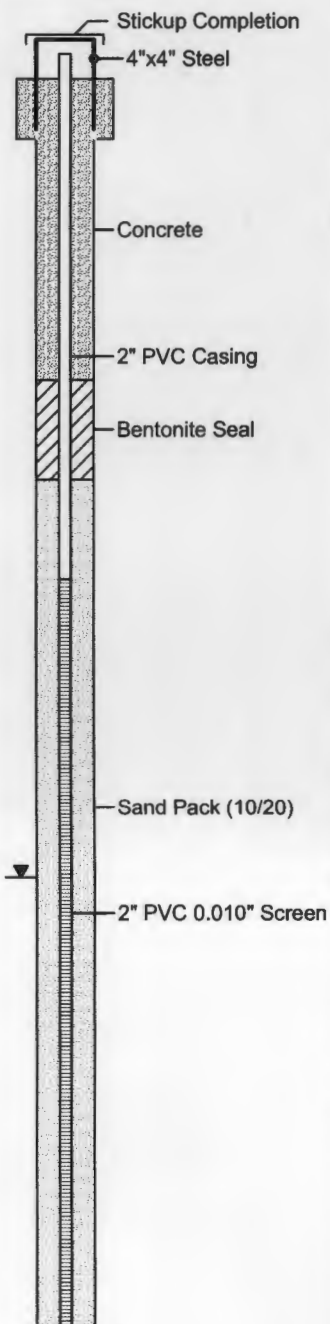
Well: MW-1  
Elev: 5579.73

Depth in Feet	Surf. Elev. 5577	USCS	GRAPHIC	DESCRIPTION	Blow Count	PID (ppm)
0	5577			Clayey Sand, Brown, Dry, No Odor, No Staining		
2	5575	SC			85.8	
4	5573					
6	5571	SM		Silty Sand, Brown, Fine Grained, Dry, No Odor, No Staining	87.4	
8	5569					
10	5567			Sand, Brown/Tan, Moist, No Odor, No Staining	190	
12	5565	SP				
14	5563					
16	5561			Sand, Brown, Fine Grained, Wet, Very Little Recovery, Slight Odor	NA	
18	5559	SP				
20	5557			Cobble/Gravel, Brown, Wet, No Odor, No Staining	2.4	
22	5555	CG				
24	5553					
26		SP		Sand, Gray, Fine Grained, Wet, Slight Odor, Slight Staining	15.3

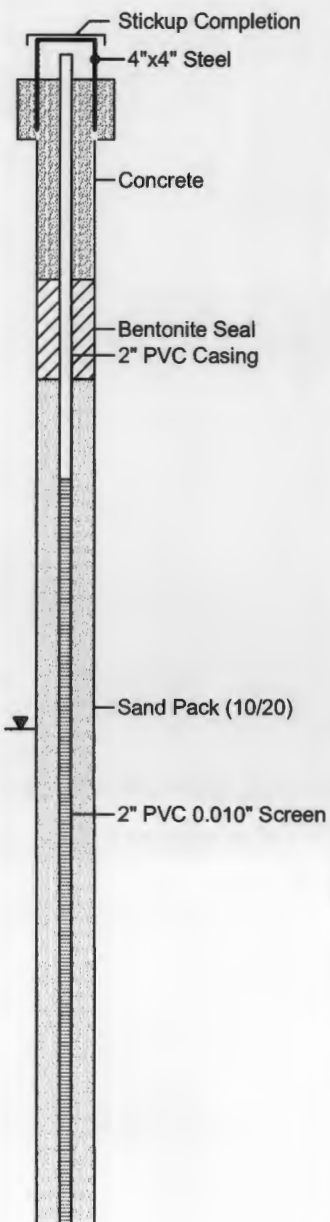
Well: MW-2  
Elev: 5579.39

Depth in Feet	Surf. Elev. 5577	USCS	GRAPHIC	DESCRIPTION	Blow Count	PID (ppm)
0	5577	SP		Sand, Brown, Fine Grained, Moist, No Odor, No Staining	93.1	
2	5575					
4	5573					
6	5571					
8	5569	SP		Sand, Brown, Moist/Wet, No Odor, No Staining	108	
10	5567					
12	5565					
14	5563	SP		Sand, Brown, Medium Grained, Wet, Very Little Recovery, No Odor, No Staining	87.0	
16	5561					
18	5559	CG		Cobble/Gravel, Brown, Wet, Slight Odor, No Staining	NA	
20	5557					
22	5555	SS			38.7	
24	5553					
26		SS		Sandstone, Gray, Fine Grained, Wet, Slight Odor, No Staining	16.1

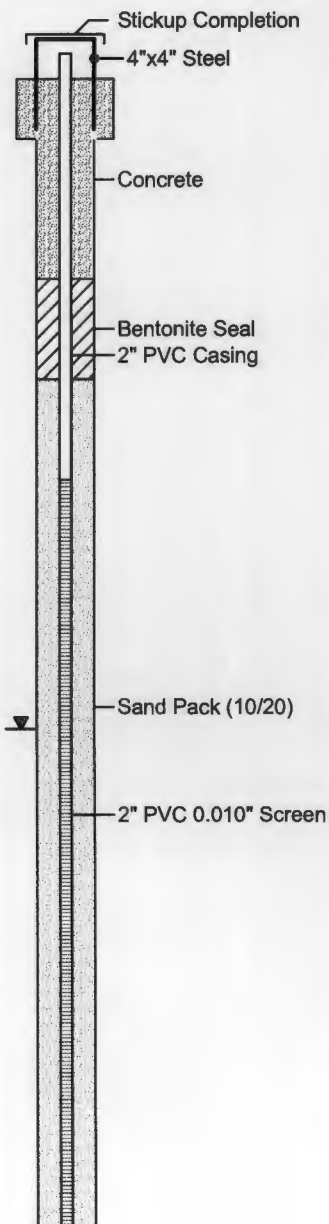
Well: MW-3  
Elev: 5579.52

Depth in Feet	Surf. Elev. 5577	USCS	GRAPHIC	DESCRIPTION	Blow Count	PID (ppm)
0	5577	SP		Sand, Brown, Fine Grained, Dry, No Odor, No Staining	5.6	
2	5575					
4	5573					
6	5571					
8	5569	SP		Sand, Brown, Fine Grained, Wet, No Odor, No Staining	2.8	
10	5567					
12	5565					
14	5563	SP		Sand, Gray, Fine to Medium Grained, Wet, No Odor, No Staining	2.9	
16	5561					
18	5559	SP		Sand, Gray, Fine to Coarse Grained, Some Gravel, Wet, No Odor, No Staining	0.8	
20	5557					
22	5555					
24	5553	SS			2.1	
26				Sandstone, Gray, Fine Grained, Wet, No Odor, No Staining

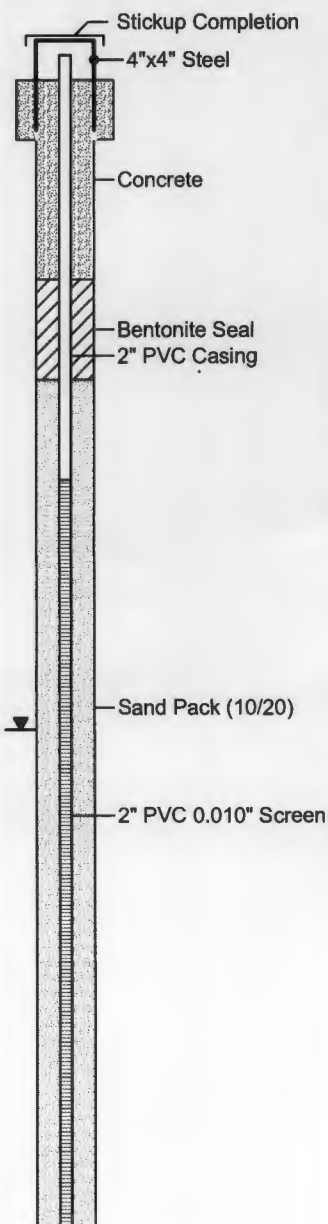
Well: MW-4  
Elev: 5580.36

Depth in Feet	Surf. Elev. 5578	USCS	GRAPHIC	DESCRIPTION	Blow Count	PID (ppm)
0	5578			Interbedded Sand and Clay, Brown, Fine Grained, Dry, No Odor, No Staining		
2	5576	SC			22.1	
4	5574					
6	5572	SP		Sand, Brown, Fine Grained, Dry, No Odor, No Staining		
8	5570				54.8	
10	5568			Sand, Brown, Fine Grained, Wet, No Odor, No Staining		
12	5566	SP			58.2	
14	5564					
16	5562			Sand, Brown, Fine Grained, Wet, No Odor, No Staining, Very Little Recovery		
18	5560	SP			NA	
20	5558			No Recovery		
22	5556	SP			NA	
24	5554					
26		SS		Sandstone, Gray, Fine Grained, Wet, No Odor, No Staining	3.6

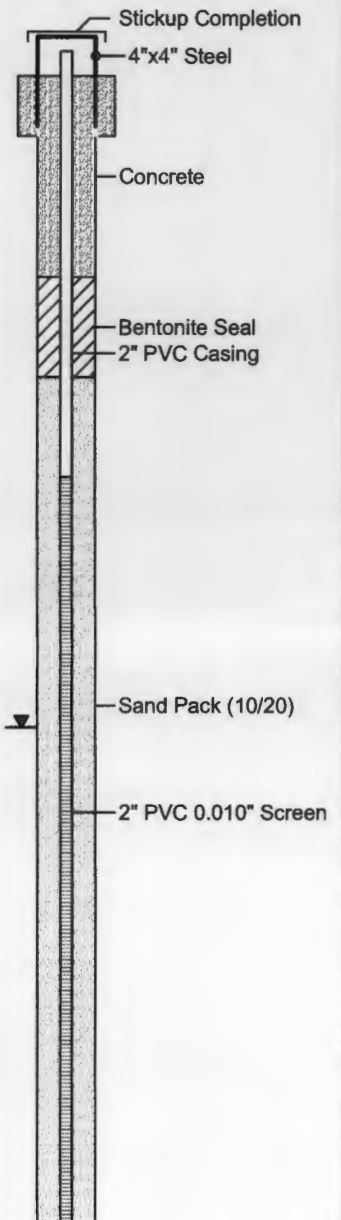
Well: MW-5  
Elev: 5583.53

Depth in Feet	Surf. Elev. 5581	USCS	GRAPHIC	DESCRIPTION	Blow Count	PID (ppm)
0	5581			Interbedded Sand and Clay, Brown, Fine Grained, Dry, No Odor, No Staining		
2	5579	SC			0.4	
4	5577					
6	5575	SC		Clayey Sand, Brown, Fine Grained, Dry, No Odor, No Staining		
8	5573				0.5	
10	5571					
12	5569	SP		Sand, Brown, Fine Grained, Wet, No Odor, No Staining		
14	5567				0.9	
16	5565					
18	5563	SC		Clayey Sand, Brown, Fine Grained, Wet, No Odor, No Staining		
20	5561				0.7	
22	5559	SP		Sand, Brown, Fine to Coarse Grained, Wet, Some Gravel, No Odor, No Staining		
24	5557				0.6	
26		SS		Sandstone, Gray, Fine Grained, Wet, No Odor, No Staining		
					0.8

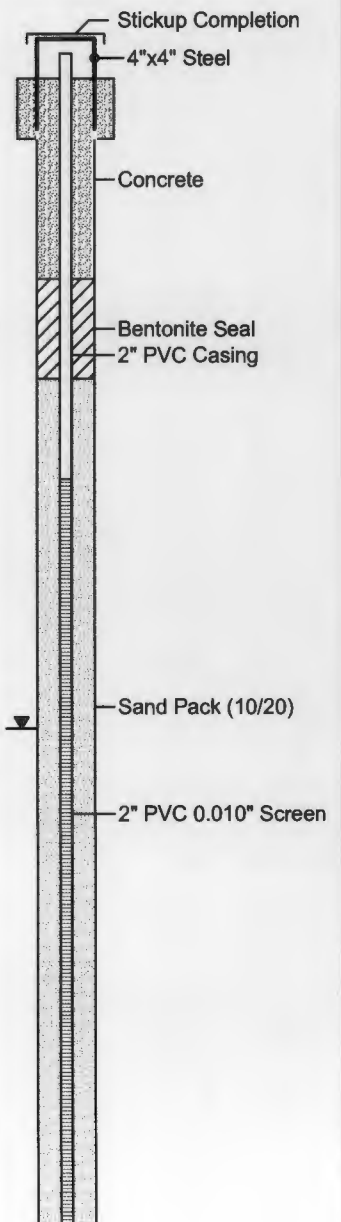
Well: MW-6  
Elev: 5582.22

Depth in Feet	Surf. Elev. 5580	USCS	GRAPHIC	DESCRIPTION	Blow Count	PID (ppm)
0	5580					
2	5578	SM		Silty Sand, Brown, Fine Grained, Dry, No Odor, No Staining	0.3	
4	5576					
6	5574	SP		Sand, Brown, Fine Grained, Dry, No Odor, No Staining	0.5	
8	5572					
10	5570	SP		Sand, Brown, Fine Grained, Wet, No Odor, No Staining	0.6	
12	5568					
14	5566	SP		Sand, Brown, Fine Grained, Some Clay, Wet, Slight Odor, Slight Staining	3.0	
16	5564					
18	5562	SP		Sand, Brown, Fine to Coarse Grained, Some Gravel, Very Little Recovery, No Staining	NA	
20	5560					
22	5558	SP				
24	5556					
26		SS		Sandstone, Gray, Fine Grained, Wet, No Odor, No Staining	1.9

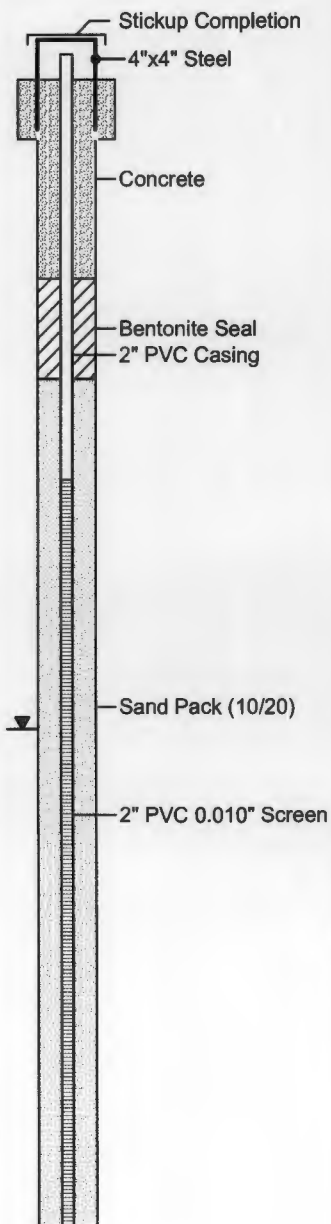
Well: MW-7  
Elev: 5582.24

Depth in Feet	Surf. Elev. 5579	USCS	GRAPHIC	DESCRIPTION	Blow Count	PID (ppm)
0	5579	SM		Silty Sand, Brown, Fine Grained, Dry, No Odor, No Staining	0.5	
2	5577					
4	5575	SC		Clayey Sand, Brown, Moist, No Odor, No Staining	0.6	
6	5573					
8	5571	SP		Sand, Brown, Fine Grained, Moist, No Odor, No Staining	0.5	
10	5569					
12	5567	SP		Sand, Brown, Fine Grained, Some Clay, Wet, Slight Odor, Slight Staining	0.7	
14	5565					
16	5563	SP		Sand, Brown, Fine to Coarse Grained, Some Gravel, Wet, No Odor, No Staining	0.5	
18	5561					
20	5559	SP			0.5	
22	5557					
24	5555	SS			0.8	
26				Sandstone, Gray, Fine Grained, Wet, No Odor, No Staining
