**3R - 438**

Groundwater Investigation  
Report  
Enterprise Products Company  
Lateral 6C September 2011  
Pipeline Release  
NE¼ SW¼ Section 26, T28N, R11W  
San Juan County, New Mexico

October 31, 2012

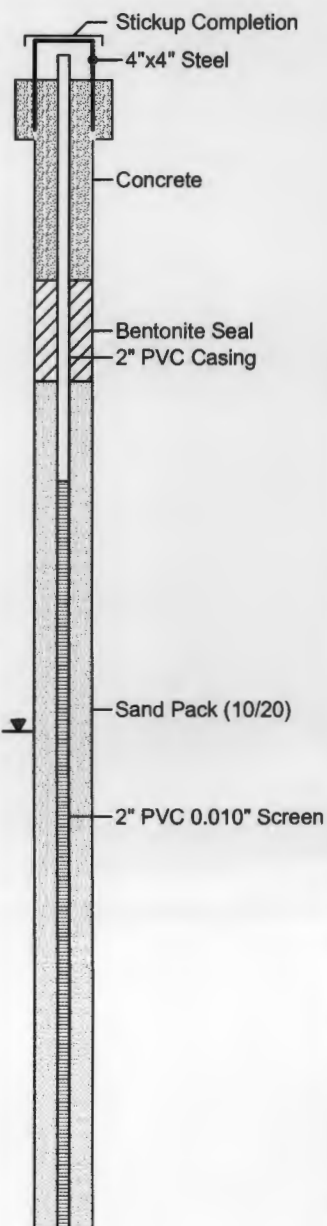
Well: MW-8  
Elev: 5577.81

Depth in Feet	Surf. Elev. 5576	USCS	GRAPHIC	DESCRIPTION	Blow Count	PID (ppm)
0	5576			Sand, Brown, Fine Grained, Dry, No Odor, No Staining		
2	5574	SP			82.8	
4	5572					
6	5570	SP		Sand, Brown, Fine Grained, Dry, No Odor, No Staining		
8	5568				219	
10	5566					
12	5564	SP		Sand, Brown, Fine Grained, Wet, Slight Odor, No Staining		
14	5562				144	
16	5560					
18	5558	SP		Sand, Gray, Fine to Medium Grained, Wet, Slight Odor, No Staining		
20	5556				147	
22	5554	SP		Sand, Gray, Fine to Medium Grained, Some Gravel, Wet, Slight Odor, No Staining		
24	5552				87.3	
26		SS		Sandstone, Gray, Fine Grained, Wet, Slight Odor, No Staining		16.9

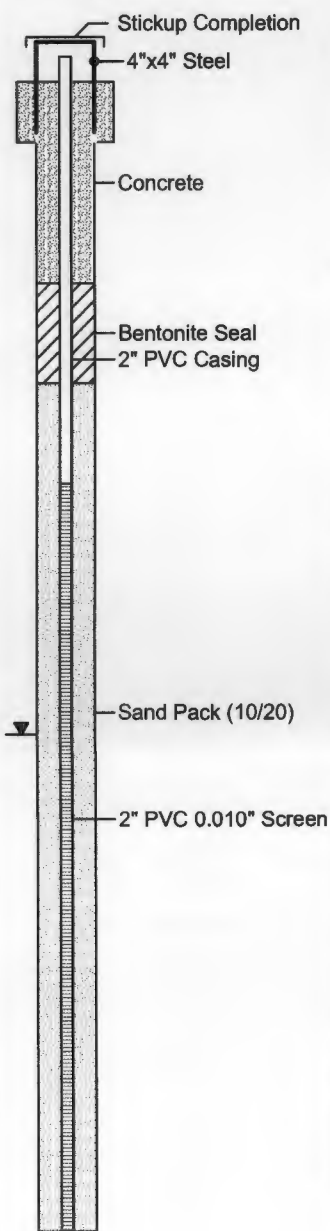
Well: MW-9  
 Elev: 5582.48

Depth in Feet	Surf. Elev. 5580	USCS	GRAPHIC	DESCRIPTION	Blow Count	PID (ppm)	
0	5580	SP		Sand, Brown, Fine Grained, Dry, No Odor, No Staining	0.3		
2	5578						
4	5576	SM		Silty Sand, Brown, Fine Grained, Dry, No Odor, No Staining	0.3		
6	5574						
8	5572	SP		Sand, Brown, Fine Grained, Moist, No Odor, No Staining	0.4		
10	5570						
12	5568	SP		Sand, Gray, Fine to Medium Grained, Wet, No Odor, No Staining	0.2		
14	5566						
16	5564	SP		Sand, Gray, Some Gravel, Wet, No Odor, No Staining	0.1		
18	5562						
20	5560	SP					
22	5558						
24	5556	SS		Sandstone, Gray, Fine Grained, Wet, No Odor, No Staining			
26
