# GENERAL CORRESPONDENCE

Re: Hydrostatic Test Wastewater Permit HIP-134, Holly Energy Partners Beeson Station Above Ground Storage Tank Project, Eddy County, New Mexico

Re: Submittal of Notice of Intent for the Discharge of Hydrostatic Test Wastewater, Holly Energy Partners Beeson Station Above Ground Storage Tank Project, Eddy County, New Mexico

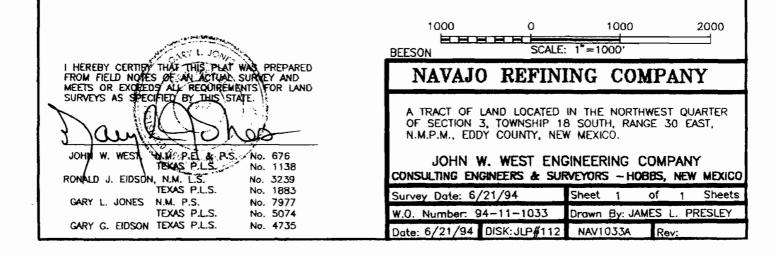
A TRACT OF LAND LOCATED IN THE NORTHWEST QUARTER OF SECTION 3, TOWNSHIP 18 SOUTH, RANGE 30 EAST, N.M.P.M., EDDY COUNTY, NEW MEXICO AND BEING MORE PARTICULARLY DESCRIBED AS FOLLOWS:

BEGINNING AT A POINT THAT LIES \$00°02'00"E, 181.95 FEET AND \$89°58'00"E, 2331.23 FEET FROM THE NORTHWEST CORNER OF SAID SECTION 3; THENCE \$87°24'23"E, 252.00 FEET; THENCE \$04°00'54"E, 486.22 FEET; THENCE \$83°01'37"W, 325.47 FEET; THENCE \$12°36'38"W, 176.63 FEET; THENCE \$132.99 FEET; THENCE \$101°20'51"W, 258.89 FEET TO THE POINT OF BEGINNING CONTAINING 3.428 ACRES, MORE OR LESS:
