RE: Corrective Action Plan for the Benson-Montin-Greer Highway 537 Llaves Pipeline 2008 Oil Spill, Rio Arriba County, New Mexico

Corrective Action Plan

Benson-Montin-Greer
Highway 537 Llaves Pipeline Spill
(2008), Schmitz Ranch,
Rio Arriba County, New Mexico

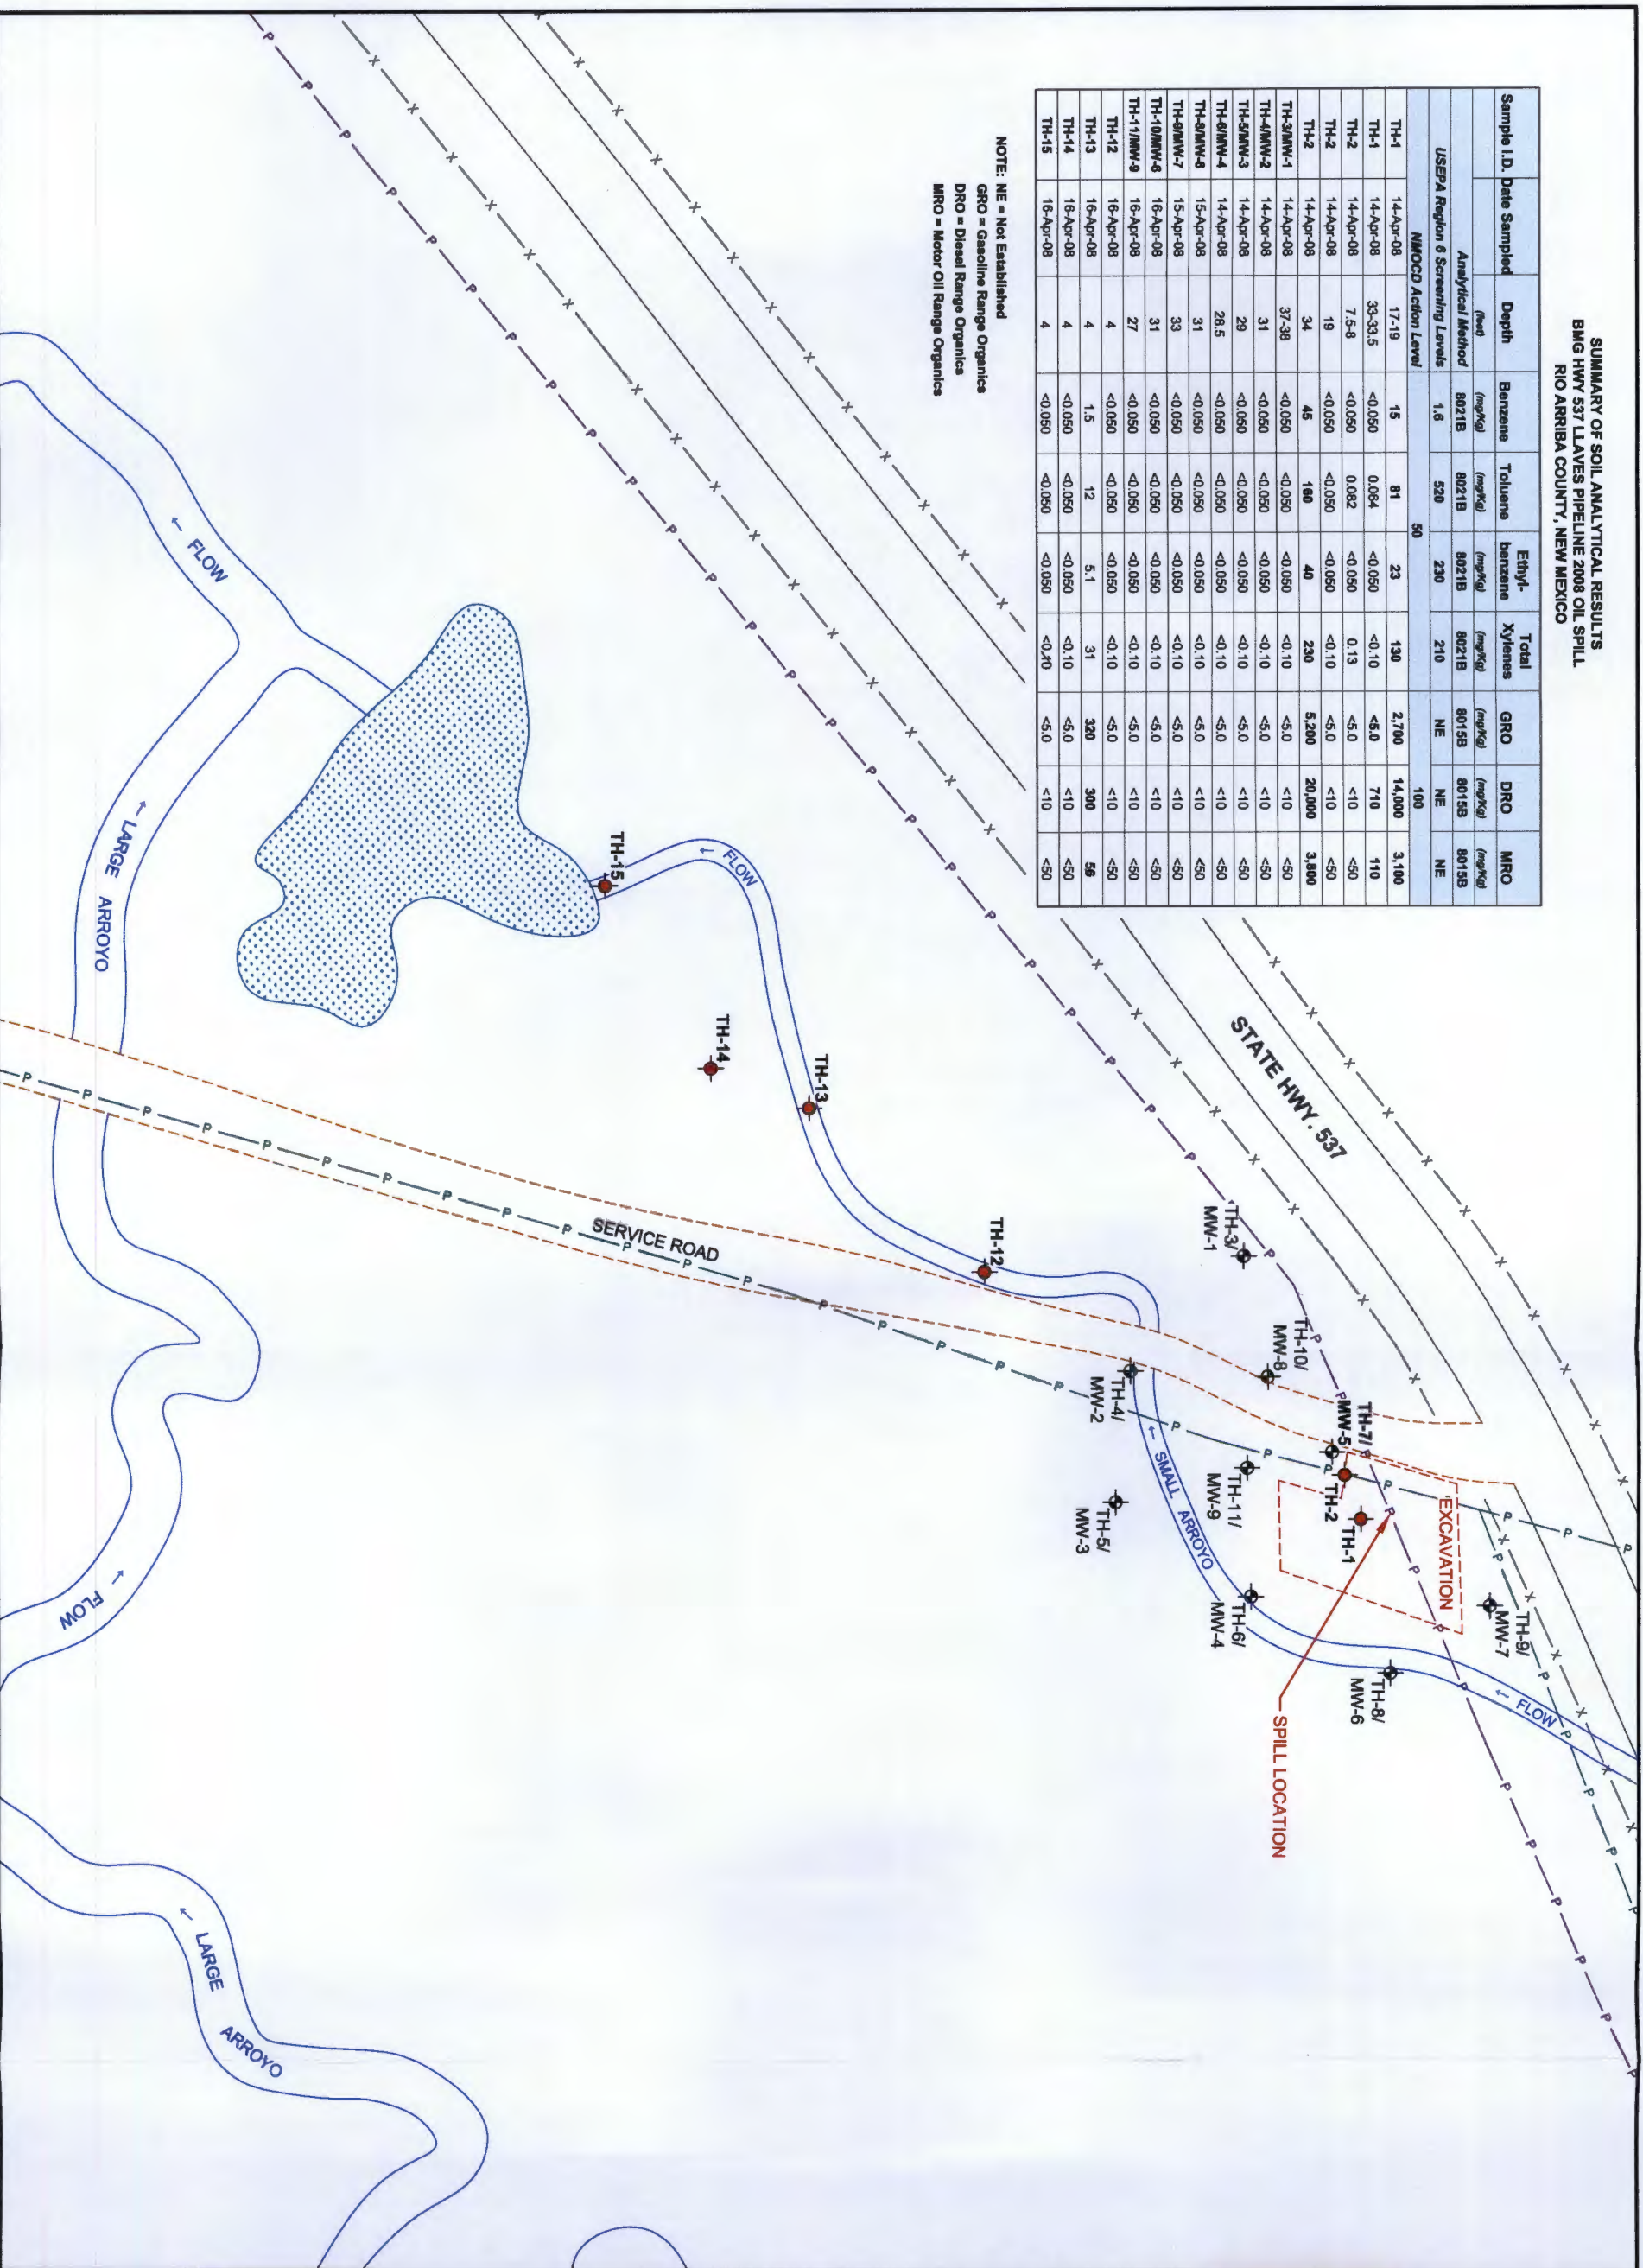
FIGURE 2

GENERAL SITE PLAN AND
SOIL SAMPLING RESULTS, 2008

1965), is included as Figure 1. A site plan illustrating the general site layout and the spill investigation area is presented as Figure 2.

The analytical results for the soil samples are presented on Figure 2. Figure 3 presents geological cross-sections and soil field screening results from the April 2008 field investigation. Soil analytical laboratory reports were presented in Appendix C of the Site Investigation Report, dated June 23, 2008. Soil Boring logs are presented in Appendix A of this CAP.

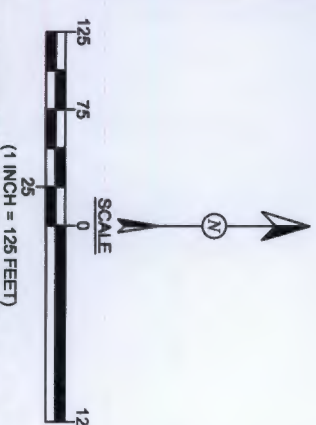
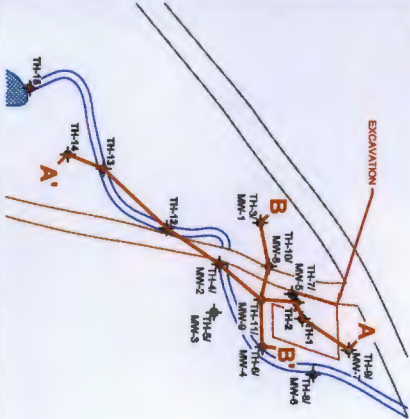
FIGURE 3

GEOLOGICAL CROSS SECTIONS
AND SOIL SCREENING RESULTS

From April 14 to 16, 2008, AES installed 15 soil borings to define the lateral and vertical extent of near surface and subsurface soil contamination. All soil borings (TH-1 through TH-15) were installed with a direct push rig. Borings TH-1 through TH-11 ranged in depth from 33.5 feet below ground surface (bgs) to 40 feet bgs. Borings TH-12 through TH-15 were each advanced to 4 feet bgs. Throughout the site, soil lithology consisted of interbedded layers of brown silty clay, poorly sorted tan sands, and very moist plastic brown clays. The locations of the soil borings installed in April 2008 are illustrated on Figure 2. Figure 3 includes a geological cross section along with soil field screening results.

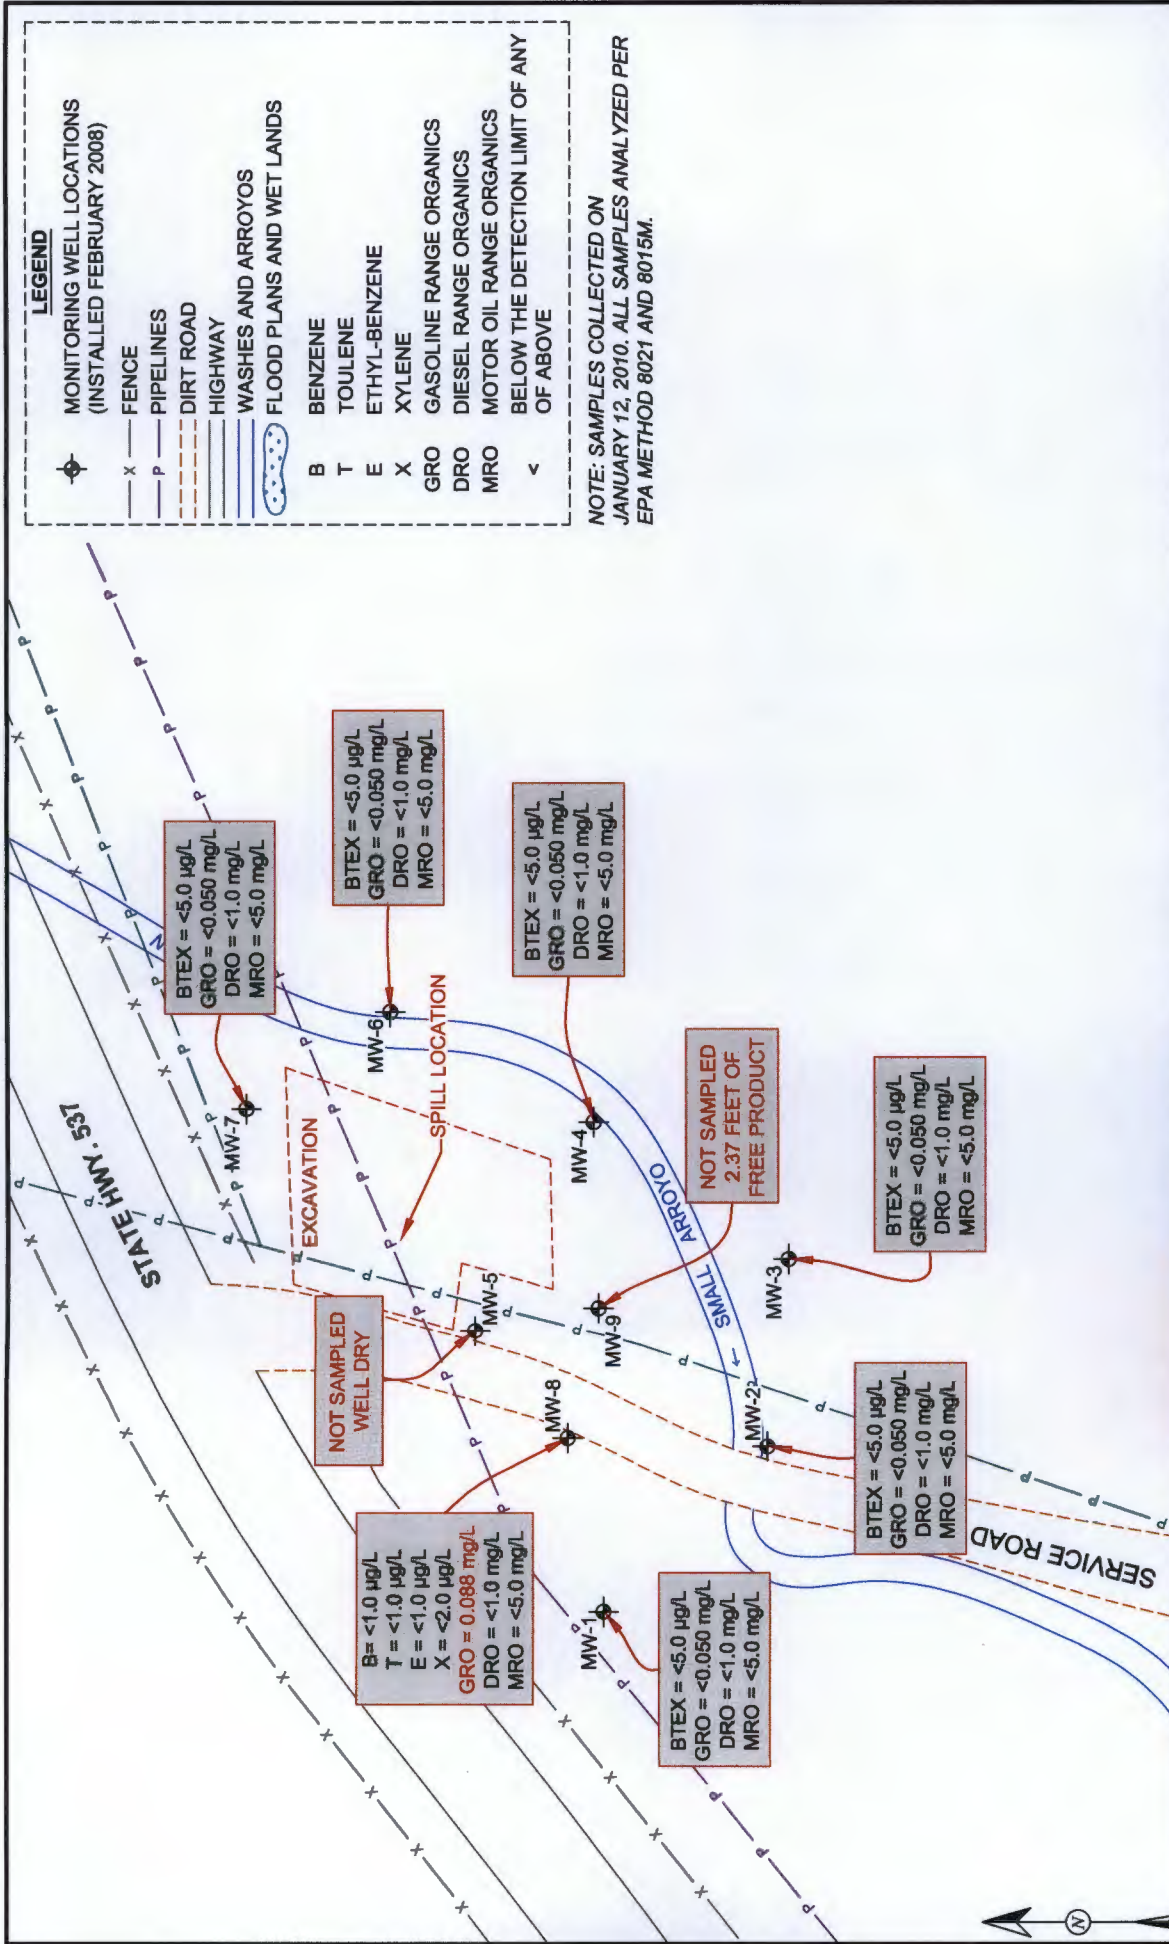
FIGURE 5

GROUNDWATER CONTAMINANT CONCENTRATIONS, JANUARY 2010

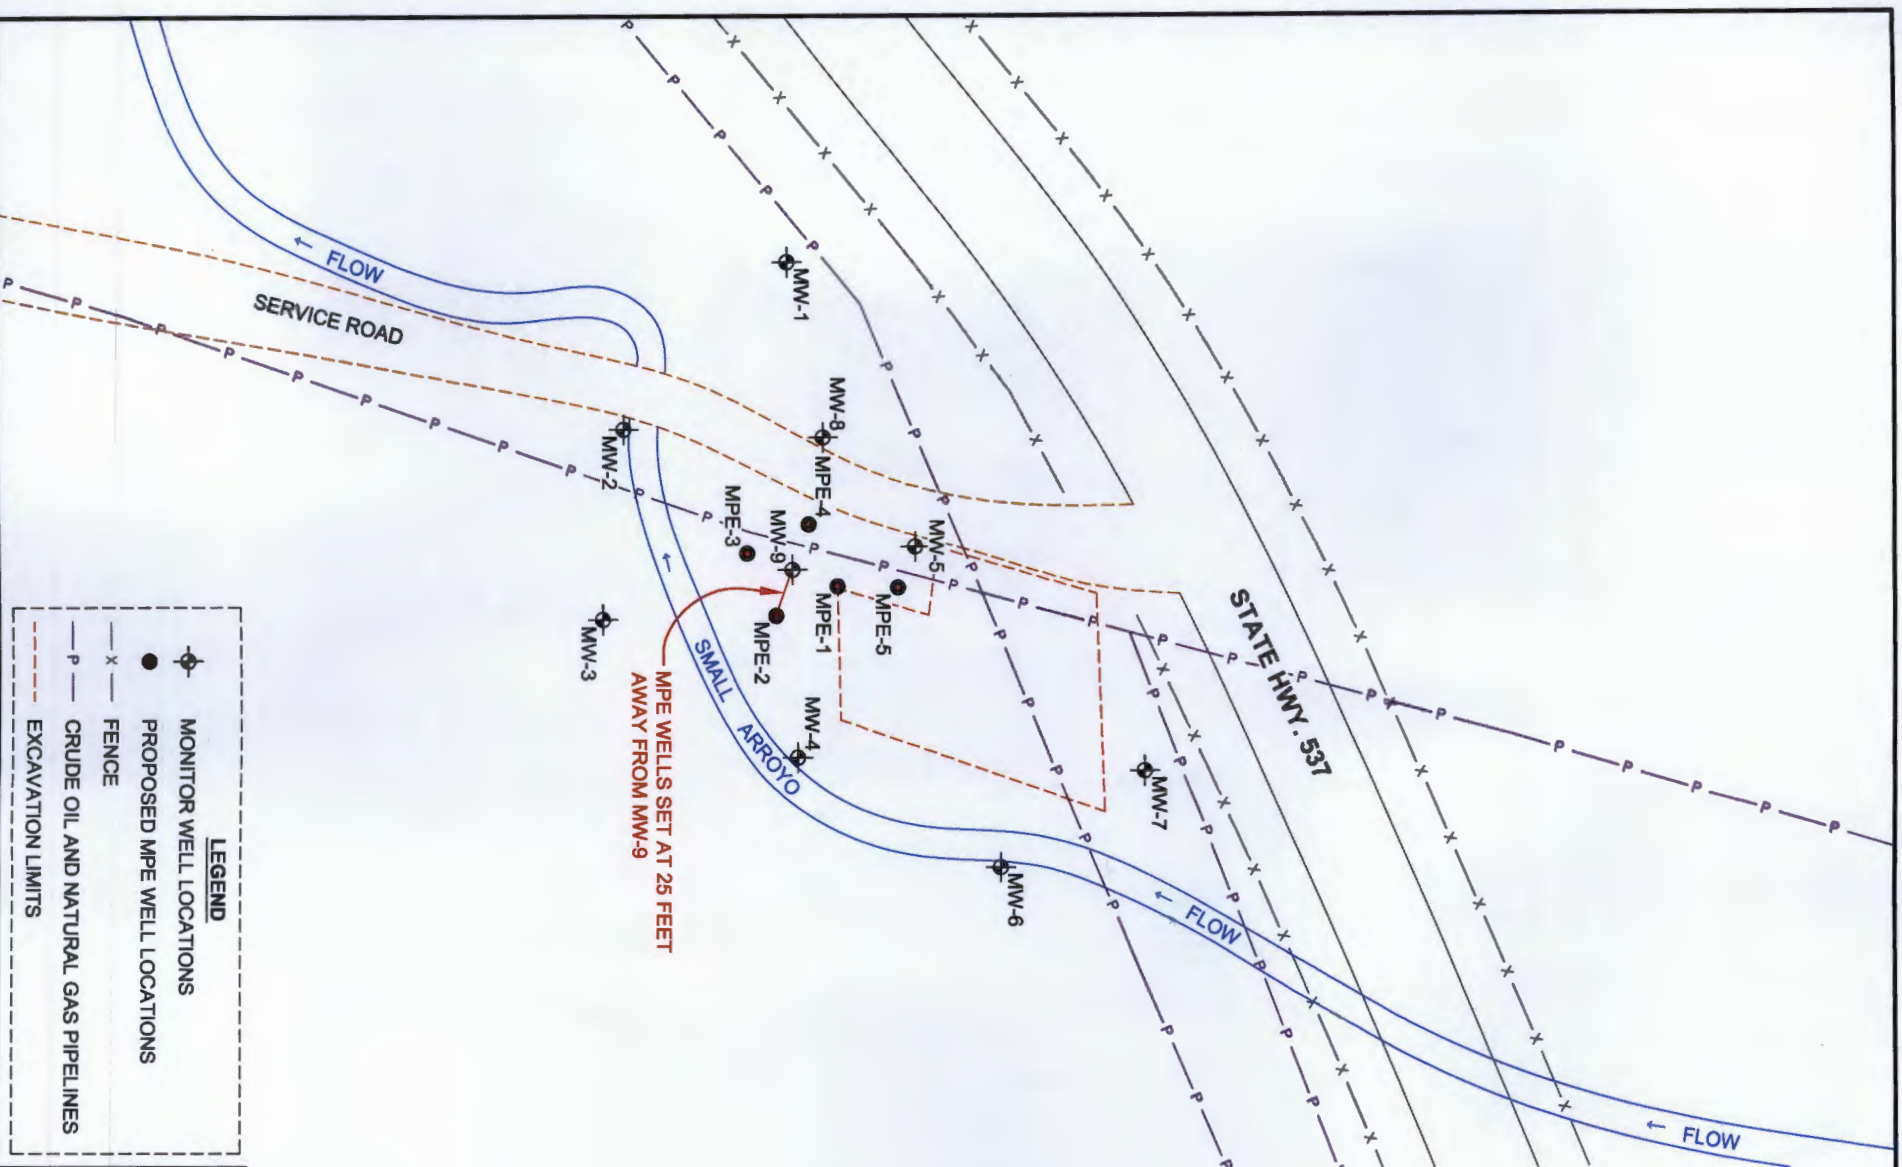
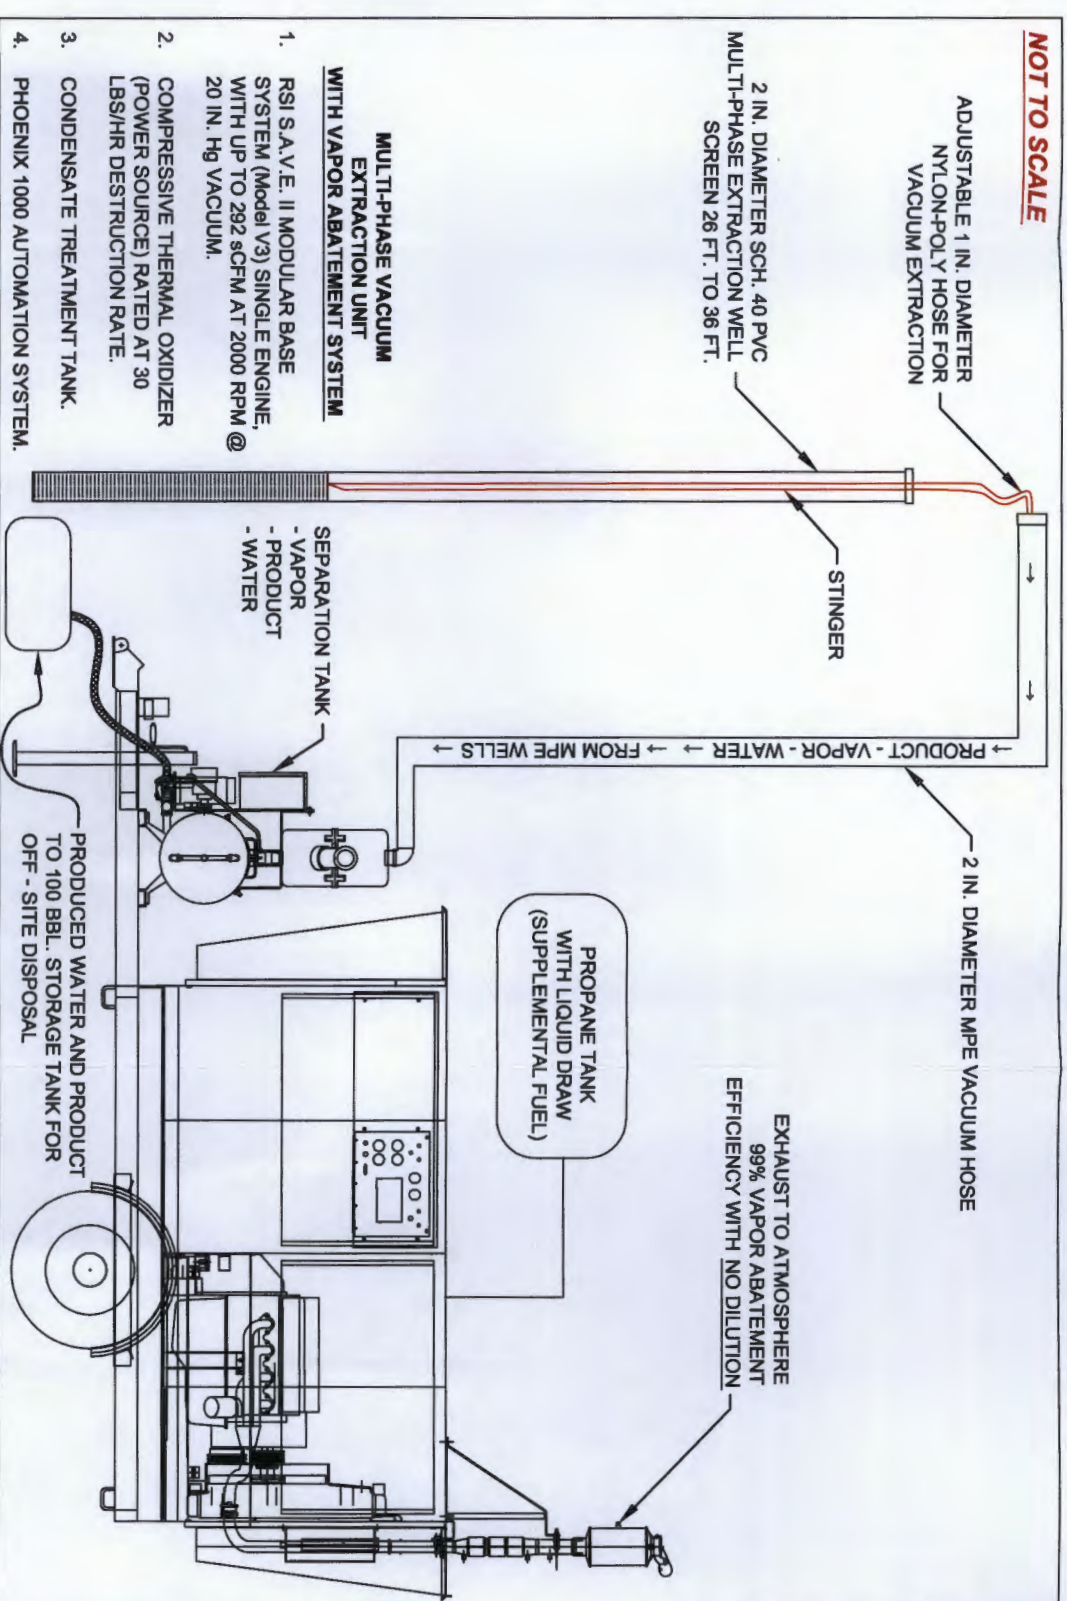
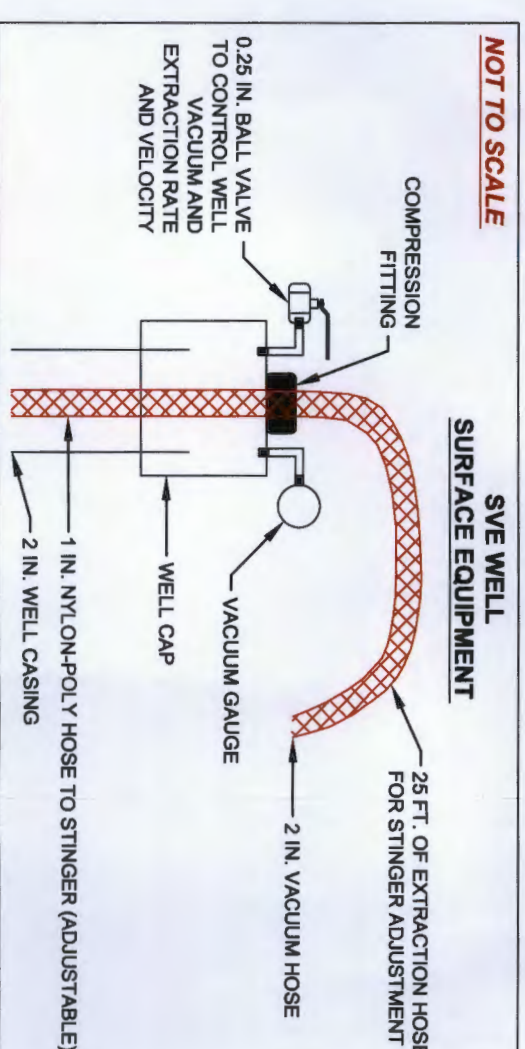
FIGURE 6

PROPOSED MULTI-PHASE EXTRACTION SYSTEM

Based on the documented site geologic conditions and AES' experience with the effectiveness of properly pilot studied MPE systems at similar sites, it appears that MPE is a viable technology for remediation of petroleum hydrocarbon contaminated soil and the presence of free product at this site. Based on site conditions and equipment specifications, AES anticipates a radius of influence (ROI) of approximately 25 to 30 feet at an applied vacuum of 20" Hg.

AES will install 1-inch diameter reinforced nylon tubing inside each MPE well and will provide excess tubing so the extraction point depth can be adjusted as needed to suit operational conditions. Each MPE wellhead will be capped with a slip-fit cap that has a compression-fit

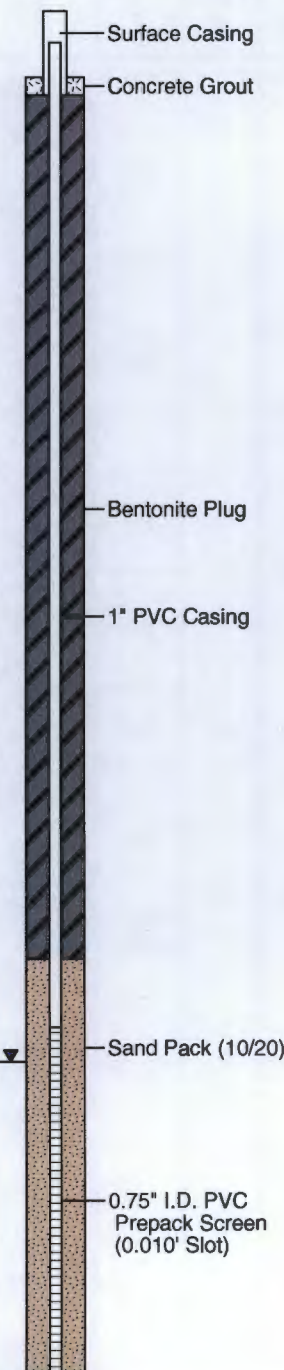
Well: TH-3/MW-1
Elev.: 7082.57

Depth in Feet	Surf. Elev. 0	USCS	GRAPHIC	DESCRIPTION	Blow Count	PID (ppm)
0	0					
2	-2	SC		SANDY CLAY, brown, dry, loose, no hydrocarbon odor or staining.		
4	-4					
6	-6	CL		CLAY, brown, dry, stiff, no hydrocarbon odor or staining.		
8	-8					
10	-10			SAND, well sorted, fine grained, tan-red, dry, no hydrocarbon odor or staining.		
12	-12					
14	-14					
16	-16	SP				
18	-18					
20	-20				3.7	
22	-22					
24	-24					
26	-26	SP		SAND, well sorted, coarse grained, tan-red, dry, no hydrocarbon odor or staining.		
28	-28					
30	-30	SP		SAND, well sorted, coarse grained, brown, saturated, no hydrocarbon odor or staining.	2.7	
32	-32					
34	-34	CL		CLAY, brown, wet, sticky, no hydrocarbon odor or staining.	1.6	
36	-36					
38	-38	SC		SANDY CLAY, brown, wet, no hydrocarbon odor or staining.	0.9	
		SP		SAND, brown, wet, no hydrocarbon odor or staining.	0.9

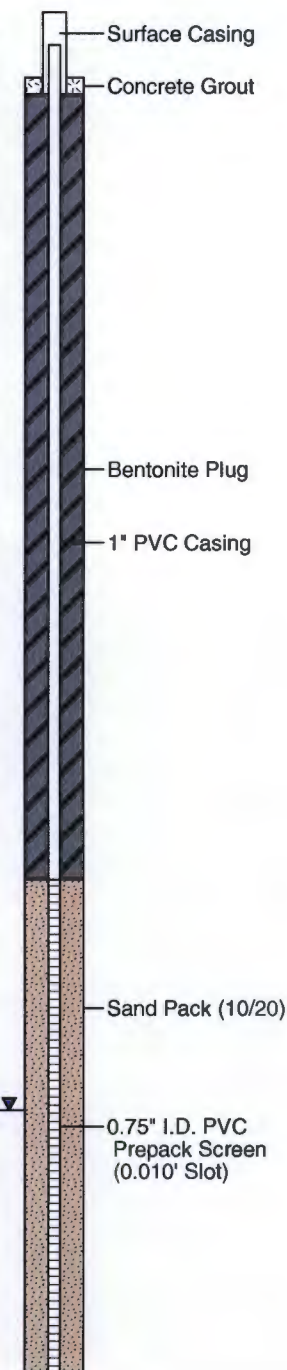
Well: TH-4/MW-2
Elev.: 7079.94

Depth in Feet	Surf. Elev. 0	USCS	GRAPHIC	DESCRIPTION	Blow Count	PID (ppm)
0	0	SC		SANDY CLAY, brown, dry, loose, no hydrocarbon odor or staining.		
5	-5	SP		SAND, well sorted, fine grained, tan-red, dry, no hydrocarbon odor or staining.		
10	-10	SC		SANDY CLAY, brown, stiff, moist, no hydrocarbon odor or staining.		
15	-15	SP		SAND, well sorted, fine grained, tan-red, dry, no hydrocarbon odor or staining.	0.9	
20	-20	CL		CLAY, brown, stiff, moist, fragments of sandstone, no hydrocarbon odor or staining.		
25	-25	SP		SAND, well sorted, fine grained, tan-red, moist, no hydrocarbon odor or staining.		
30	-30	SP		SAND, well sorted, coarse grained, tan-red, wet, no hydrocarbon odor or staining.		
35	-35	CL		CLAY, brown, sticky, wet, no hydrocarbon odor or staining.		
40	-40	SP		SAND, well sorted, coarse grained, tan-red, wet, no hydrocarbon odor or staining.	0.7	
		SC		SANDY CLAY, brown, wet, no hydrocarbon odor or staining.	0.7

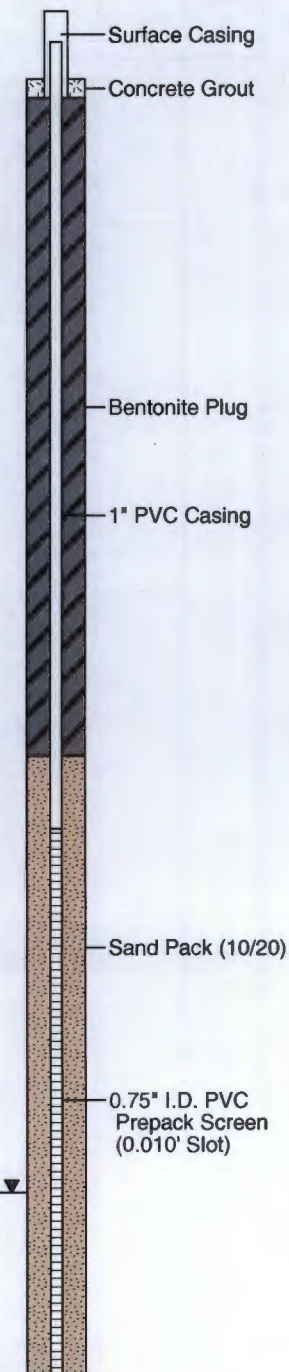
Well: TH-5/MW-3
Elev.: 7081.10

Depth in Feet	Surf. Elev. 0	USCS	GRAPHIC	DESCRIPTION	Blow Count	PID (ppm)
0	0					
3	-3	SC		SANDY CLAY, brown, dry, loose, no hydrocarbon odor or staining.		
6	-6			SAND, well sorted, fine grained, tan-red, dry, no hydrocarbon odor or staining.		
9	-9	SP				
12	-12					
15	-15	SP		SAND, well sorted, coarse grained, tan-red, dry, no hydrocarbon odor or staining.		
18	-18	CL		CLAY, brown, hard, dry, no hydrocarbon odor or staining.		
21	-21	SP		SAND, well sorted, coarse grained, tan-red, dry, no hydrocarbon odor or staining.	0.8	
24	-24	SC		SAND, well sorted, fine grained, tan-red, moist, no hydrocarbon odor or staining.		
27	-27	CL		CLAY, brown, sticky, wet, no hydrocarbon odor or staining.	0.6	
30	-30	SP		SAND, well sorted, coarse grained, tan-red, wet, no hydrocarbon odor or staining.		
33	-33	SP		SAND, well sorted, fine grained, tan-red, saturated, no hydrocarbon odor or staining.	0.6	
36

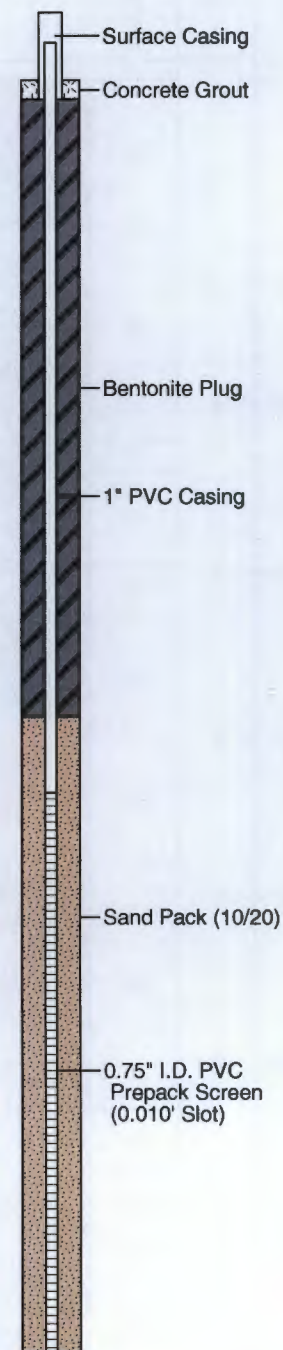
Well: TH-7/MW-5
Elev.: 7087.98

Depth in Feet	Surf. Elev. 0	USCS	GRAPHIC	DESCRIPTION	Blow Count	PID (ppm)
0	0			SANDY CLAY, brown, dry, loose, no hydrocarbon odor or staining.		
5	-5	SC				
10	-10	SP		SAND, well sorted, fine grained, tan-red, dry, no hydrocarbon odor or staining.		
15	-15	SP		SAND, well-sorted, coarse grained, tan-red, dry, no hydrocarbon odor or staining.		
20	-20	CL		CLAY, brown, stiff, moist, no hydrocarbon odor or staining.		
25	-25	SP		SAND, well sorted, fine grained, tan-red, moist, no hydrocarbon odor or staining.		
30	-30	SP		SAND, well sorted, coarse grained, tan-red, moist, no hydrocarbon odor or staining.		
35	-35	SP		SAND, well sorted, coarse grained, tan-red, moist, slight hydrocarbon odor, no hydrocarbon staining.		
		SP		SAND, well sorted, coarse grained, tan-brown, moist, strong hydrocarbon, free oil present.		
		SS		SANDSTONE, tan-red, hard, strong hydrocarbon odor, free oil present.

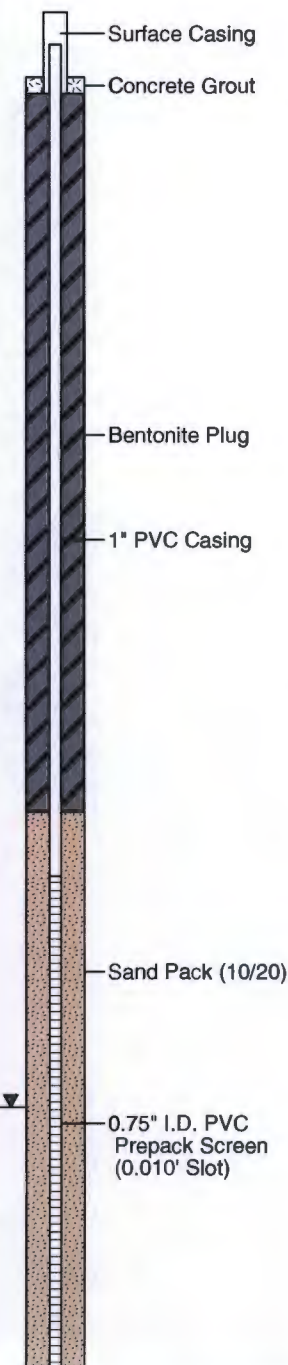
Well: TH-8/MW-6
Elev.: 7088.43

Depth in Feet	Surf. Elev. 0	USCS	GRAPHIC	DESCRIPTION	Blow Count	PID (ppm)
0	0	SC		SANDY CLAY, brown, loose, moist, no hydrocarbon odor or staining.		
5	-5	SP		SAND, well sorted, fine grained, tan-red, loose, moist, no hydrocarbon odor or staining.	0.1	
10	-10	SP		SAND, well sorted, coarse grained, tan-red, moist, no hydrocarbon odor or staining.	0.0	
		SP		SAND, well sorted, fine grained, tan-red, moist, no hydrocarbon odor or staining.		
15	-15	SC		SANDY CLAY, brown, soft, moist, no hydrocarbon odor or staining.	0.1	
		SP		SAND, well sorted, fine grained, tan-red, moist, no hydrocarbon odor or staining.	0.1	
20	-20	SP		SAND, well sorted, coarse grained, tan-red, moist, no hydrocarbon odor or staining.	0.2	
25	-25	SP		SAND, well sorted, fine grained, tan-red, moist, no hydrocarbon odor or staining.	0.1	
30	-30	SP		SAND, well sorted, fine grained, tan-red, wet, very minor clay content, no hydrocarbon odor or staining.	0.0

SC		SANDY CLAY, brown, soft, saturated, no hydrocarbon odor or staining.		
35	-35	SP		SAND, well sorted, coarse grained, tan-red, saturated, no hydrocarbon odor or staining.	0.0	
40

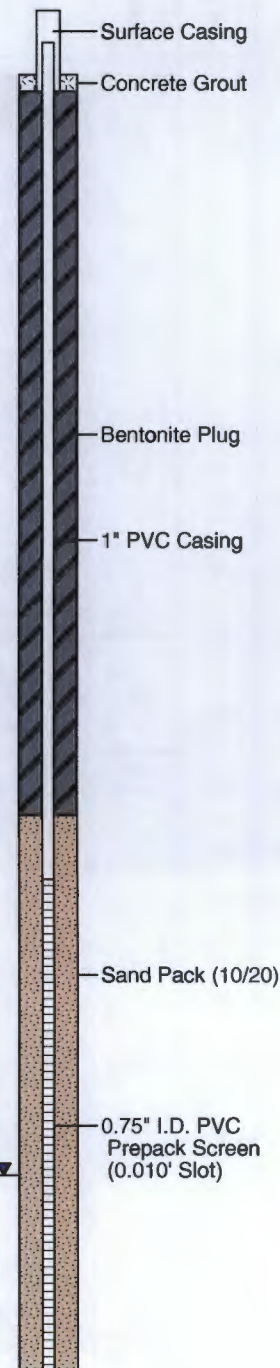
Well: TH-9/MW-7
Elev.: 7090.15

Depth in Feet	Surf. Elev. 0	USCS	GRAPHIC	DESCRIPTION	Blow Count	PID (ppm)
0	0	SC		SANDY CLAY, brown, loose, dry, no hydrocarbon odor or staining.		
5	-5	CL		CLAY, brown, dry, stiff, no hydrocarbon odor or staining.	0.0	
10	-10	SP		SAND, well sorted, fine grained, tan-red, dry, loose, no hydrocarbon odor or staining.	0.0	
15	-15	CL		CLAY, brown, dry, stiff, no hydrocarbon odor or staining.	0.0	
20	-20	SP		SAND, well sorted, coarse grained, tan-red, loose, dry, no hydrocarbon odor or staining.	0.1	
25	-25	SP		SAND, well sorted, fine grained, tan-red, loose, dry, no hydrocarbon odor or staining.	0.0	
30	-30	SC		SANDY CLAY, brown, stiff, moist, no hydrocarbon odor or staining.	0.0	
		SP		SAND, well sorted, coarse grained, tan-red, moist, loose, no hydrocarbon odor or staining.	0.0	
35	-35	SP		SAND, well sorted, fine grained, tan-red, saturated, no hydrocarbon odor or staining.	0.0	
40

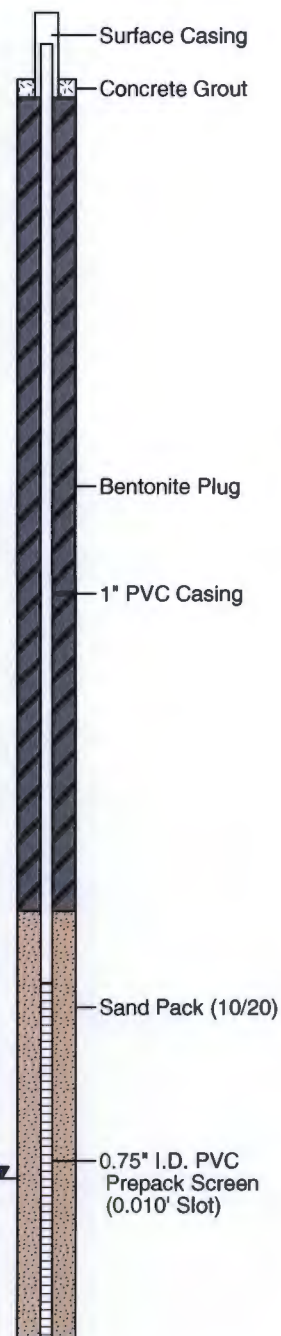
Well: TH-10/MW-8
Elev.: 7085.20

Depth in Feet	Surf. Elev. 0	USCS	GRAPHIC	DESCRIPTION	Blow Count	PID (ppm)
0	0			SANDY CLAY, brown, loose, dry, no hydrocarbon odor or staining.		
2	-2	SC				
4	-4			CLAY, brown, dry, stiff, no hydrocarbon odor or staining.		
6	-6	CL				
8	-8			SAND, well sorted, fine grained, tan-red, dry, no hydrocarbon odor or staining.		6.3
10	-10					
12	-12	SP				6.0
14	-14					
16	-16			SANDY CLAY, tan-red, dry, no hydrocarbon odor or staining.		
18	-18	SC				
20	-20			SAND, well sorted, fine grained, tan-red, loose, dry, no hydrocarbon odor or staining.		34.0
22	-22	SP		SANDY CLAY, red-tan, dry, no hydrocarbon odor or staining.		
24	-24	SC				
26	-26			SAND, well sorted, fine grained, tan-red, dry, no hydrocarbon odor or staining.		3.8
28	-28	SP				
30	-30			SAND, well sorted, coarse grained, tan-red, moist, no hydrocarbon odor or staining.		2.5
32	-32	SP		SAND, well sorted, fine grained, tan-red, saturated, no hydrocarbon odor or staining.

34	-34	SC		SANDY CLAY, brown, saturated, no hydrocarbon odor or staining.		1.9
36	-36					
				SAND, well sorted, fine grained, tan-red, saturated, no hydrocarbon odor or staining.		
				SANDY CLAY, brown, saturated, no hydrocarbon odor or staining.

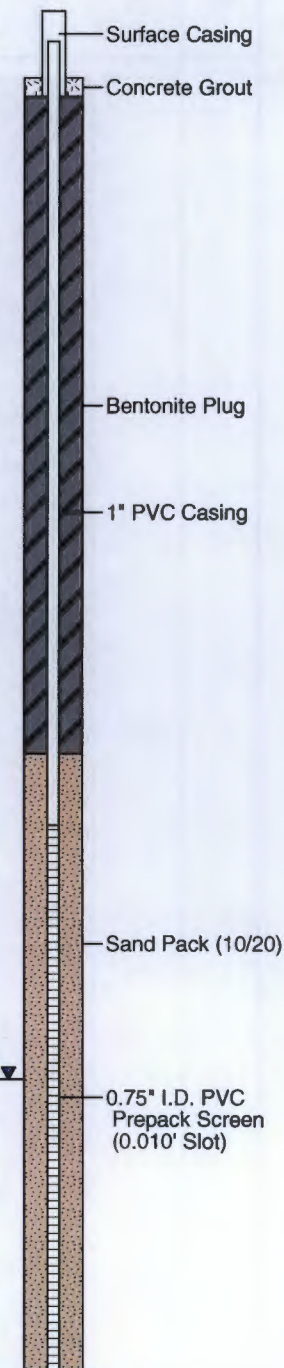
Well: TH-11/MW-9
Elev.: 7083.64

Depth in Feet	Surf. Elev. 0	USCS	GRAPHIC	DESCRIPTION	Blow Count	PID (ppm)
0	0					
2	-2	SC		SANDY CLAY, brown, loose, dry, no hydrocarbon odor or staining.		
4	-4					
6	-6					
8	-8	SP		SAND, well sorted, fine grained, tan-red, dry, no hydrocarbon odor or staining.	32.7	
10	-10					
12	-12				32.6	
14	-14	SC		SANDY CLAY, tan-red, dry, no hydrocarbon odor or staining.		
16	-16				34.0	
18	-18					
20	-20	SP		SAND, well sorted, coarse grained, tan-red, dry, no hydrocarbon odor or staining.	5.3	
22	-22			SAND, well sorted, fine grained, tan-red, dry, no hydrocarbon odor or staining.		
24	-24	SP			2.3	
26	-26					
28	-28	SC		SANDY CLAY, brown, saturated, no hydrocarbon odor or staining.	11.2	
30	-30			SAND, well sorted, fine grained, tan-red, saturated, no hydrocarbon odor or staining.		
32	-32	SP			0.7	
34	-34					
36
