**3R - 448**

PERIODIC  
PROGRESS REPORT

**Re: Periodic Progress Report  
Benson-Montin-Greer  
Highway 537 Truck Receiving Station 2009 Oil Release  
Rio Arriba County, New Mexico**

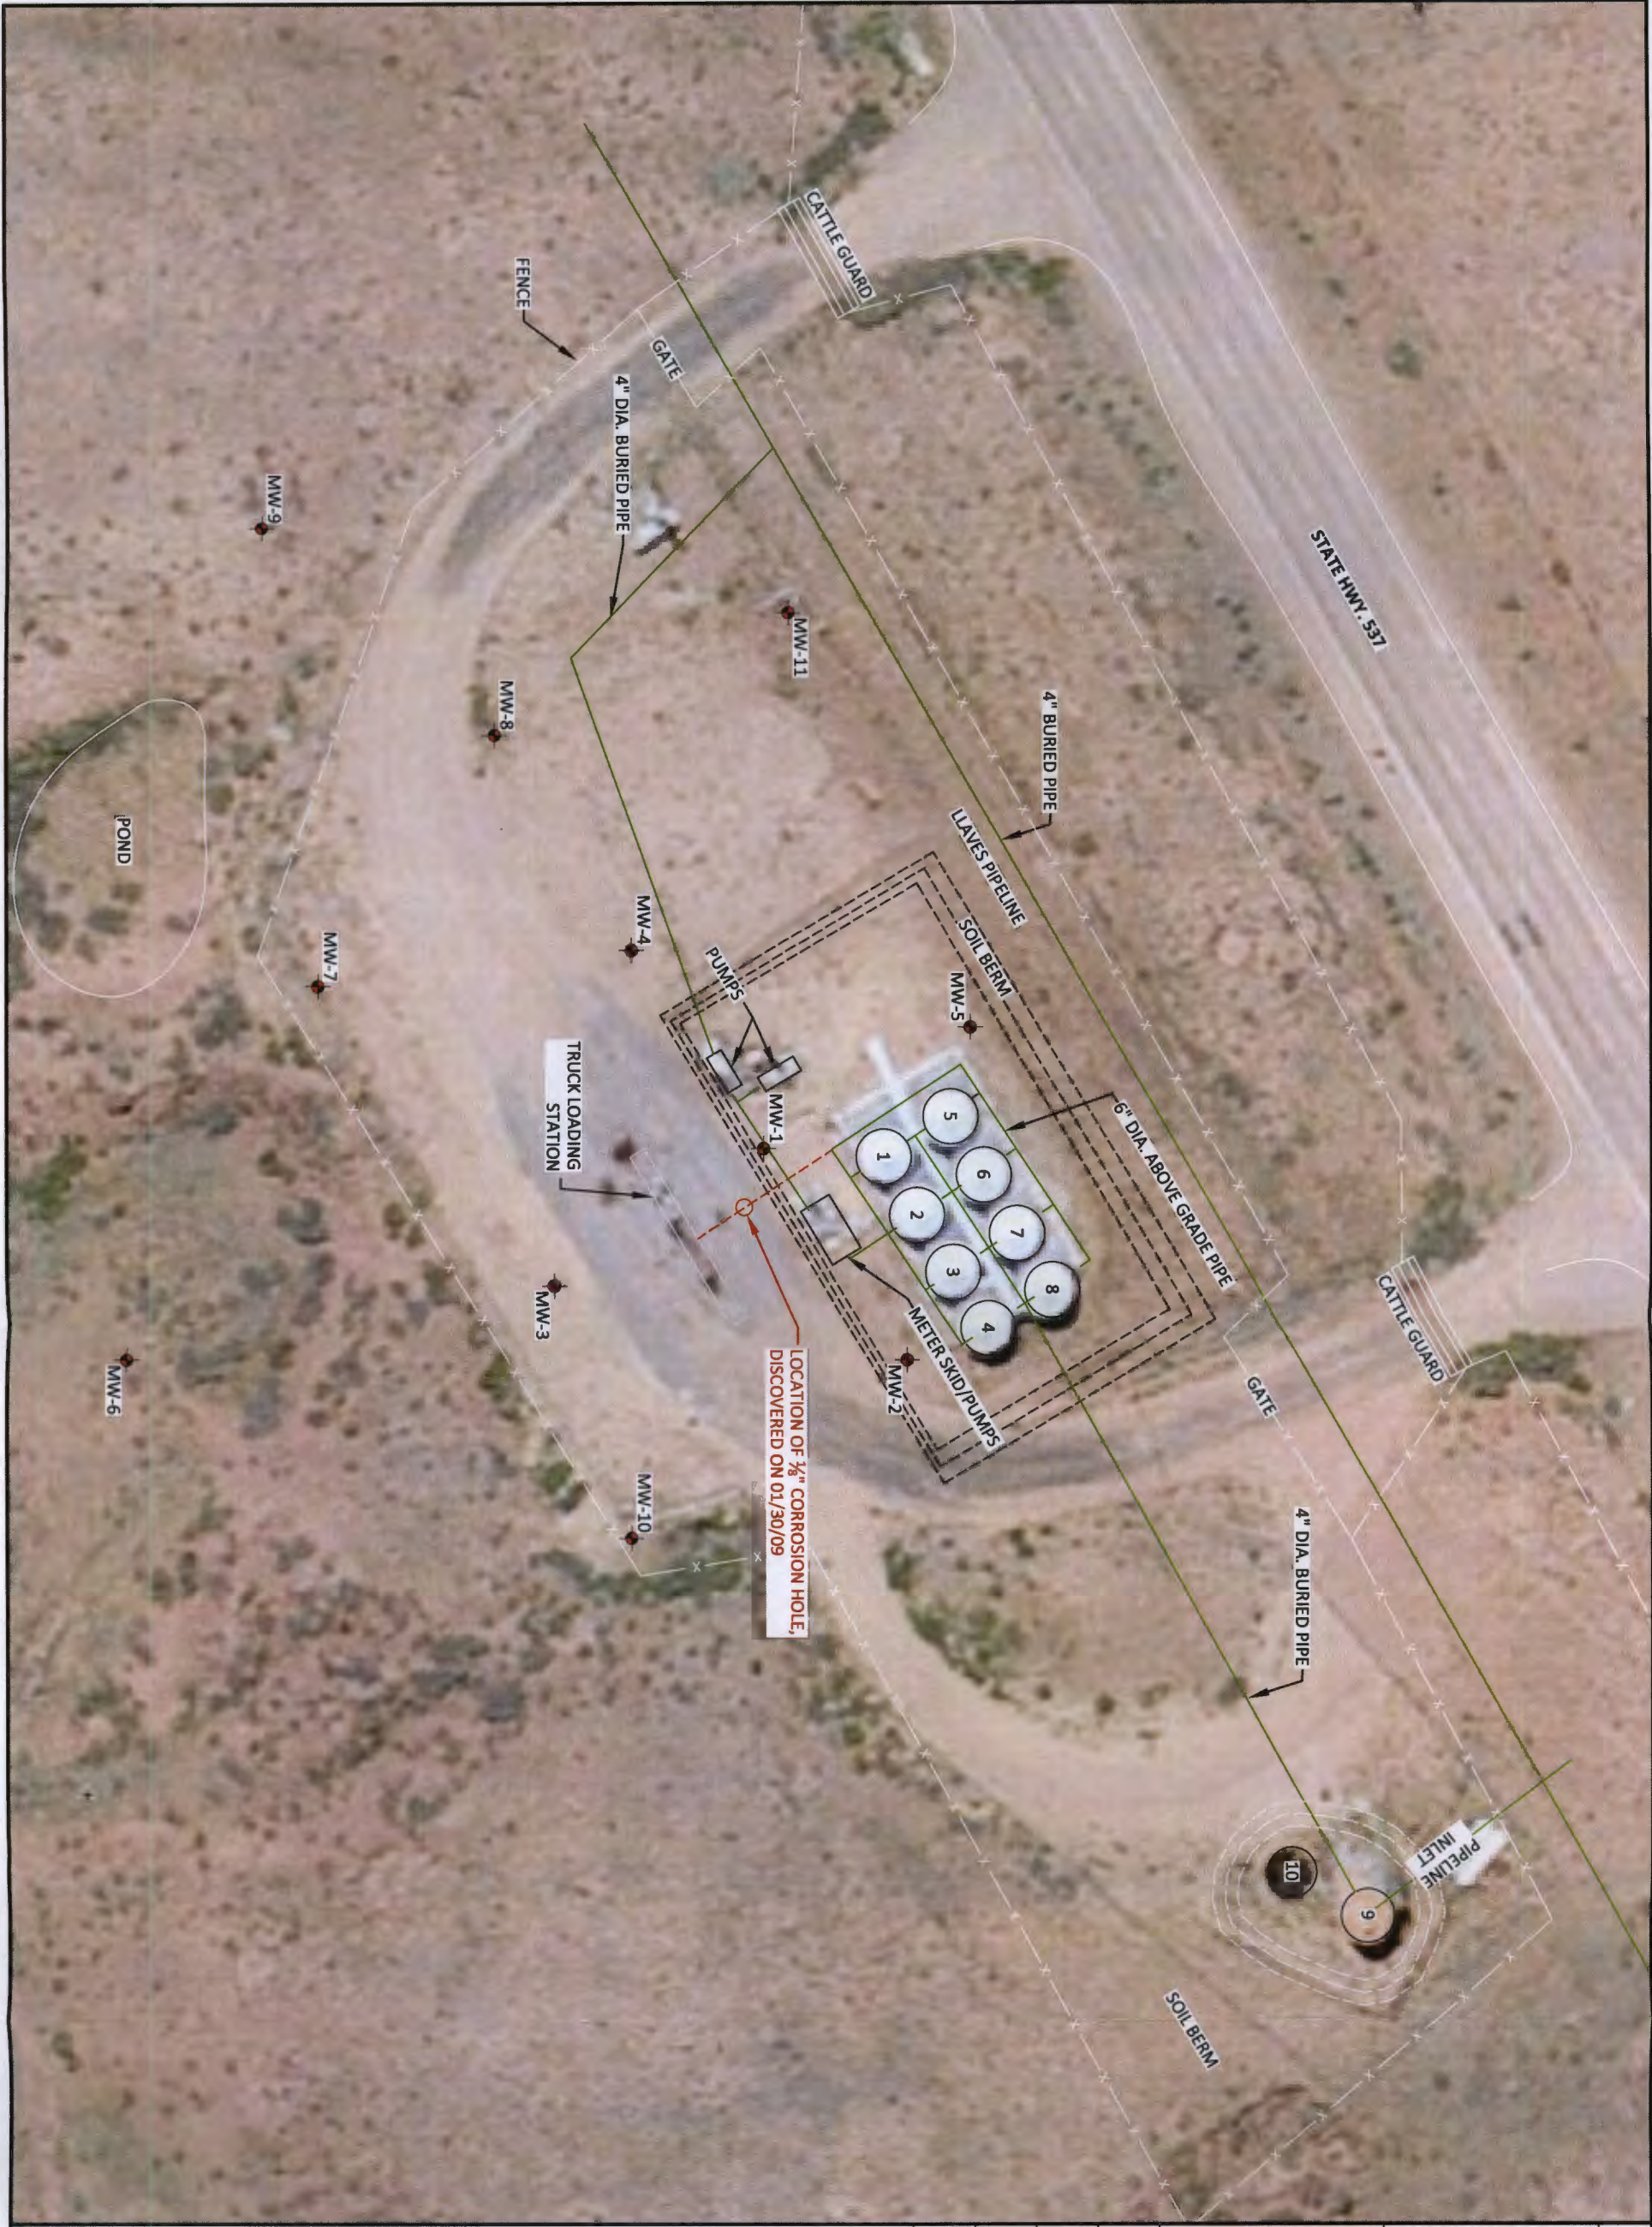
FIGURE 3

During the September 2012 sampling event, groundwater measurements were recorded for MW-1 through MW-11. Average groundwater elevations decreased across the site by an average of 0.35 feet since the May 2012 sampling event. Groundwater gradient was calculated between MW-2 and MW-8, with a magnitude of 0.008 ft/ft to the southwest. Groundwater elevations ranged from 28.54 feet below top of casing (TOC) in MW-10 to 30.38 feet below TOC in MW-11. No groundwater was present in MW-6. Groundwater elevation data and contours are presented in Figure 3.

GROUNDWATER ELEVATION  
CONTOURS, SEPTEMBER 2012

NOTE: ALL GROUNDWATER ELEVATION  
MEASUREMENTS WERE MADE ON  
SEPTEMBER 10, 2012.
