1R - 426-124

**RE: Corrective Action Plan Report on the Vadose Zone Remediation
Rice Operating Company – BD SWD System
BD jct. P-30 (1R426-124): UL/P sec. 30 T21S R37E**

Figure 1

Figure 2

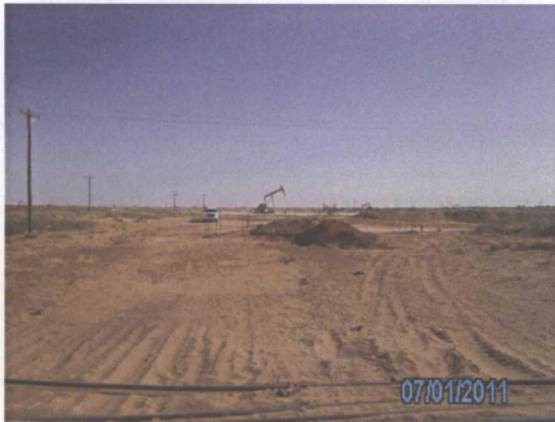
Site prior to excavation, facing north 7/1/11

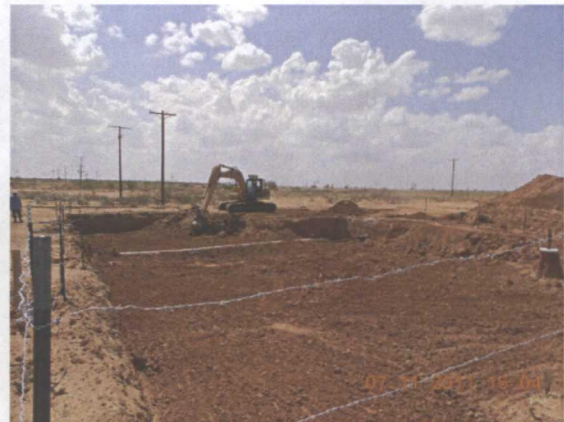
Excavating site, facing west 7/11/11

On July 1st, 2011, ROC began the NMOCD approved CAP excavation at the BD jct. P-30 site. The site was excavated to 104 ft x 111 ft x 4.5 ft deep. The excavated soil was field tested for chlorides and hydrocarbons using a PID meter and soils that did not meet the requirement for backfill were taken to a NMOCD facility for disposal. A total of 936 yard of soil was taken to Sundance Facility for disposal. The remaining soil was blended on site and an eight point composite sample was taken and field tested for hydrocarbons using a PID meter. Field testing showed a PID reading of 22.5 ppm (Appendix A). The soil was then taken to a commercial laboratory for analysis on July 22nd, 2011. Laboratory chloride readings returned 480 mg/kg (Appendix B).

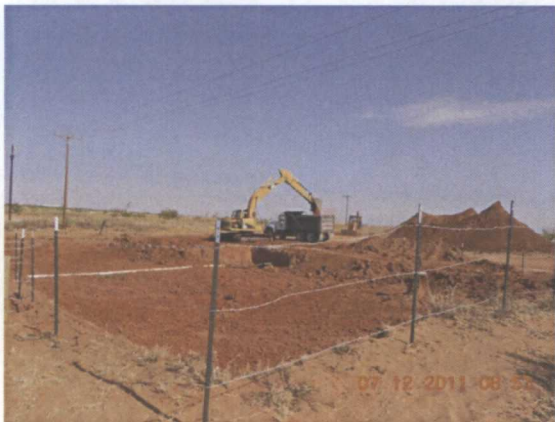
Exporting soil to Sundance, facing northwest 7/12/11

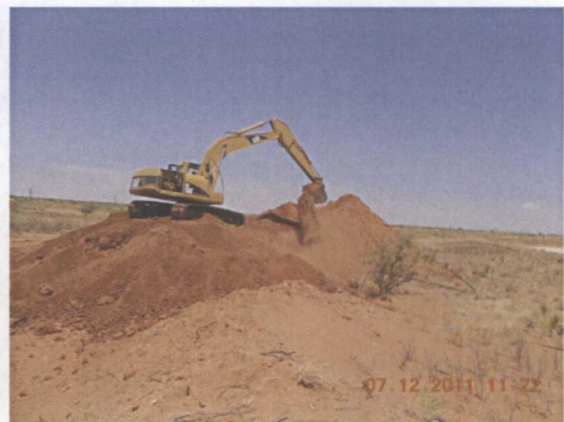
Blending spoil pile, facing west 7/12/11

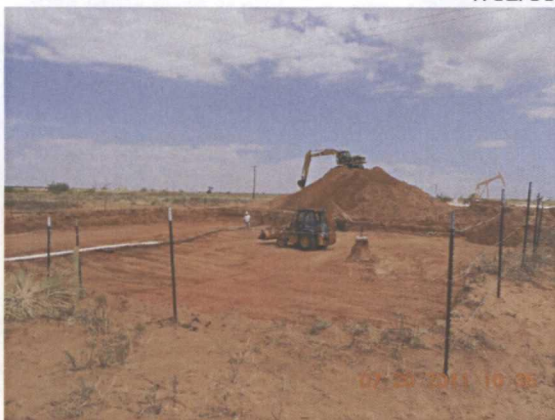
Excavation complete, facing north 7/20/11

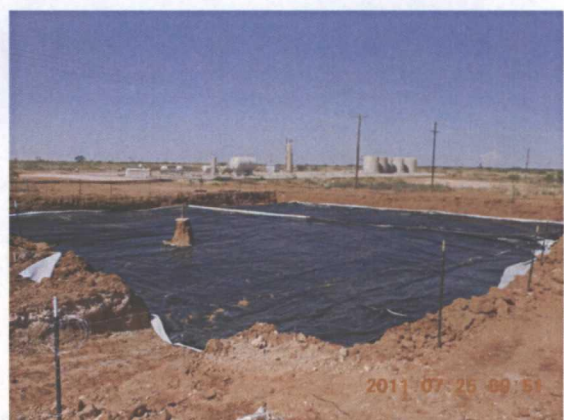
Liner installed, facing southwest 7/25/11

On July 25th, 2011, a 20-mil reinforced poly liner was installed at the bottom of the excavation at 4.5 ft bgs. Since the site contained primarily sandy/silty soils without appreciable rock, it was not necessary to pad either the top or bottom of the liner. The blended soil and imported soil were used to backfill the excavation to ground surface. A total of 936 yards of imported, clean soil was used to bring the excavation up to ground surface. An 8 point composite sample of the imported soil was field tested for hydrocarbons using a PID. Field testing showed a PID reading of 18.4 ppm (Appendix A). The samples was prepared and taken to a commercial laboratory for analysis. The imported soil returned with a laboratory chloride reading of non-detect (Appendix

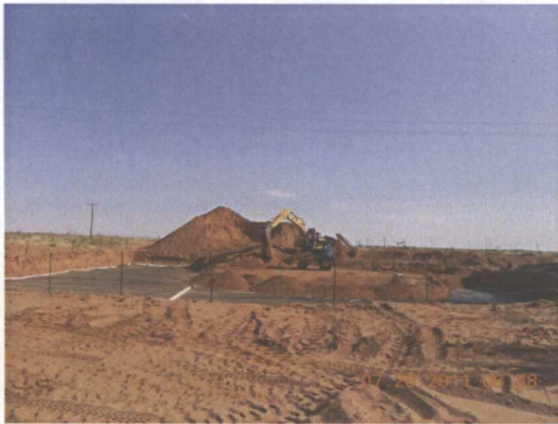
Backfilling site, facing north 7/26/11

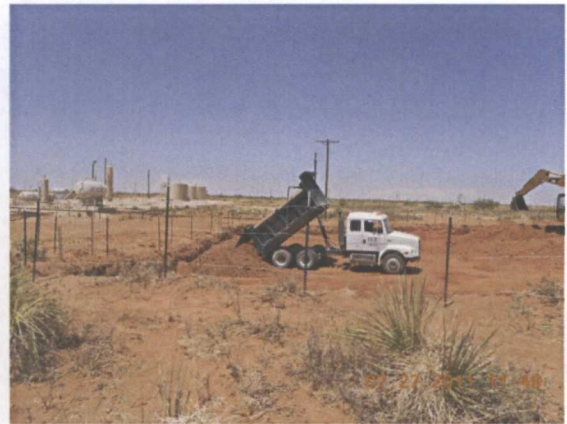
Unloading topsoil at site, facing west 7/27/11

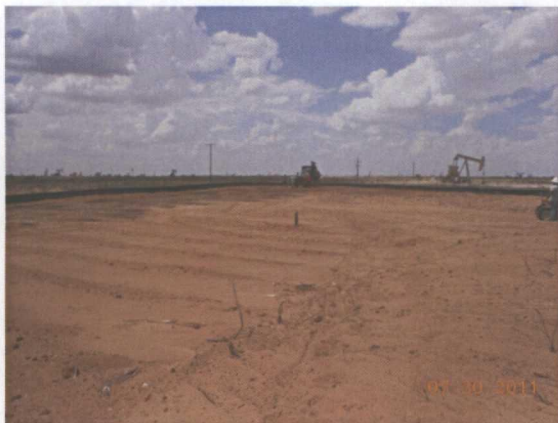
Spreading soil amendments, facing northwest 7/30/11

C). The area was contoured to the surrounding landscape and compost and peat moss were added to the soil to promote vegetative growth. On July 30th, 2011, the site was seeded with 35 lbs of native vegetative mix and the site is expected to return to normal vegetative capacity (Appendix D). Silt net fencing was installed around the excavation to help keep the seed in place. Photo documentation of these activities will be found in Appendix E.

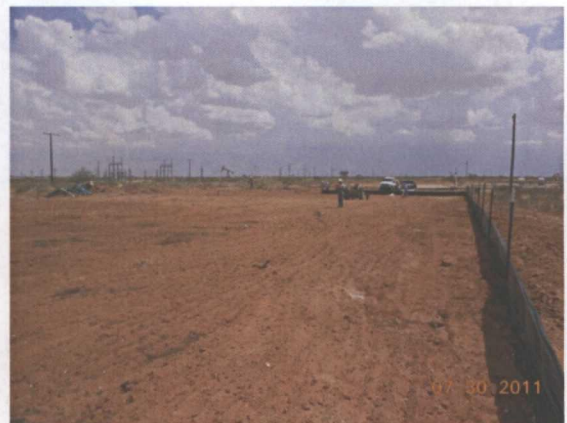
Seeding the site, facing south 7/30/11

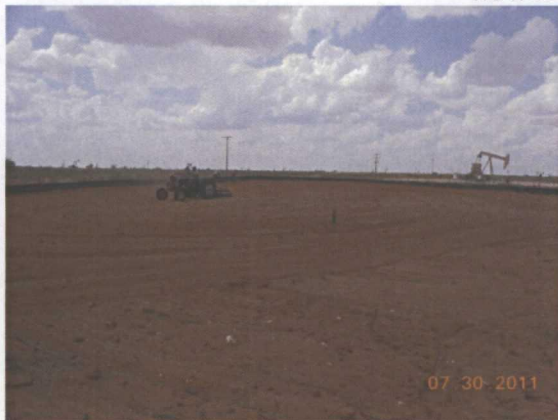
Disking the site for seed, facing west 7/30/11

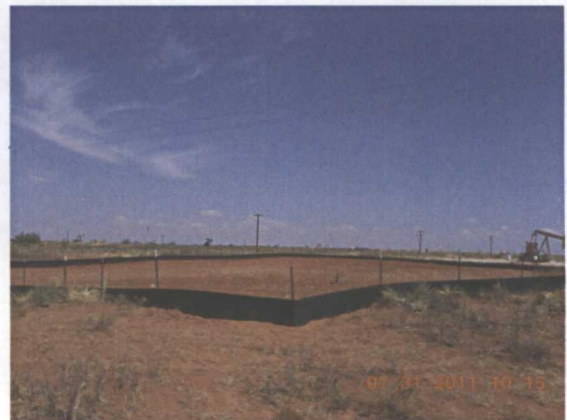
Excavation complete, facing northwest 7/31/11
