RE: Corrective Action Plan Report on the Vadose Zone Remediation

Rice Operating Company – EME SWD System

EME jct. K-8-1 (1R427-316): UL/K sec. 8 T20S R37E

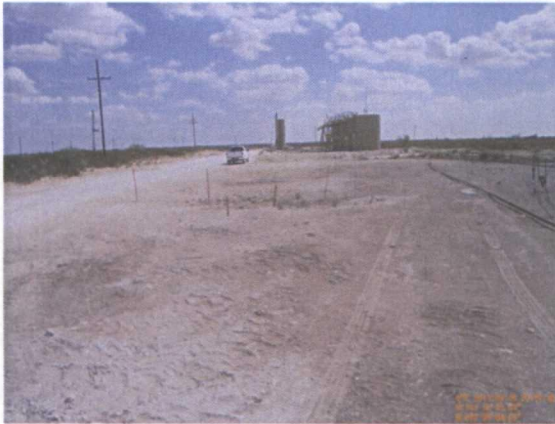
site prior to excavation, facing south

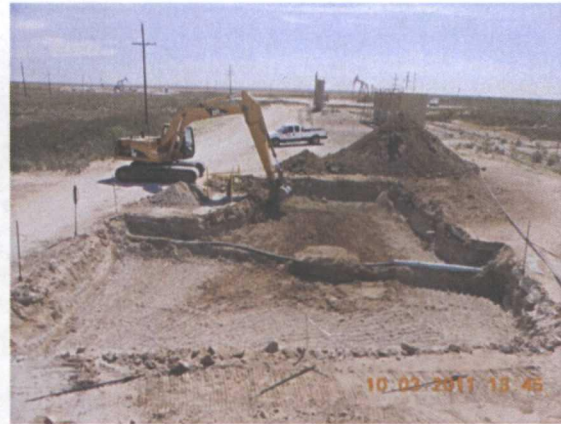
excavating the site, facing south

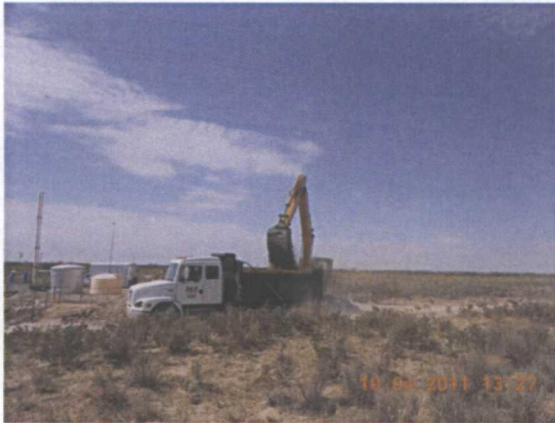
exporting excavated soil, facing west

A total of 156 yards of the excavated soil was taken for disposal at an NMOCD approved facility. The remaining soil was blended on site to use as backfill. The blended soil was tested for hydrocarbons using a PID meter with a result of 2.5 ppm (Appendix A). The composite sample was then taken to a commercial laboratory for analysis of chlorides and returned a chloride reading of 192 mg/kg (Appendix B). The excavation was backfilled up to 6 inches bgs with the blended, excavated soil. Since the site is located next to a lease road and lease pad, the site was topped with 6 inches of imported caliche (72 yards) and seeding was not required. Photo documentation of these activities will be found in Appendix C.

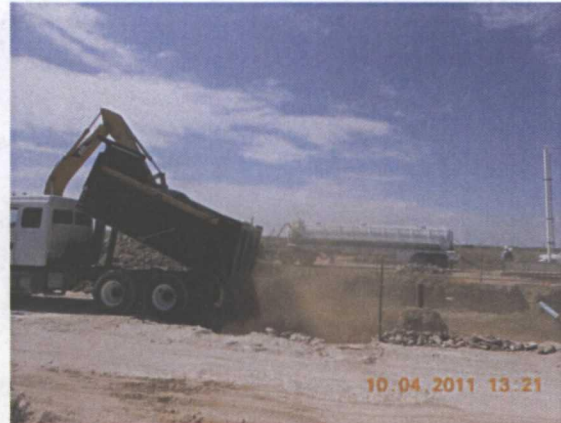
importing soil, facing west

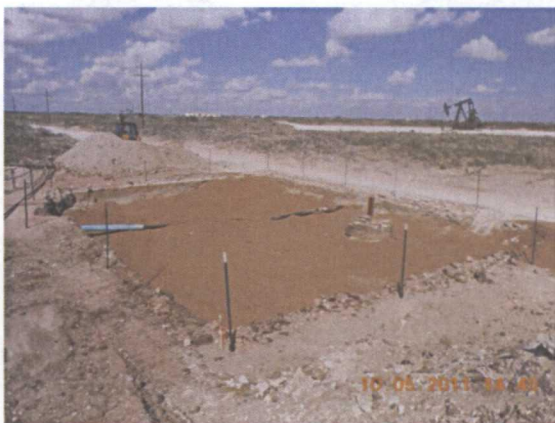
58x42x5 ft deep excavation complete with 6 inches of blow sand, facing north

Beginning October 3, 2011, the site was excavated to approximately 42 ft x 58 ft x 5 ft deep and the bottom of the excavation was padded with 6 inches of imported blow sand to protect the liner from punctures. A 20-mil reinforced plastic liner was installed and properly seated at approximately 4.5 ft bgs (Figure 3). An additional 6 inches of blow sand was used to pad the top of the liner. The imported blow sand used to pad the liner was screened in the field for hydrocarbons with a photo-ionization detector (PID) and resulted in a PID reading of 0.5 ppm (Appendix A). The composite sample was then taken to a commercial laboratory for analysis of chlorides and resulted in a chloride reading of non-detect (Appendix B).

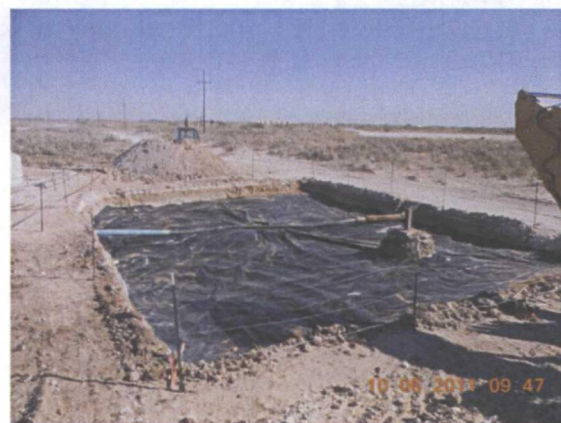
58x42 ft 20-mil, reinforced liner, facing northeast

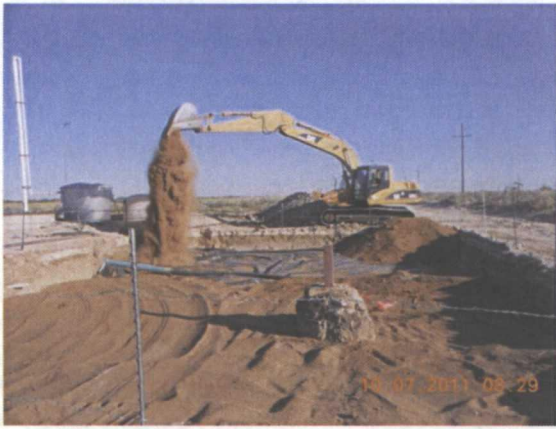
installing a 6 inch blow sand pad above the liner,
facing north

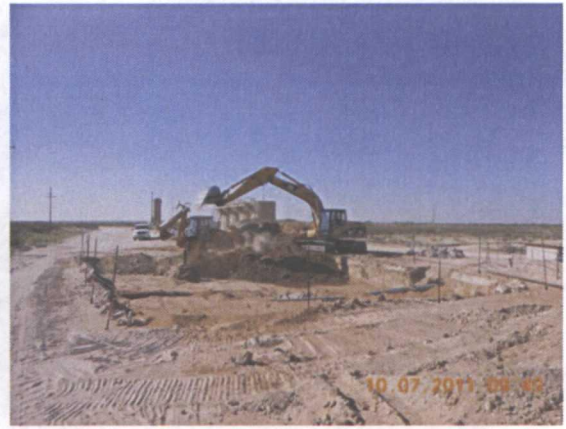
backfilling the excavation with excavated soil,
facing south

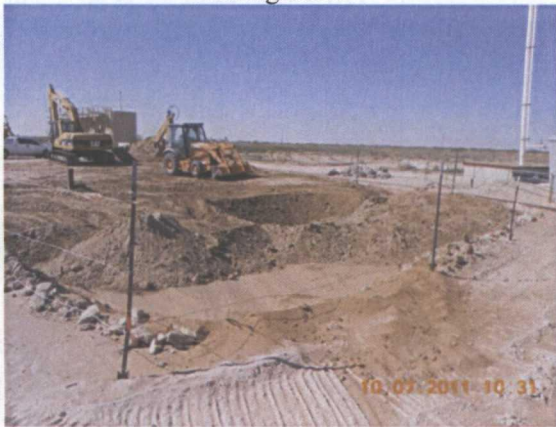
backfilling the excavation with excavated soil,
facing southwest

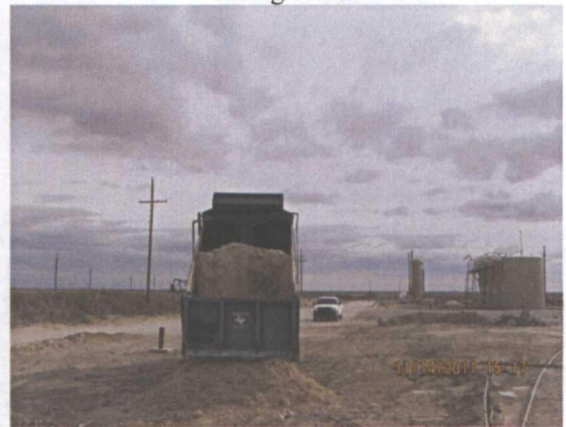
importing caliche, facing south

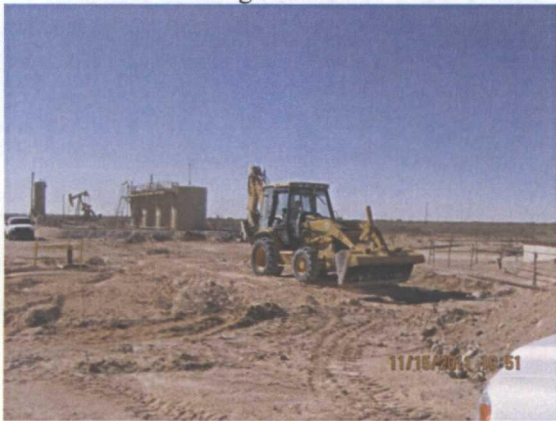
leveling the site with caliche, facing southwest

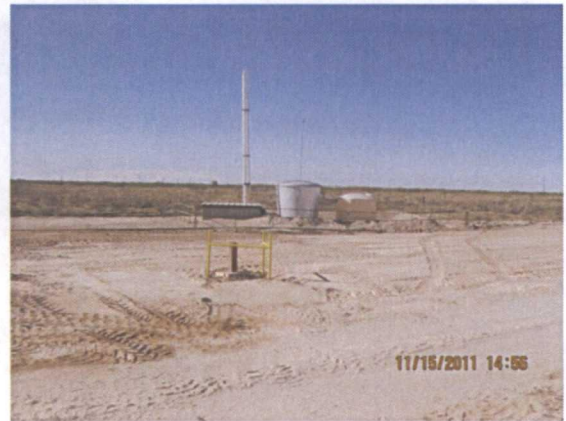
site complete, facing west
