1R - 426-259

WORKPLANS

Soil Bore and MW Installation and Proposed Liner

**RE: ICP Report and Corrective Action Plan (CAP)
Rice Operating Company – BD SWD System
BD N-11 boot (1R426-259): UL/N sec. 11 T22S R37E**

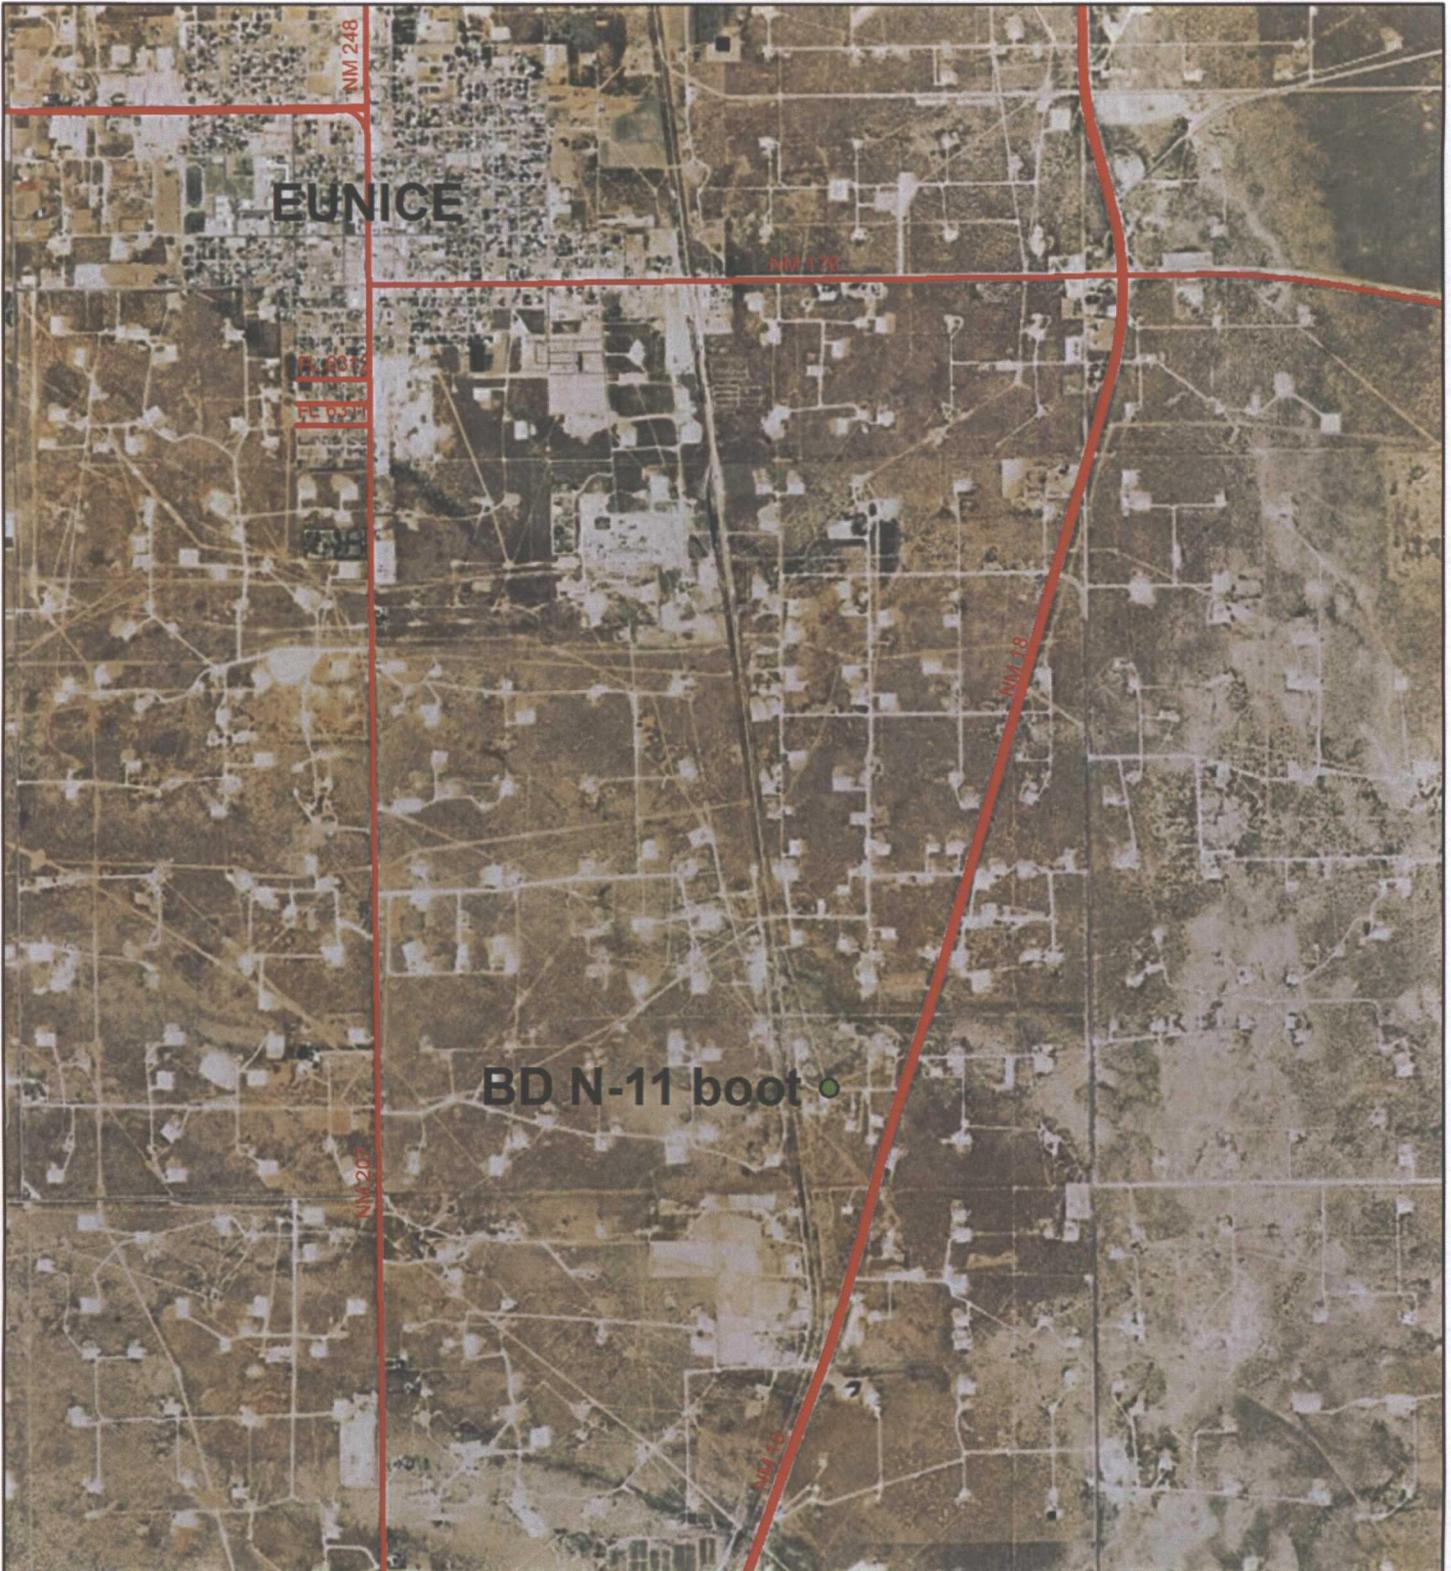
Figure 1

Site Location Map

The site is located approximately 2.5 miles southeast of Eunice, New Mexico at UL/N sec. 11 T22S R37E as shown on the Site Location Map (Figure 1). Monitor well sampling at the site establishes groundwater at a depth of +/- 44 feet.

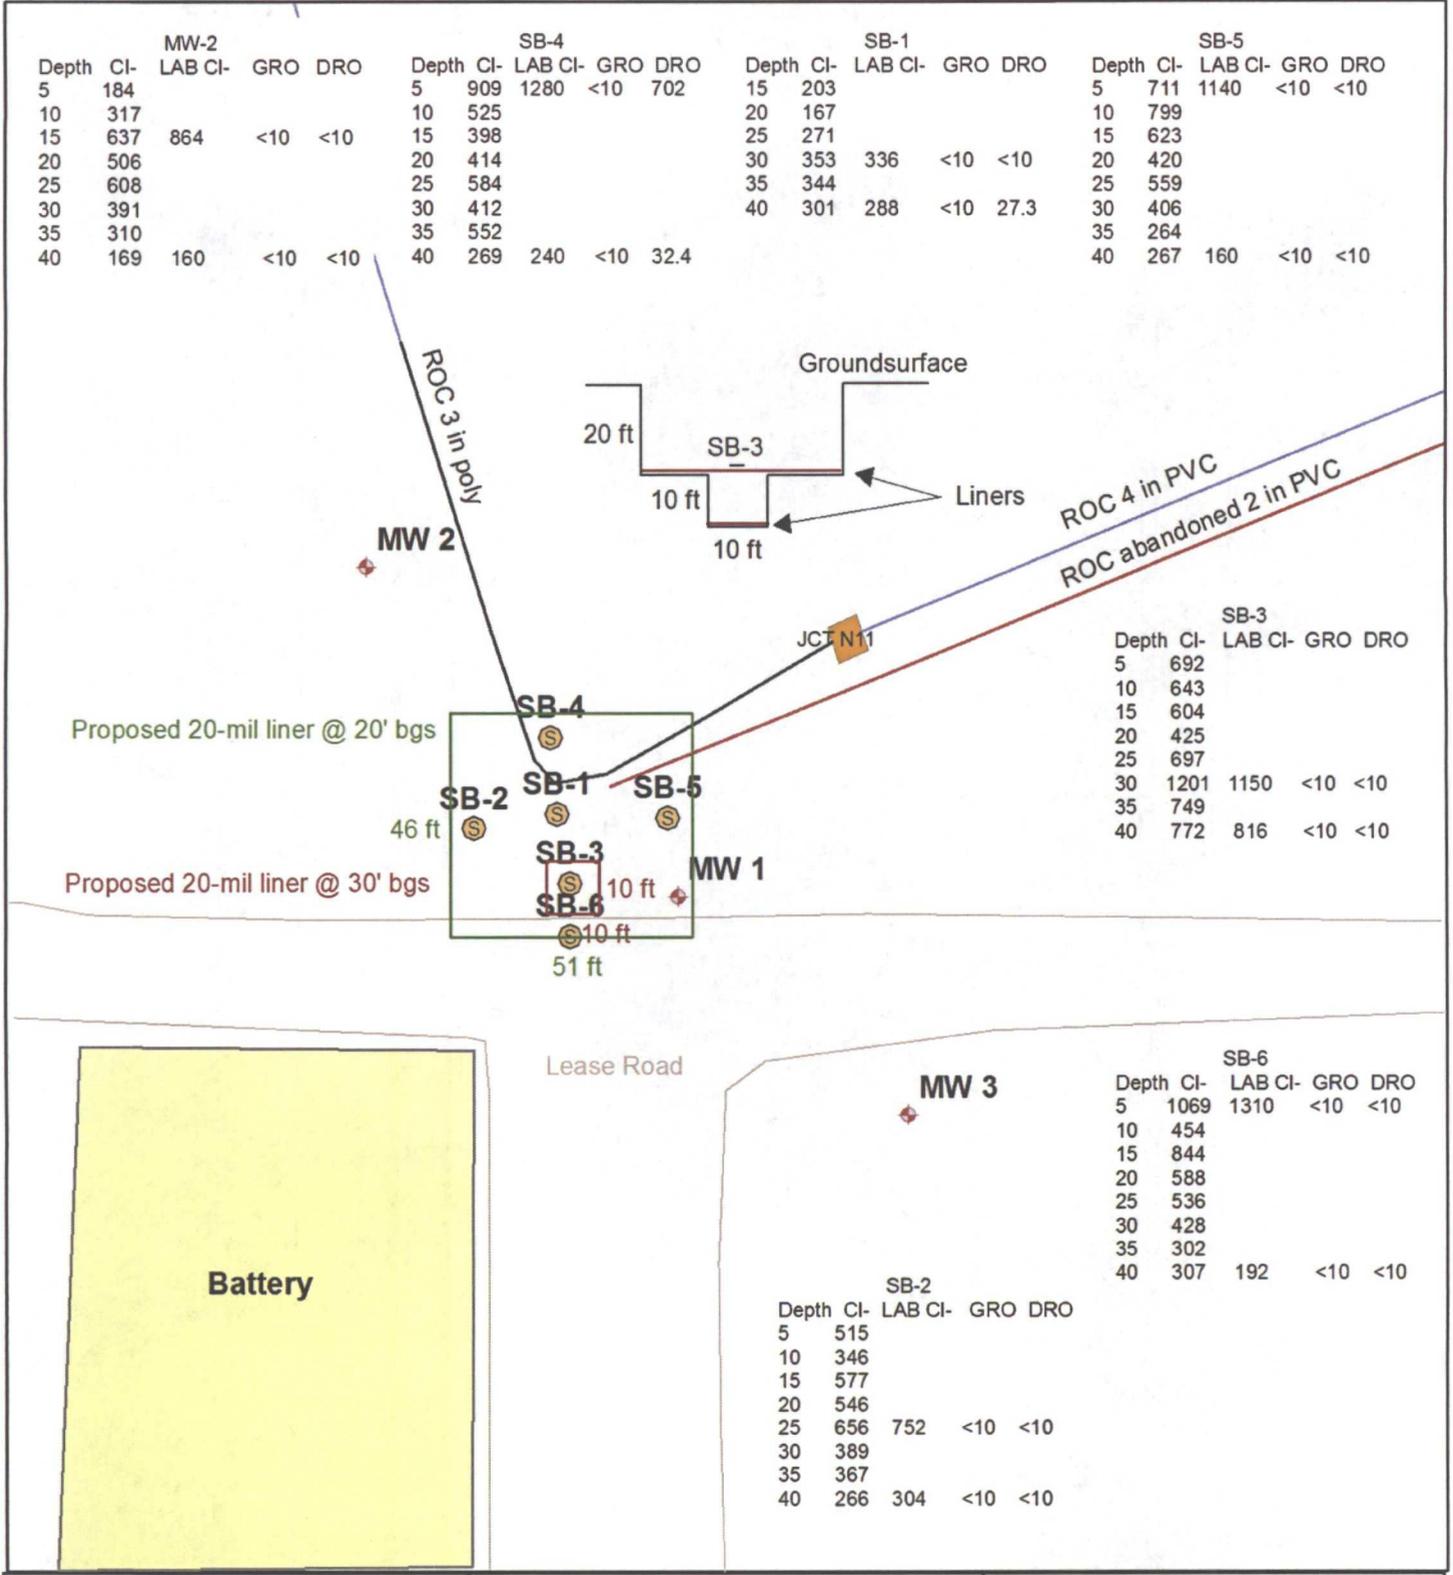
Figure 2

Soil Bore and MW Installation and Proposed Liner

ROC proposes to excavate the site to dimensions of 46 ft x 51 ft and properly seat a 20-mil, reinforced poly liner at approximately 20 ft bgs. In addition, a 10 ft x 10 ft area

surrounding SB-3 will be excavated an additional 10 ft to a total depth of 30 ft bgs and an additional 20-mil reinforced poly liner will be installed and properly seated (Figure 2). Excavating the area surrounding SB-3 will remove the highest soil chloride concentrations from the site, and the two liners will provide a barrier that will inhibit the downward migration of chloride and hydrocarbons to groundwater. The soils placed above each liner will have a laboratory chloride reading no greater than 500 mg/kg and a field PID measurement below 100 ppm. Excavated soil will be evaluated for use as backfill and any soil requiring disposal will be properly disposed of at a NMOCD approved facility.

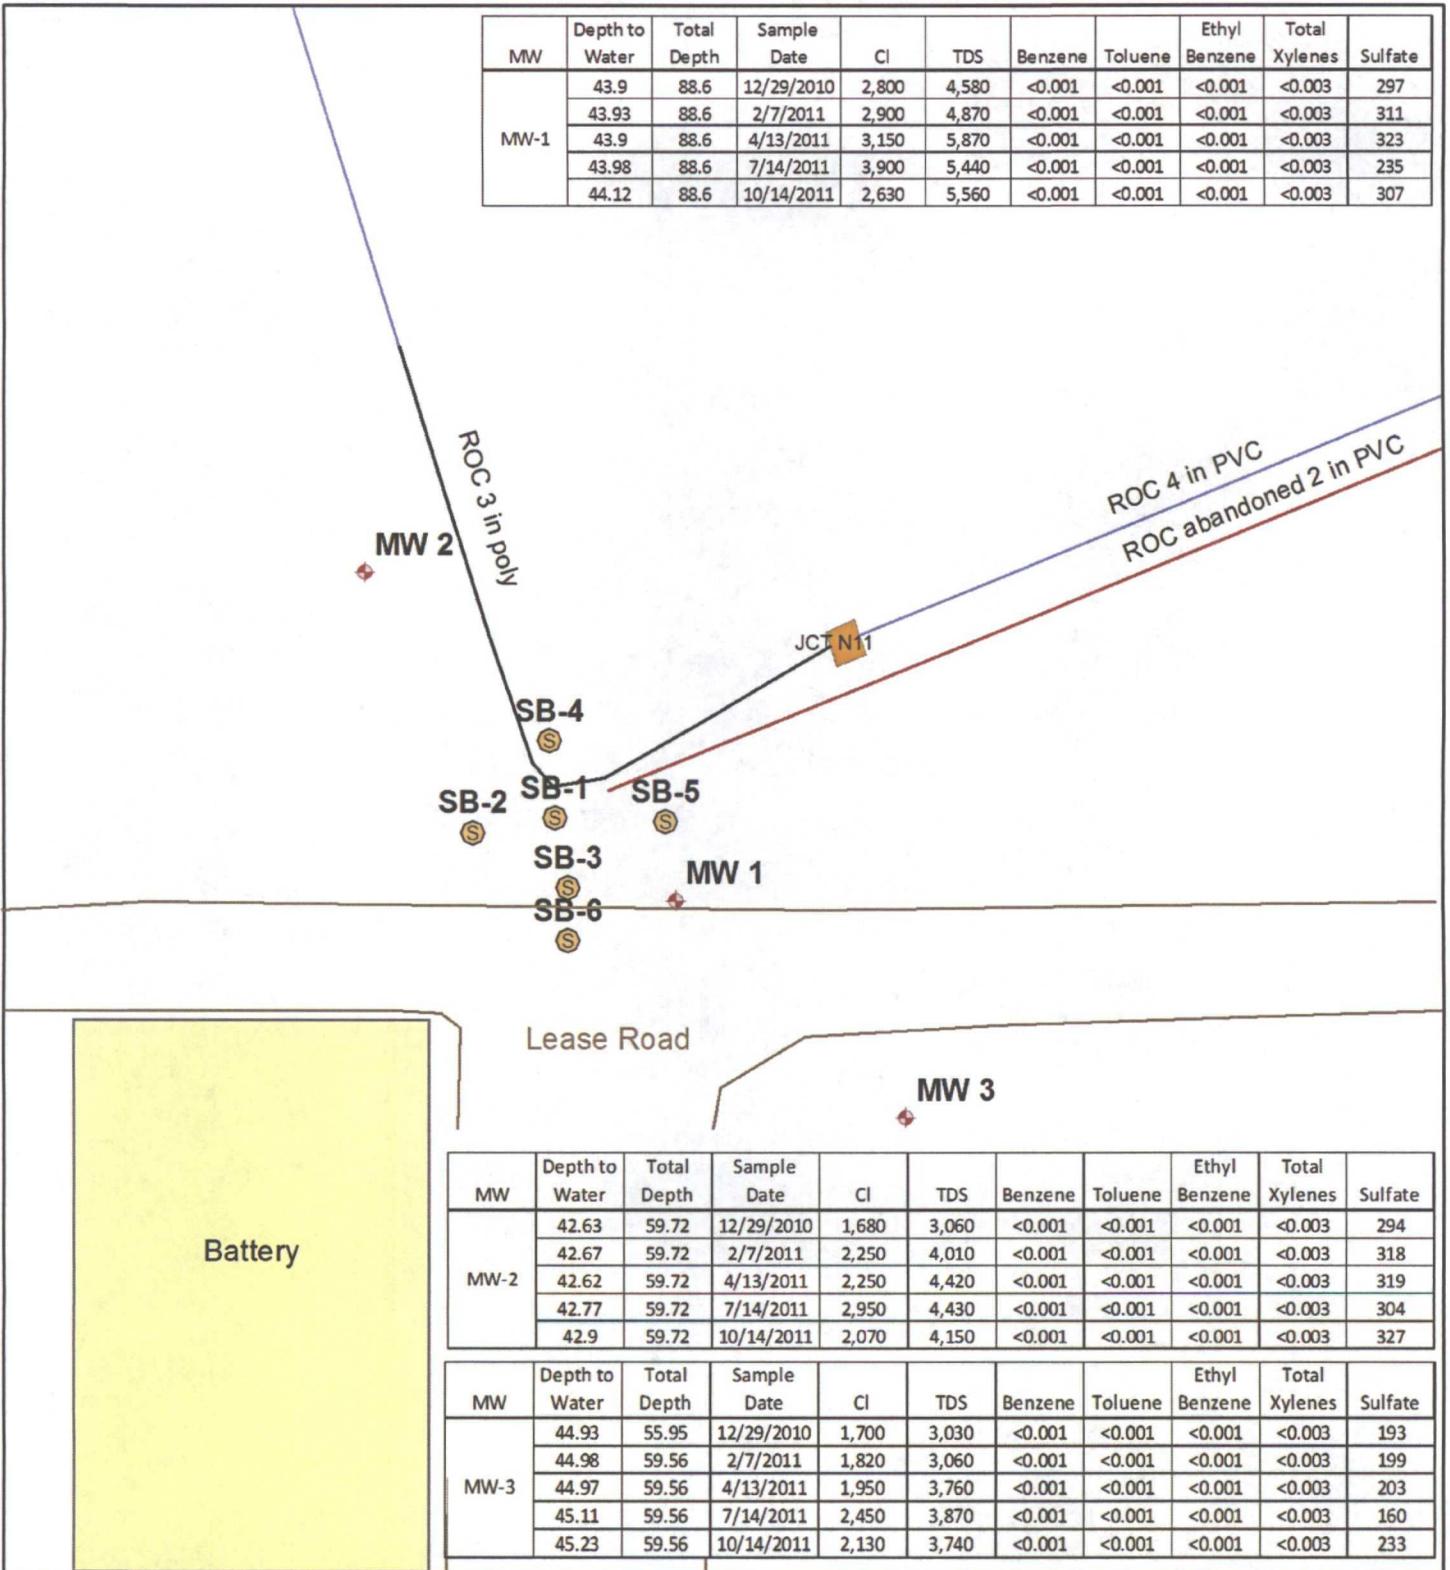
Figure 3

Monitor Well Sampling Data

MW	Depth to Water	Total Depth	Sample Date	Cl	TDS	Benzene	Toluene	Ethyl Benzene	Total Xylenes	Sulfate
MW-1	43.9	88.6	12/29/2010	2,800	4,580	<0.001	<0.001	<0.001	<0.003	297
	43.93	88.6	2/7/2011	2,900	4,870	<0.001	<0.001	<0.001	<0.003	311
	43.9	88.6	4/13/2011	3,150	5,870	<0.001	<0.001	<0.001	<0.003	323
	43.98	88.6	7/14/2011	3,900	5,440	<0.001	<0.001	<0.001	<0.003	235
	44.12	88.6	10/14/2011	2,630	5,560	<0.001	<0.001	<0.001	<0.003	307

Since installation, the monitor wells have been sampled quarterly (Figure 3). From the sampling data, it is evident that groundwater quality is impaired from an up gradient source. During the last sampling event that occurred on October 14th, 2011, MW-2, the up gradient monitor well, showed a chloride concentration of 2,070 mg/L. The near source monitoring well, MW-1, showed a chloride concentration of 2,630 mg/L and the chloride concentration in the down gradient monitor well, MW-3, was 2,130 mg/L. All three monitor wells had BTEX levels of non-detect (Appendix C).
