**RE: CAP Report and Termination Request
Rice Operating Company – EME SWD System
EME jct. O-30 (1R427-319): UL/O sec. 30 T19S R37E
(formerly EME jct. I-30)**

Corrective Action Plan Report

**EME Jct. O-30 (1R427-319)
Unit O, Section 30, T-19-S, R-37-E**

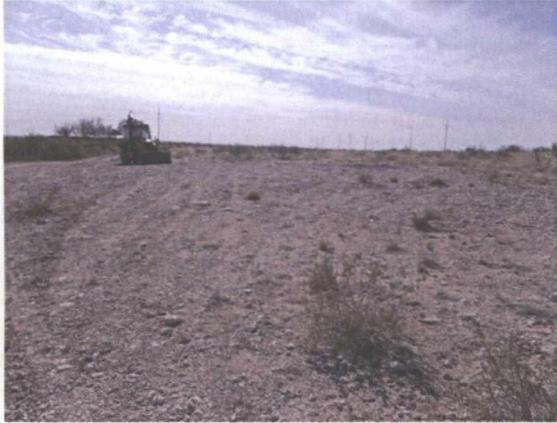
site prior to excavation, facing south
11/1/2011

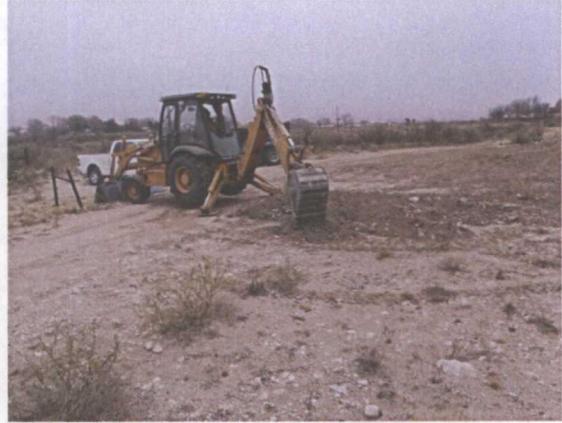
scraping the site, facing southeast
11/2/2011

RECS personnel were on site beginning on December 1st, 2011, to scrape the site of all rock and soil down to approximately 6 inches to 1 ft. A total of 192 yards of rock and soil was taken for disposal at a NMOCD approved facility. The site was backfilled with 252 yards of clean, imported soil to ground surface and contoured to the surrounding area. A sample of the clean, imported soil was field tested for hydrocarbons and returned a result of 93 ppm. The sample was then taken to a commercial laboratory for analysis of chlorides with a result of <16 mg/kg. The site was seeded with a blend of native vegetation and is expected to return to a productive capacity at a normal rate. Silt net

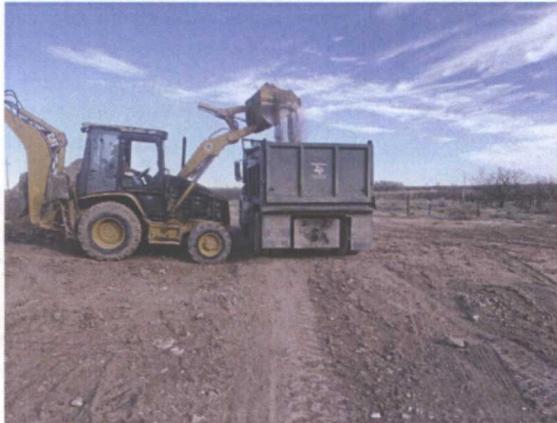
exporting scraped soil, facing north
1/16/2012

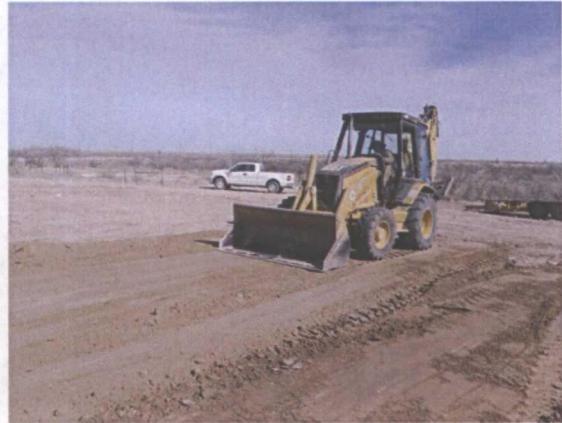
backfilling the scraped site, facing north
1/18/2012

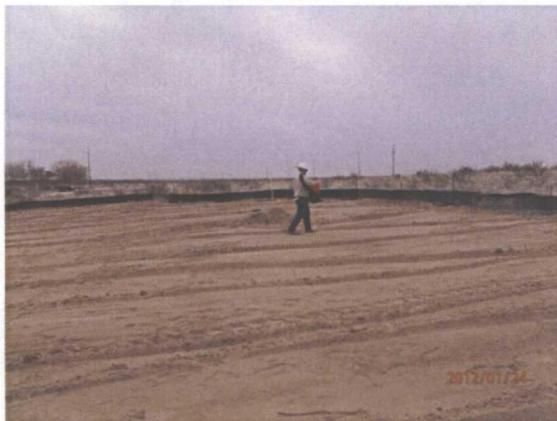
seeding the backfilled site, facing south
1/24/2012

Custom seed mix <input checked="" type="checkbox"/>	Prescribed mix <input type="checkbox"/>	Seed mix name: 11 LBS WINTER WHEAT 8 LBS SIDE OATS GRAMA 3 LBS BLACK GRAMA	Seeding date: 1-24-12
Broadcast <input checked="" type="checkbox"/>			
Method: Portable seeder			
Soil conditions during seeding: Dry <input checked="" type="checkbox"/> Damp <input type="checkbox"/> Wet <input type="checkbox"/>			
Photos attached <input checked="" type="checkbox"/>	Observations:		
Number of photos:

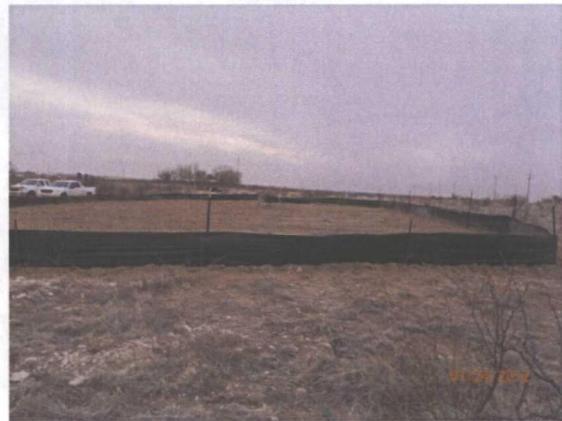
site complete, facing south
1/24/2012

fencing was placed around the site to maintain seed integrity. All documentation of the CAP work is provided in Appendix A.
