1R - 2552

# WORKPLANS

**RE: Update Report and Corrective Action to Groundwater  
Rice Operating Company – EME SWD System  
EME K-6 leak (IRP-2552): UL/K sec. 6 T20S R37E**

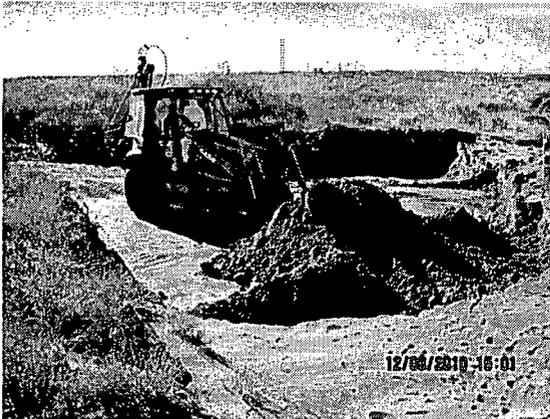
excavating the site

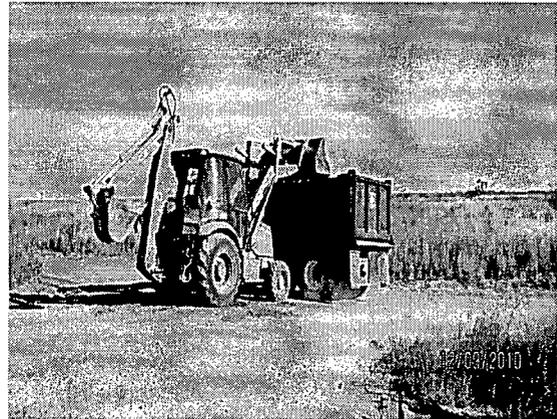
hauling excavated soil to Sundance for disposal

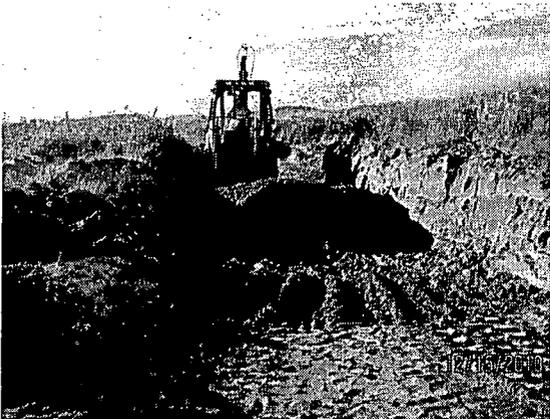
excavating the site

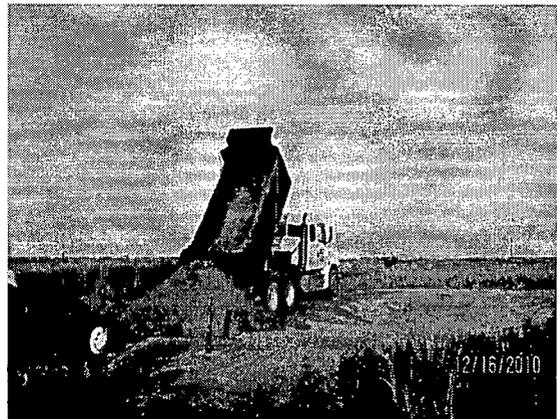
importing blow sand

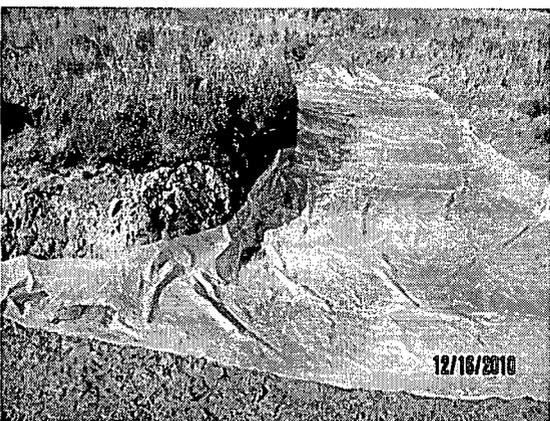
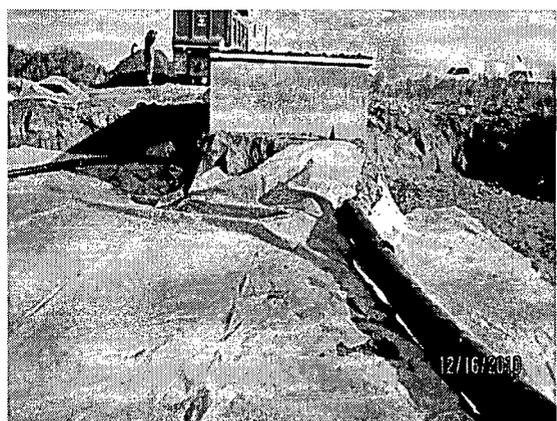
installing the plastic liner

The estimated impact area is 6,560 square feet. ROC installed a 20-mil plastic liner throughout the leak area which will stop the further migration of residual chlorides to groundwater. Therefore, only the bottom 10 feet of the vadose zone will have the potential to affect the groundwater beneath the site. The volume of impacted vadose zone is determined by multiplying the two values together to achieve a volume of 65,600

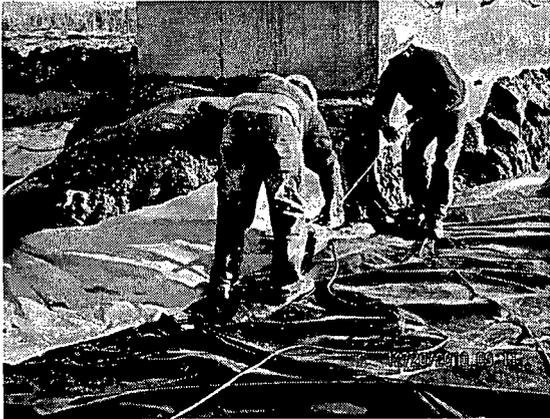
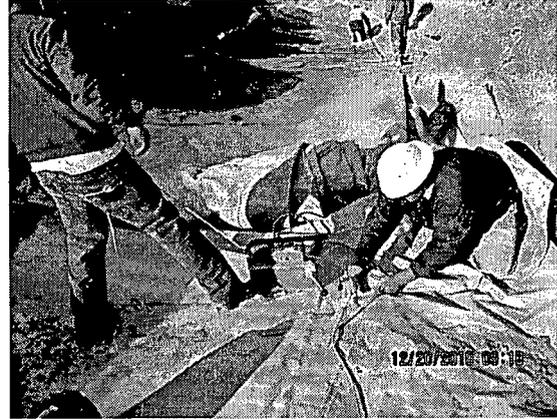
seaming the liners together

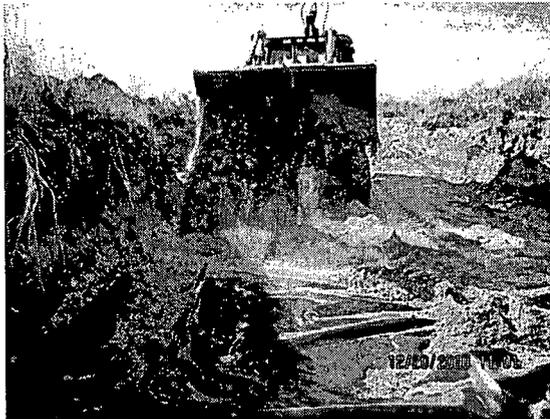
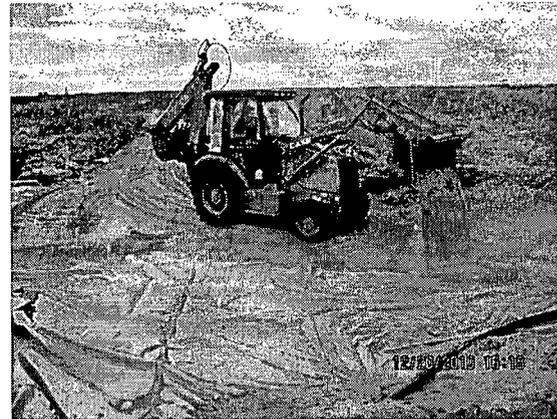
padding the liner with blow sand

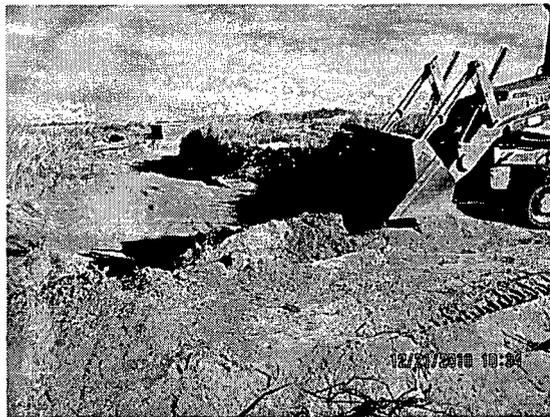
backfill the site with surrounding dunes

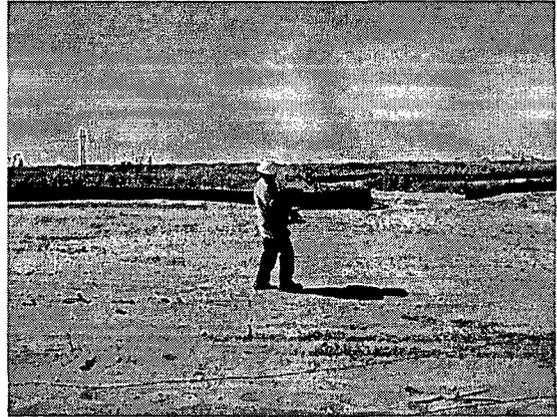
seeding the backfilled site

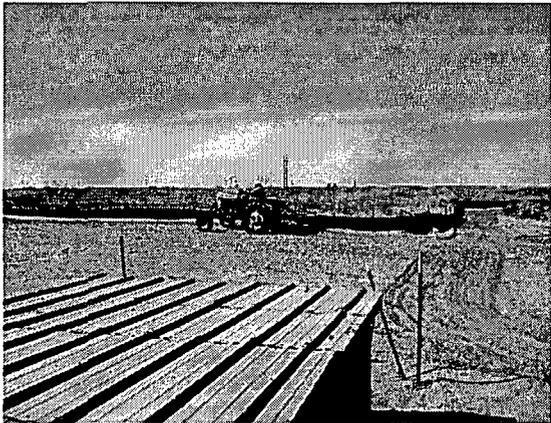
disking the site

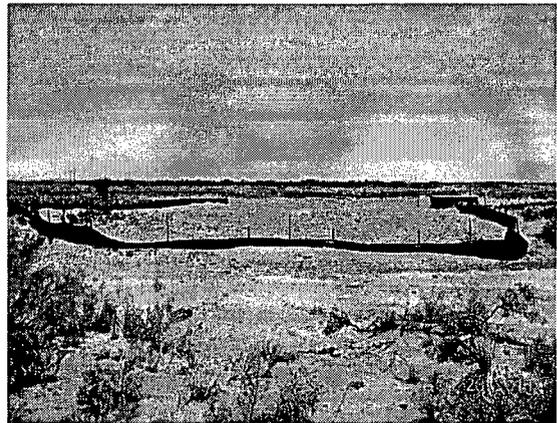
completed site work
