AP - 75

**STAGE 1 & 2
WORKPLANS**

RE: Project Update

Rice Operating Company – BD SWD System
BD J-26 T21S, R37E, Sec 26, UL J
NMOCD Case Number: AP-75

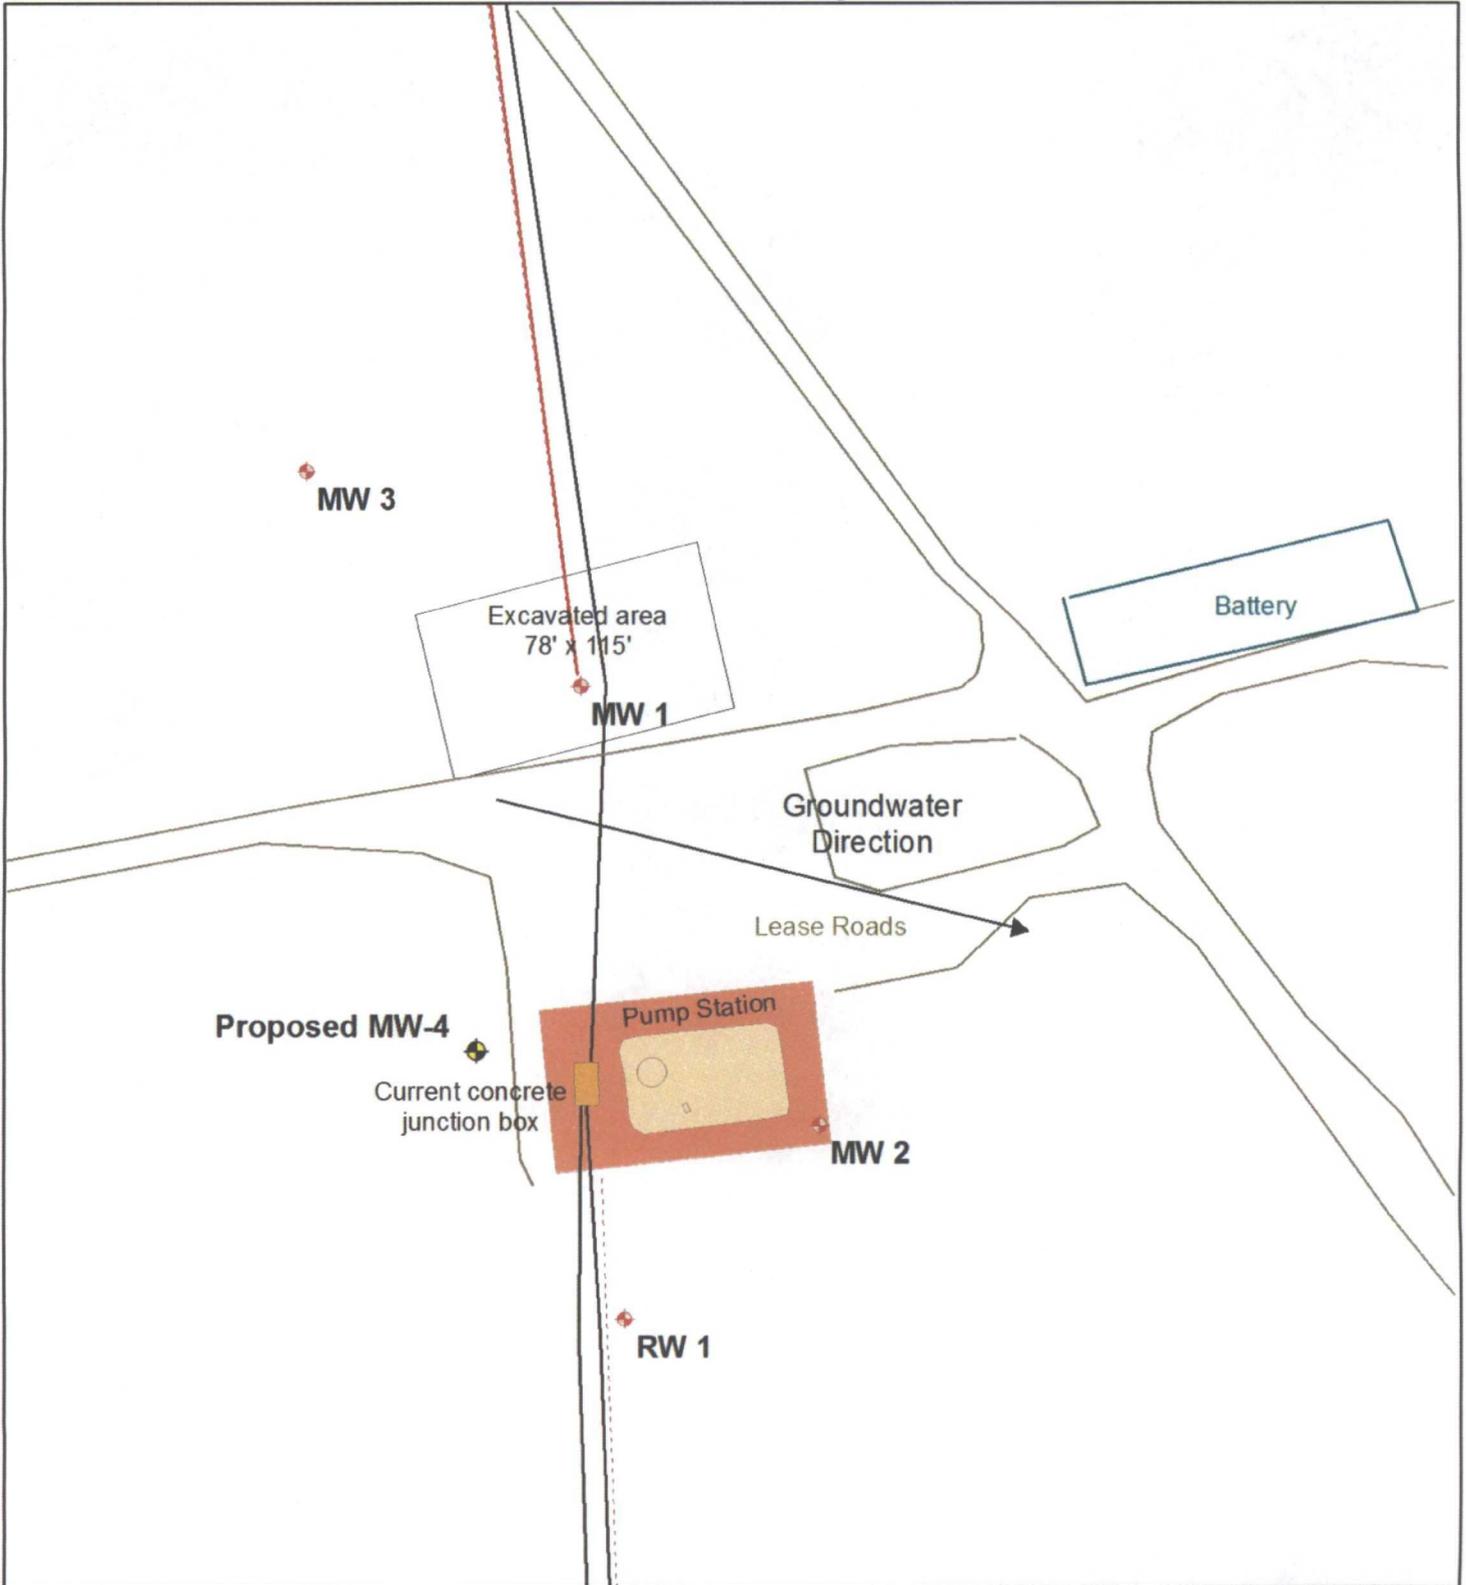
Site map

"We believe, based on the analyses and results presented here, that the BD J-26 site is no longer a threat to groundwater quality. We therefore propose to ~~cease further sampling from monitor wells MW-1, MW-3 and RW-1 and to plug and abandon these wells~~ install one two inch monitor well upgradient of MW-2 (west) per NMOCD request during the May 1, 2012 meeting between ROC and NMOCD. ~~However,~~ We propose to continue ~~to~~ sampling ~~MW-2~~ on a quarterly basis ~~through 2012~~ and to submit a report to NMOCD with recommendations ~~when ROC has further delineated upgradient water conditions for the best path forward by April 1, 2013.~~ See attached plat for approximate location."

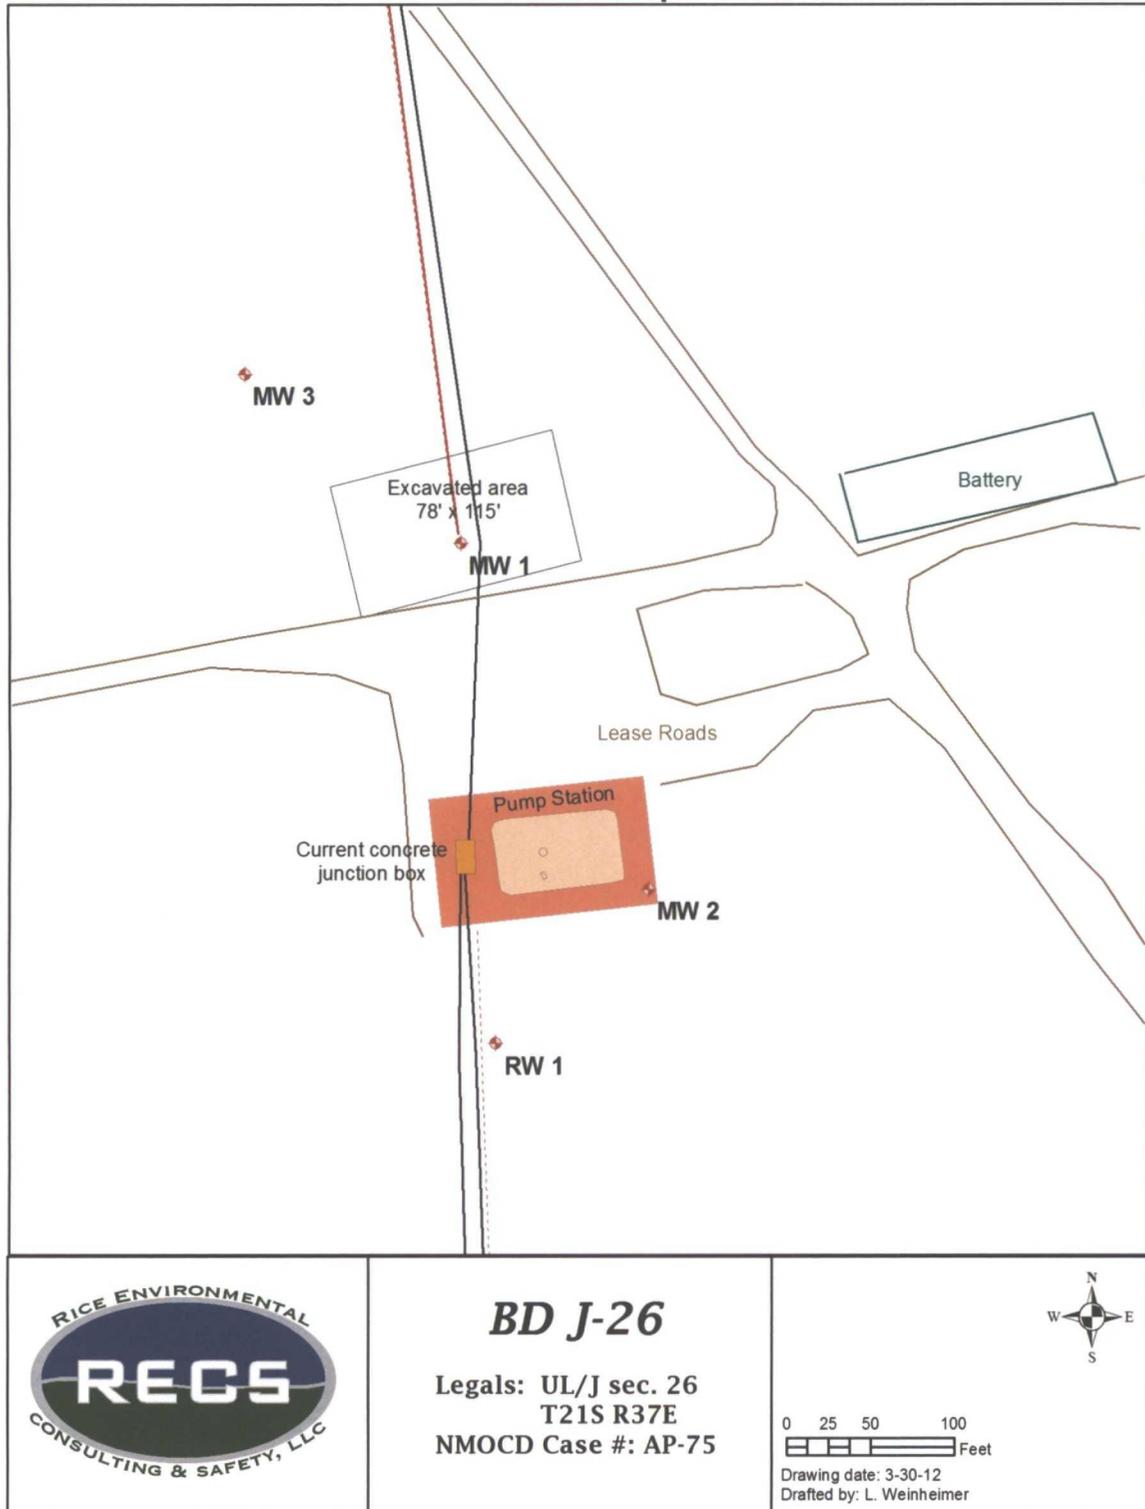
Figure 2 – BD J-26 site layout and monitor well locations. Note that MW-1 is next to the former (since removed) junction box and within the area of contaminated soil removal.

This report is to provide an update of groundwater monitoring results for Rice Operating Company's (ROC's) BD J-26 project near Eunice, New Mexico (Figures 1 & 2) and to propose a path forward for future work.

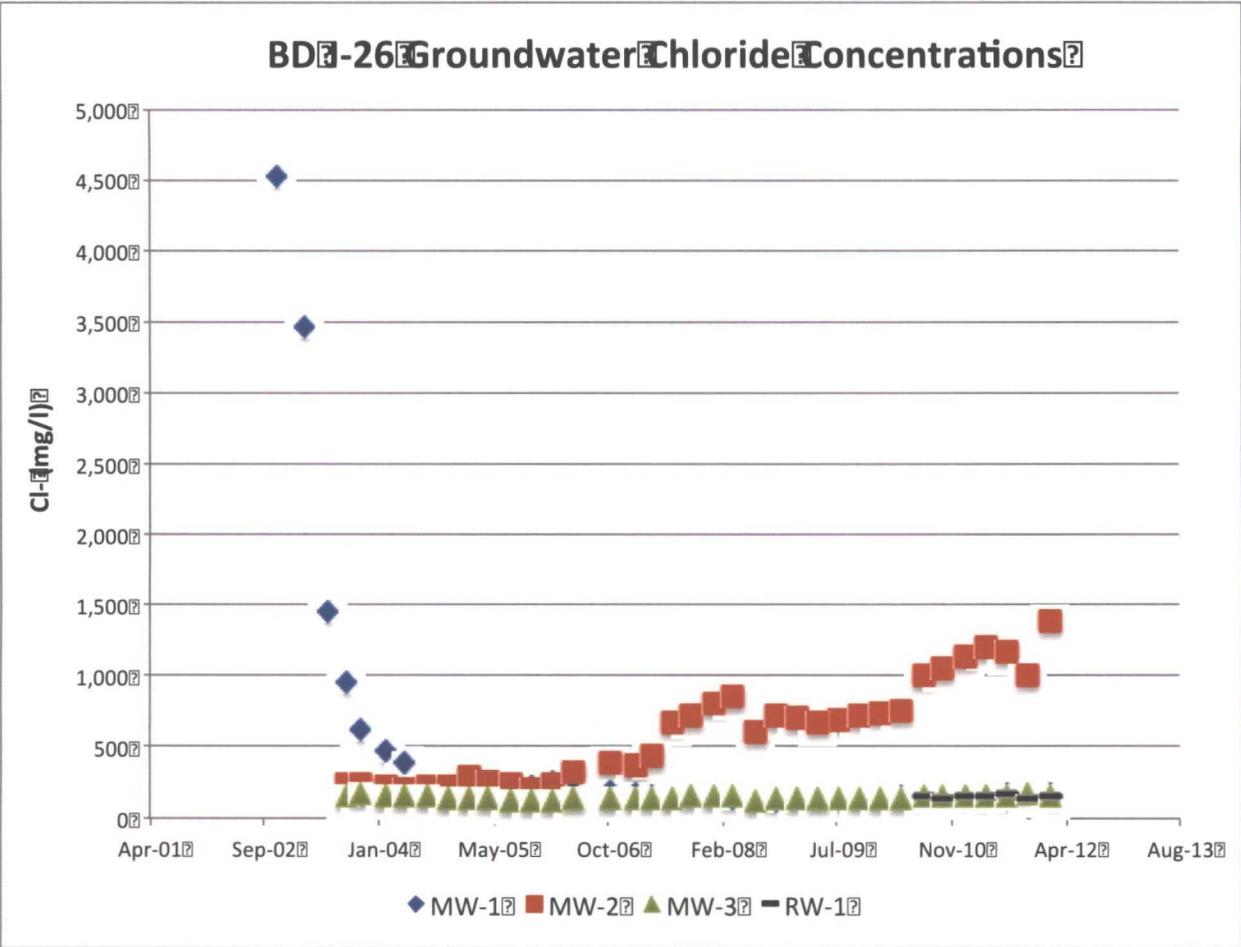
Figure 3 – BD J-26 groundwater chloride concentrations.

Groundwater chloride concentrations (Figure 3) in the at-source monitor well (MW-1) have dropped from their measured high values of approximately 4,500 mg/l in 2002 to less than 250 mg/l in August 2004. This is in all likelihood due to the effectiveness of soil remediation work completed in 2002 (Figures 4 & 5) and to natural attenuation (dilution) processes¹. Chloride concentrations in the up-gradient monitor well (MW-3) have ranged between 119 and 172 mg/l since 2003. Chloride concentrations in a southerly well (RW-1) have similarly ranged between 136 and 200 mg/l since its installation in May of 2010. These wells are presumably indicative of the local, baseline groundwater chloride concentrations. It should further be noted that groundwater BTEX concentrations were negligible in MW-1, MW-2 and MW-3 from 2003 through 2006 after which their measurement was suspended. Thus, petroleum hydrocarbons in groundwater have been ruled out as an item of concern for this project.

In contrast, chloride concentrations in a southeasterly located monitor well (MW-2) have risen steadily from less than 250 mg/l in 2003 to 1,380 mg/l in early 2012. Although MW-2 is adjacent to an ROC SWD pump station, this facility was constructed in 2002, lined with a synthetic liner, and no spills or system upsets have been experienced at this facility. The east/southeasterly groundwater gradient (Figure 6) suggests that the source of these chlorides is not from the former junction box (near MW-1), but rather from a more westerly source. This is further supported by historical aerial photographs (Figures 7 - 13) which indicate a severely impacted area to the west/northwest of MW-2 and the ROC SWD pump station.

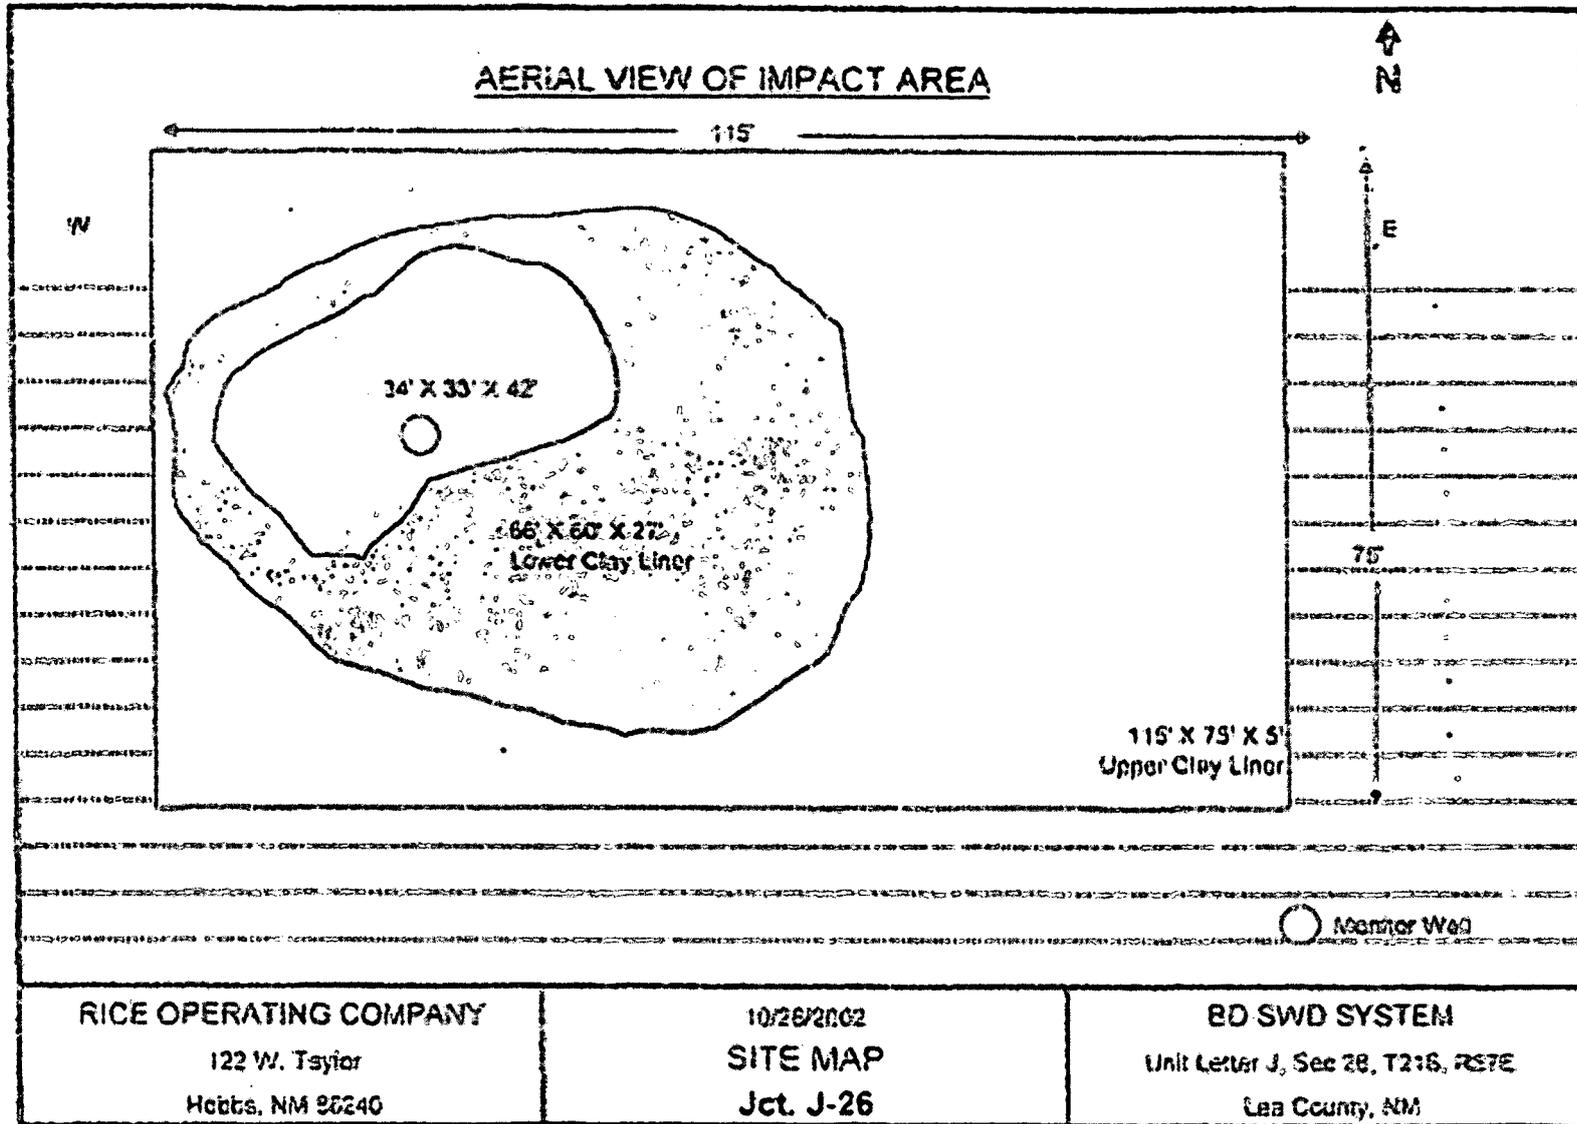
Figure 4- Plan view of cross sectional diagram of excavated soil at BD J-26 in 2002.

The area of impact from the operation of the former junction box was excavated and protected by a double clay liner system in 2002 (Figures 4 and 5), where the composite average soil chloride concentration of backfilled soil material is approximately 500 mg/kg (Figure 15).

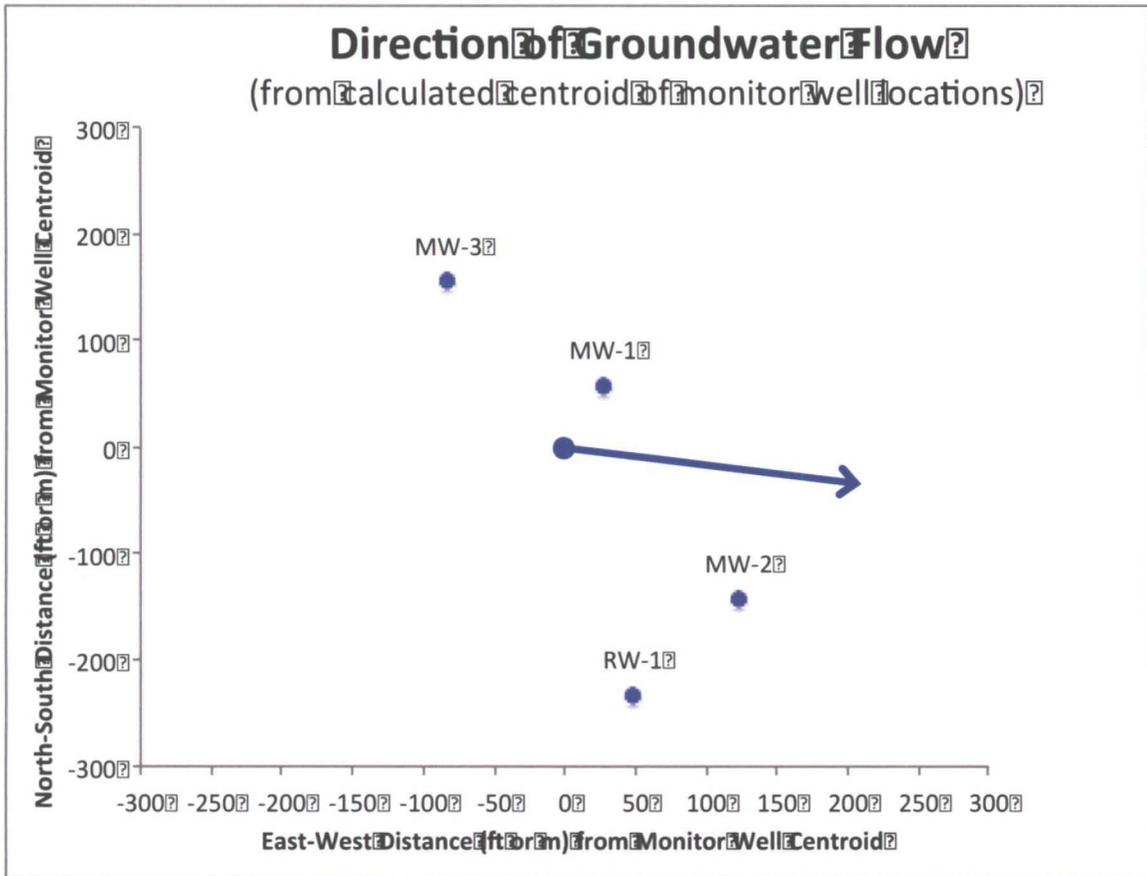
Figure 6 – Calculated average annual groundwater flow directions based on 4 quarterly depth-to-groundwater measurements taken in the respective monitor wells.

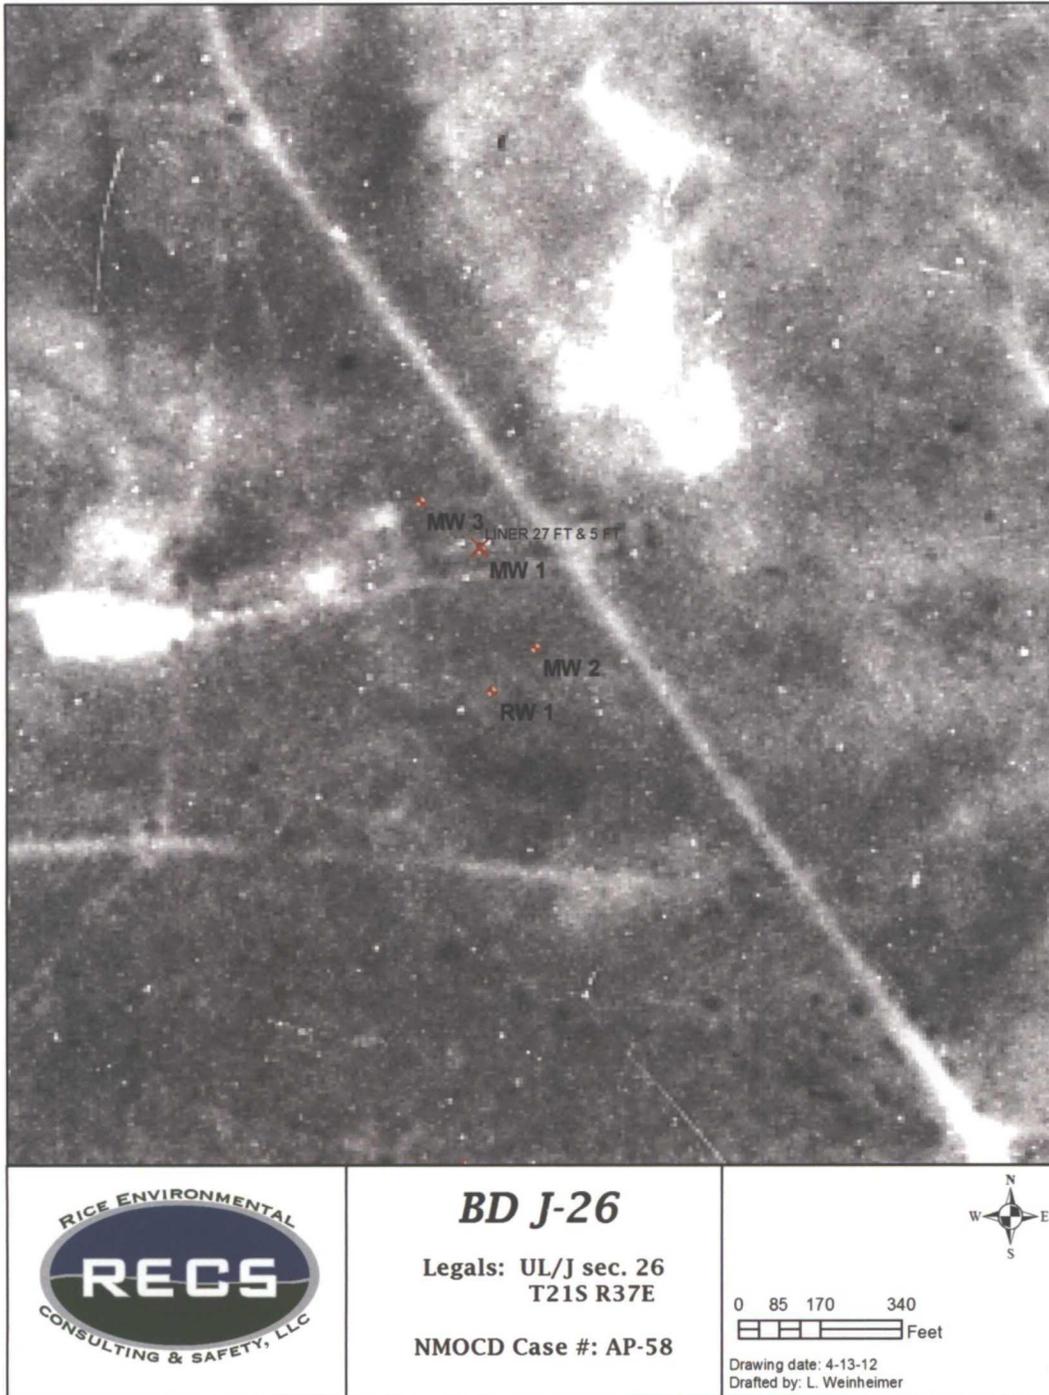
Figure 7 - BD J-26 1964 satellite photograph.

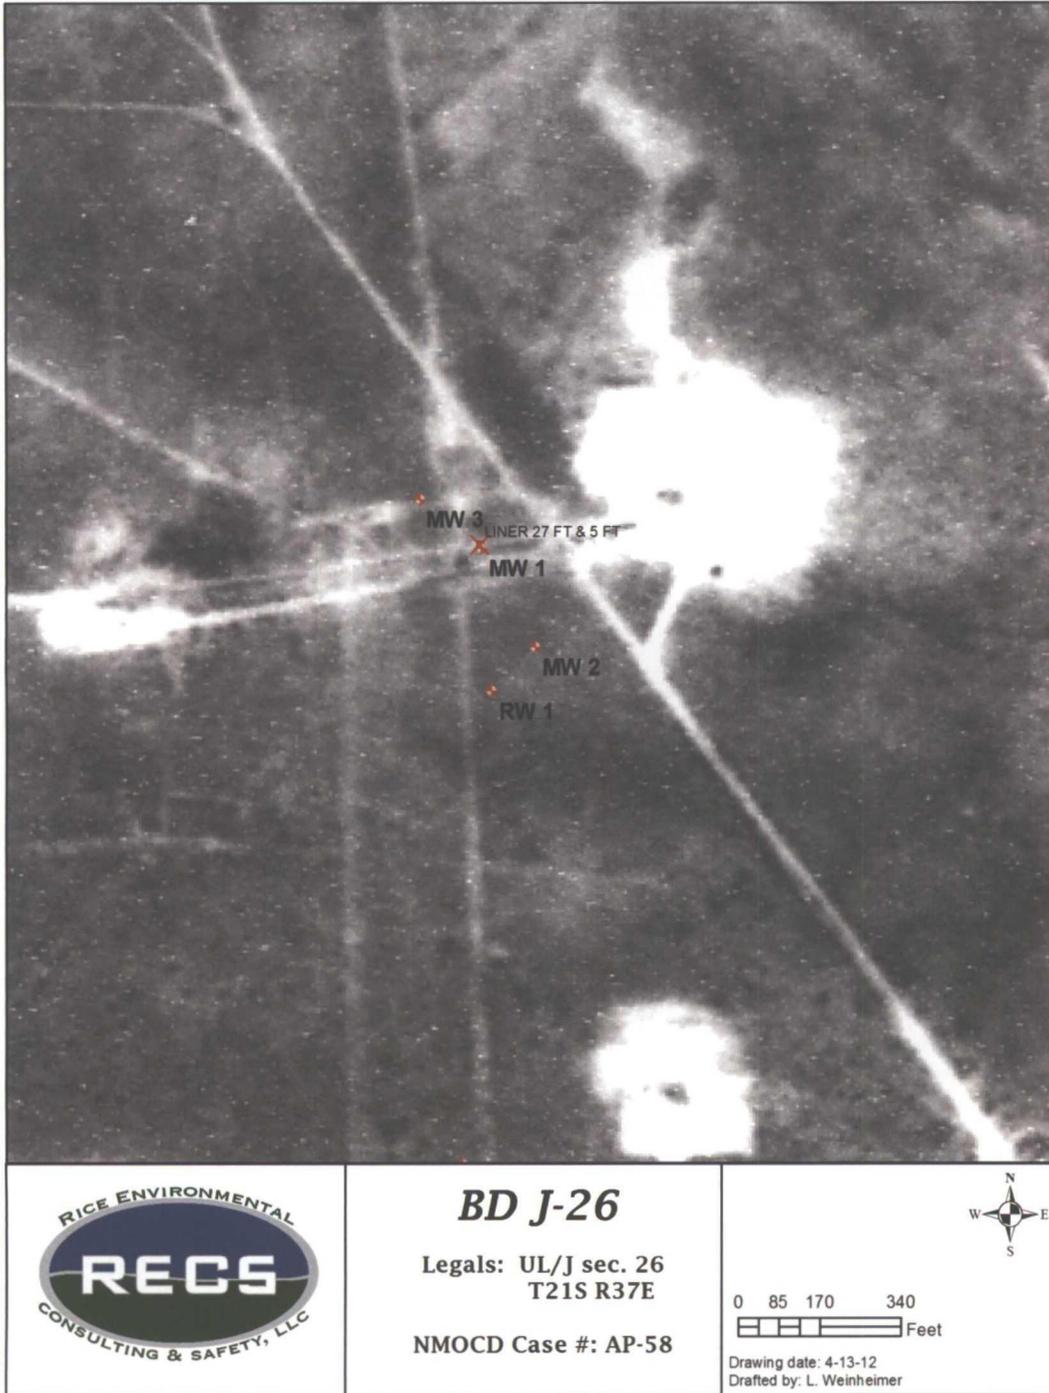
Figure 8 - BD J-26 1977 satellite photograph.

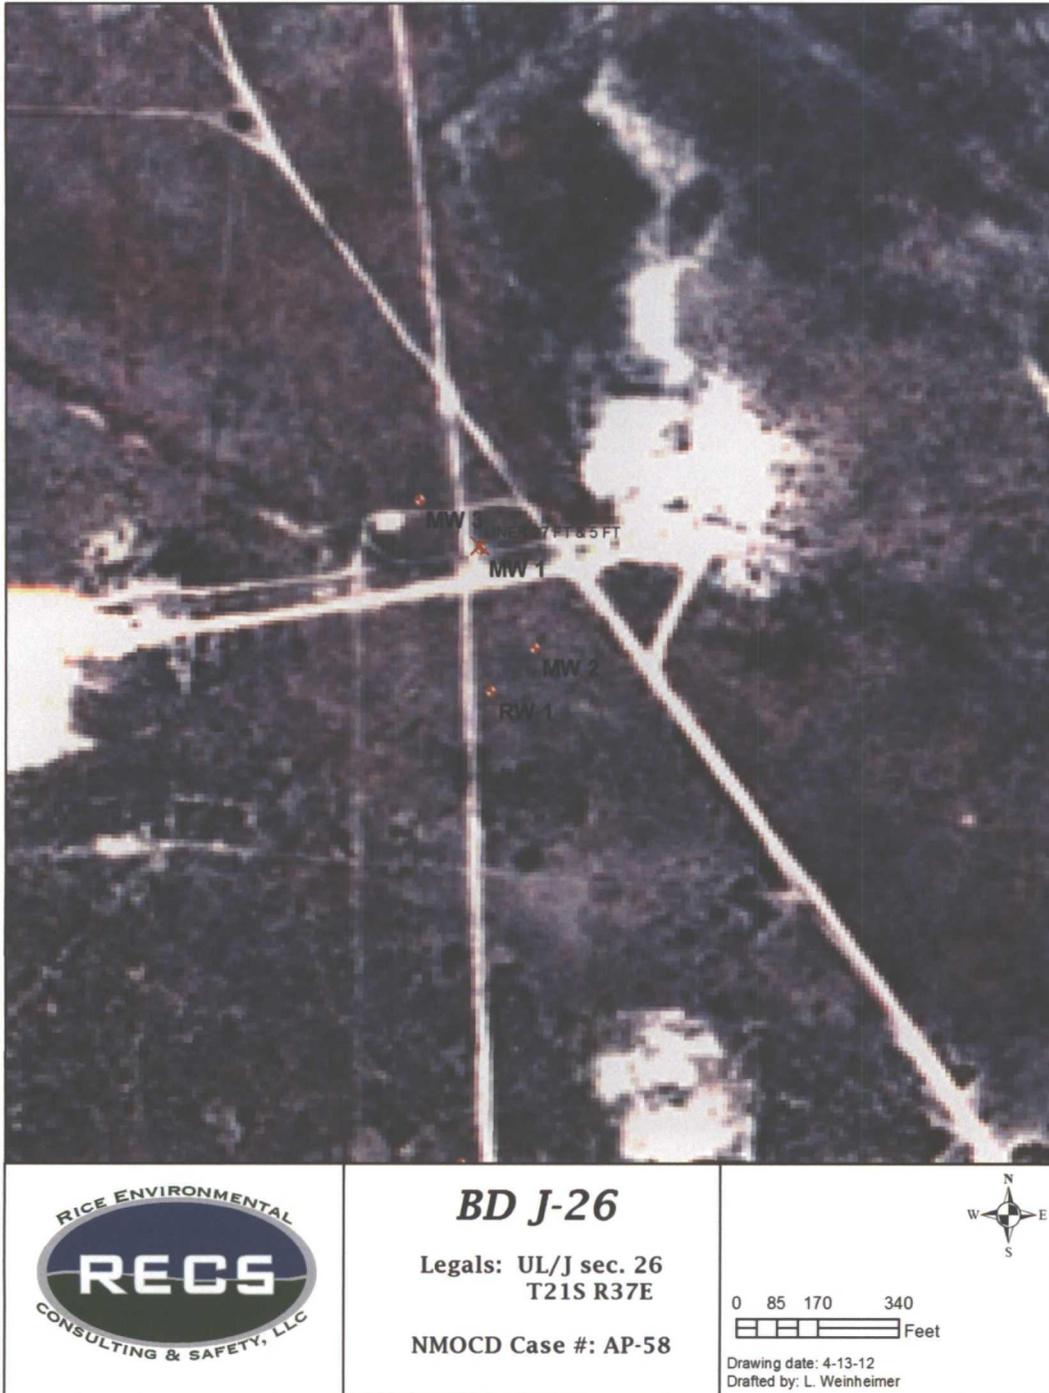
Figure 9 – BD J-26 1986 satellite photograph.

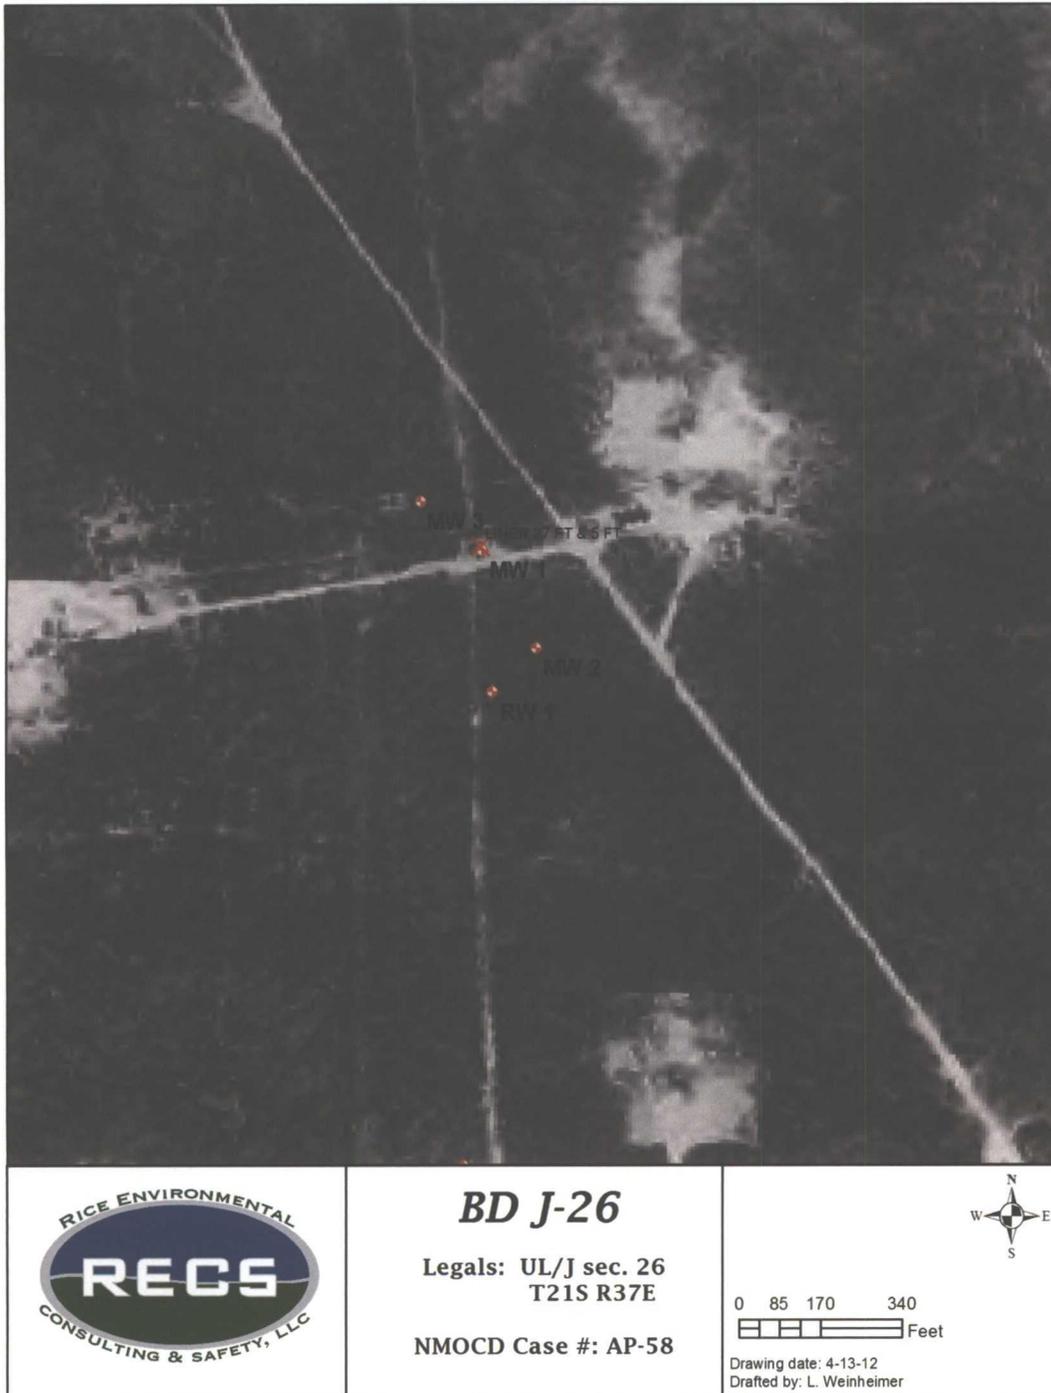
Figure 10 - BD J-26 1996 satellite photograph.

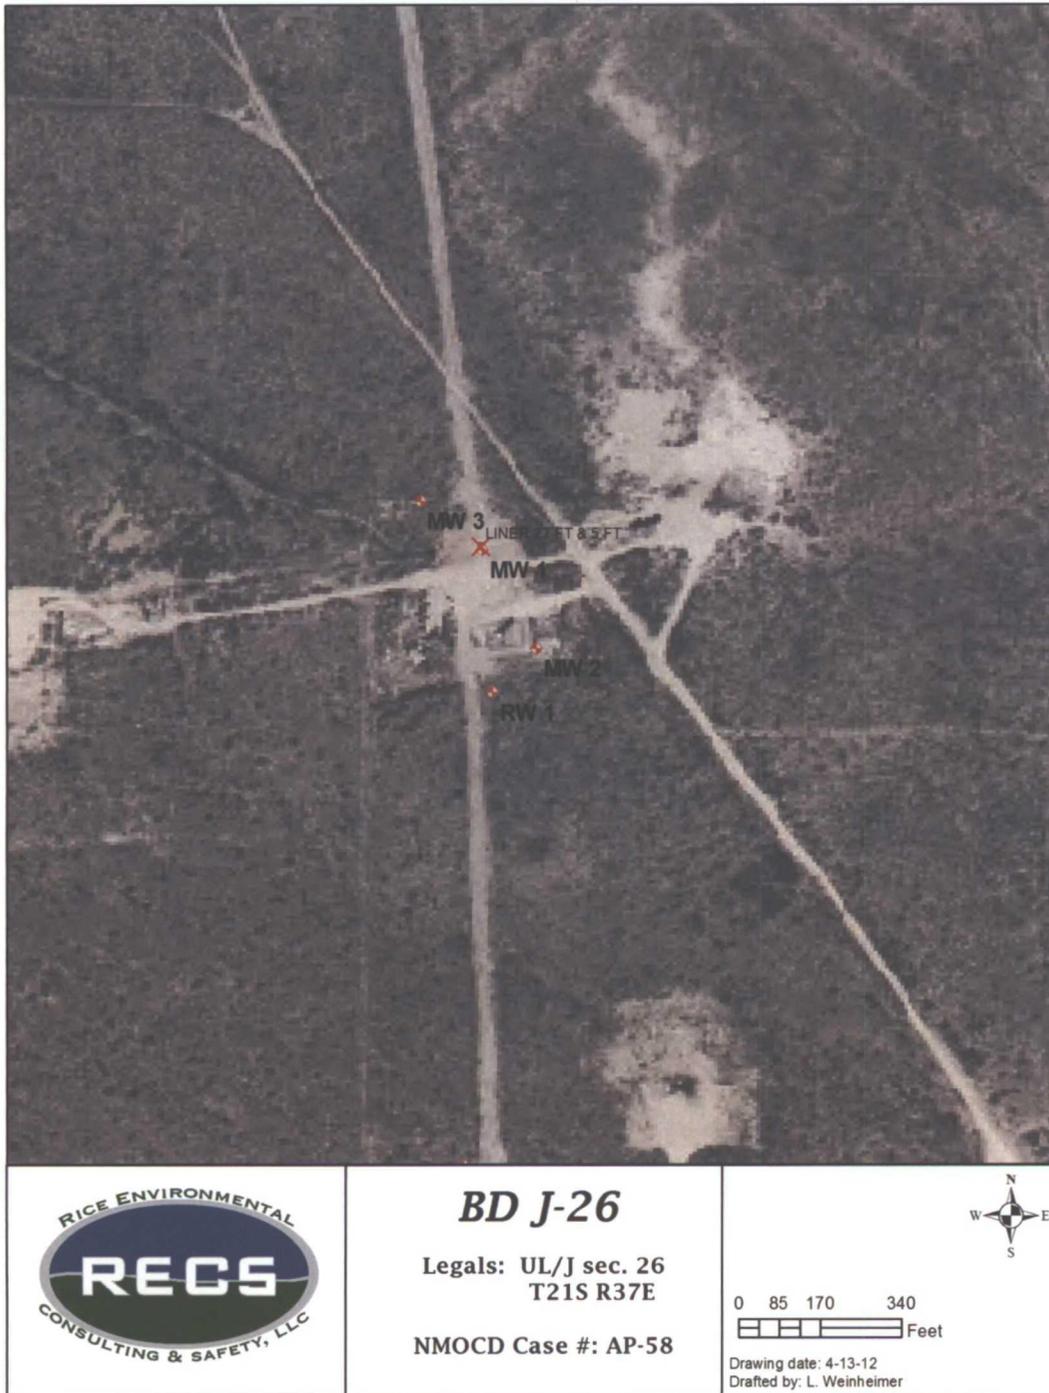
Figure 11 - BD J-26 2004 satellite photograph.

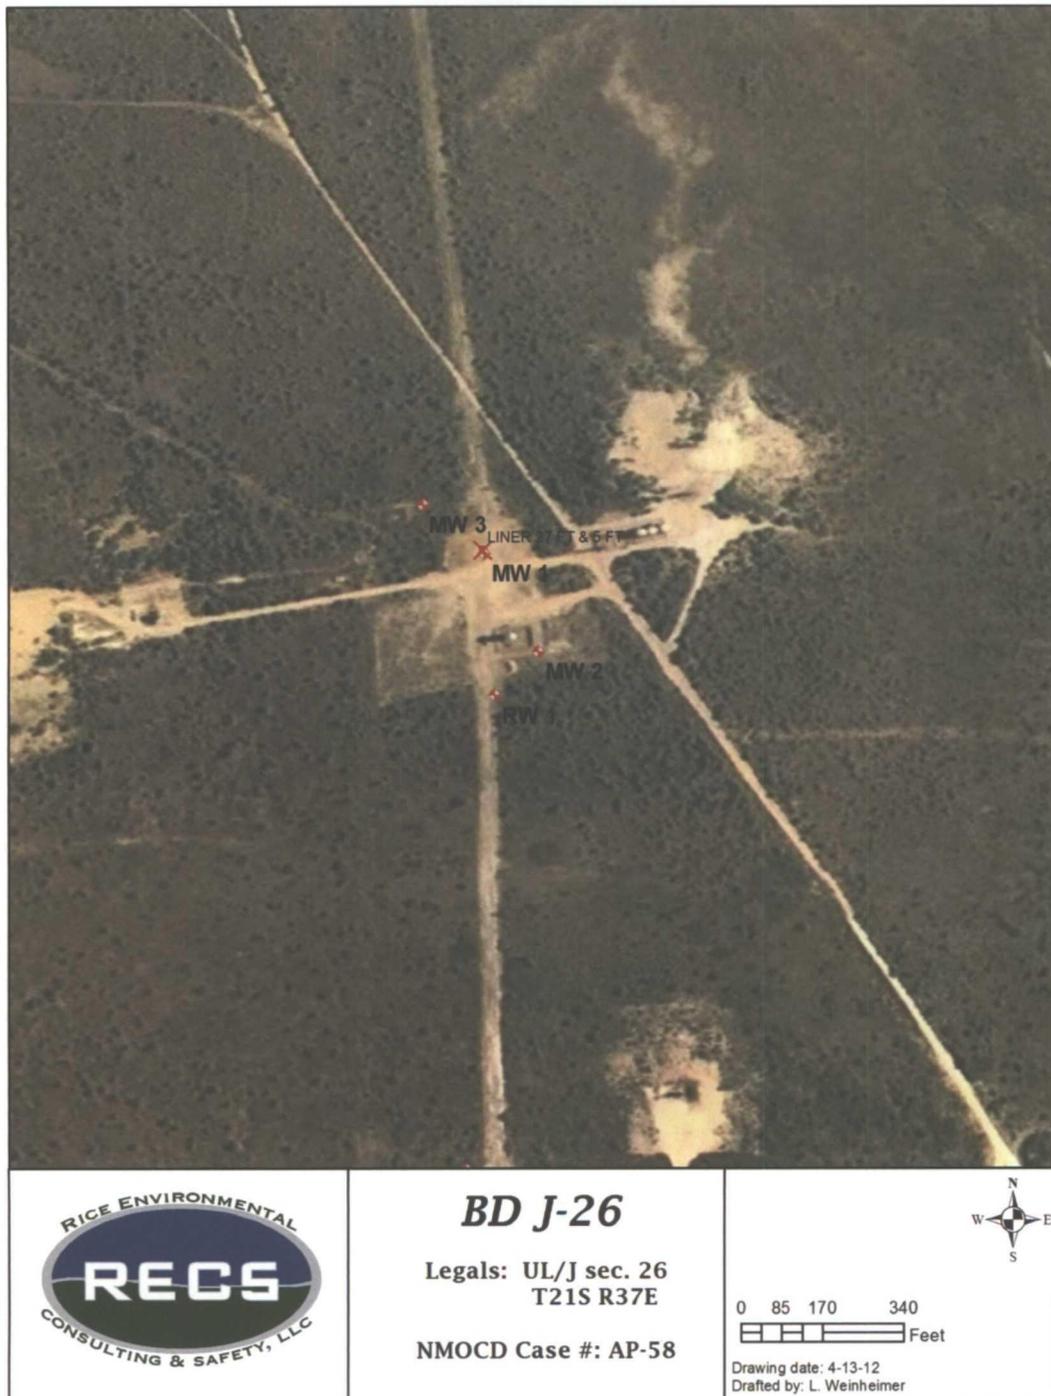
Figure 12 - BD J-26 2005 satellite photograph.

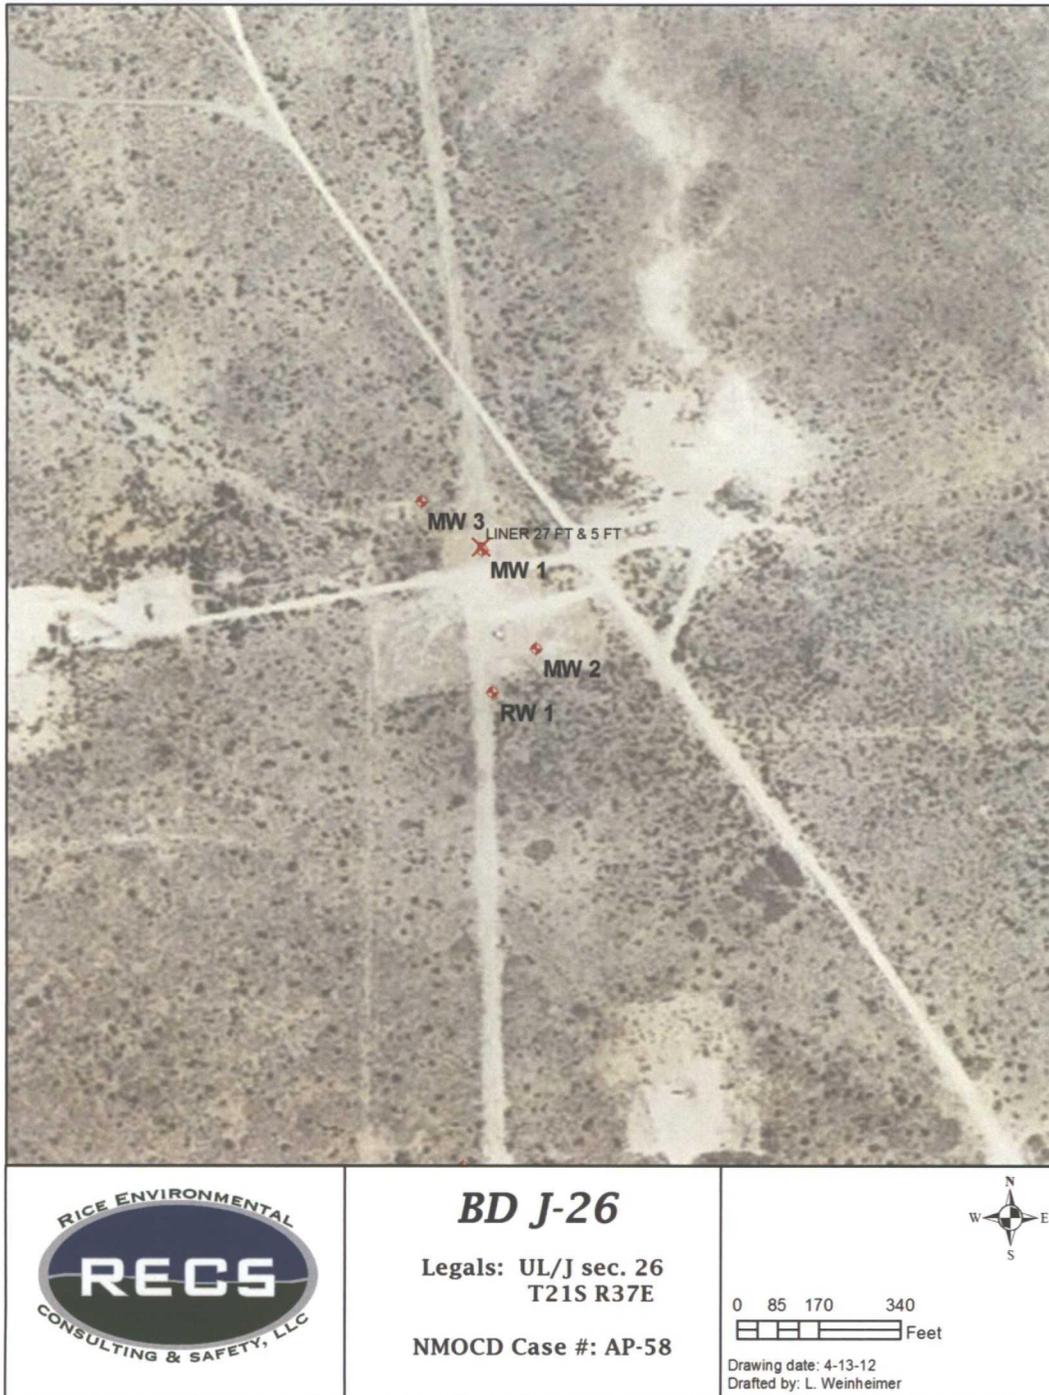
Figure 13 – BD J-26 2009 satellite photograph.

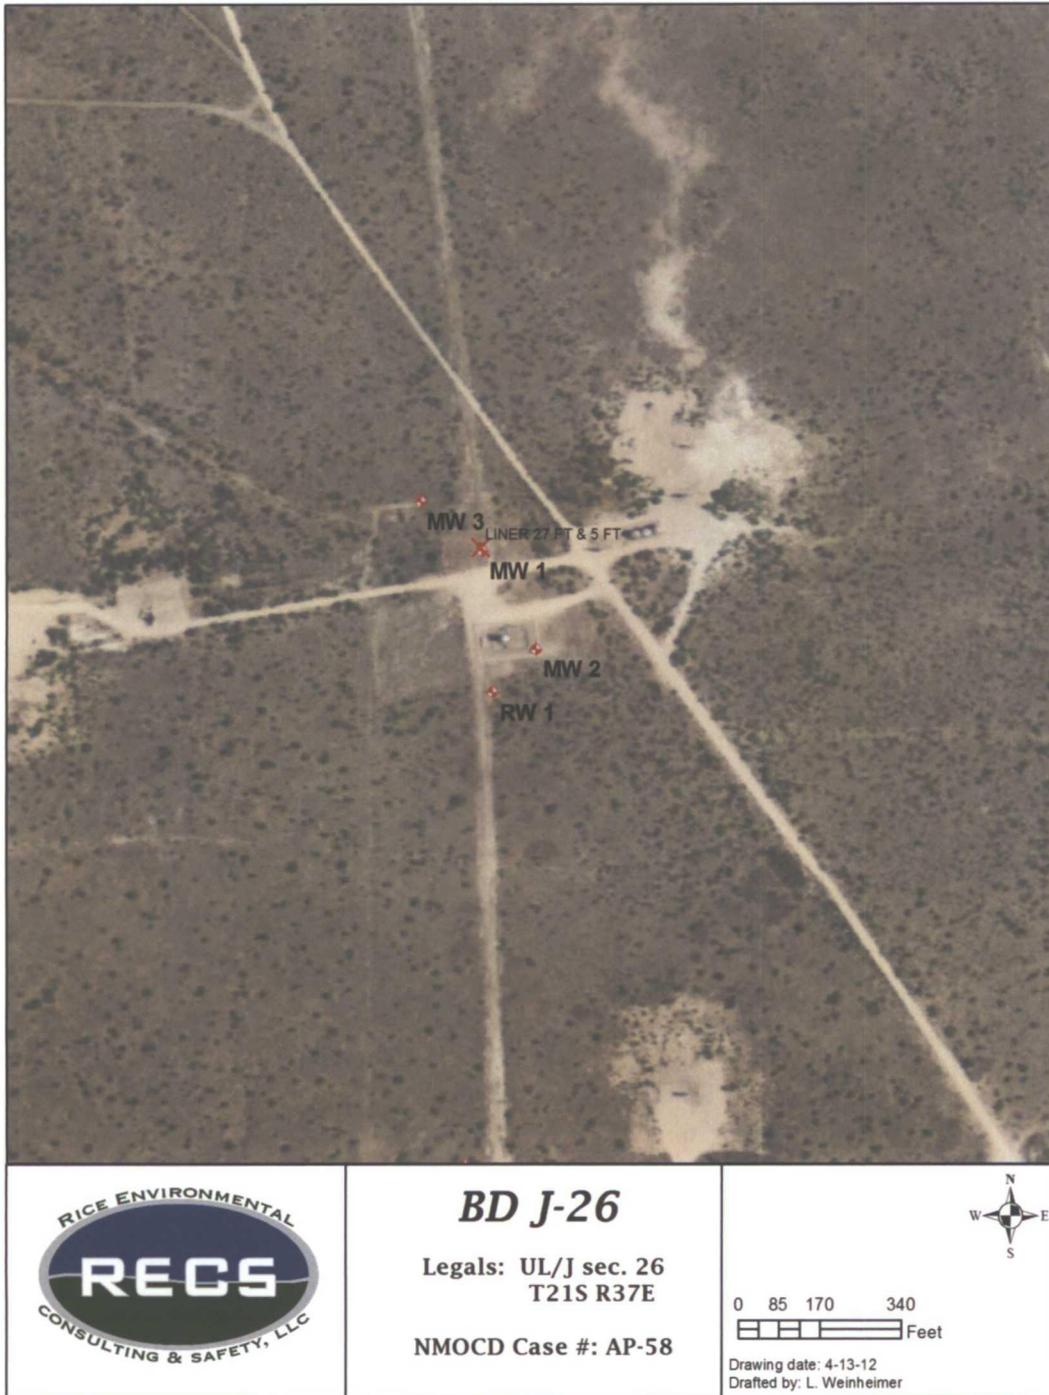
Figure 14 - BD J-26 2011 satellite photograph.
