RE: Termination Request
Vacuum M-33 vent (1R425-52): UL/M, Sec. 33, T17S, R35E
RICE Operating Company – Vacuum SWD System

**RICE OPERATING COMPANY
JUNCTION BOX FINAL REPORT**

Vacuum vent M-33

Unit M, Section 33, T17S, R35E

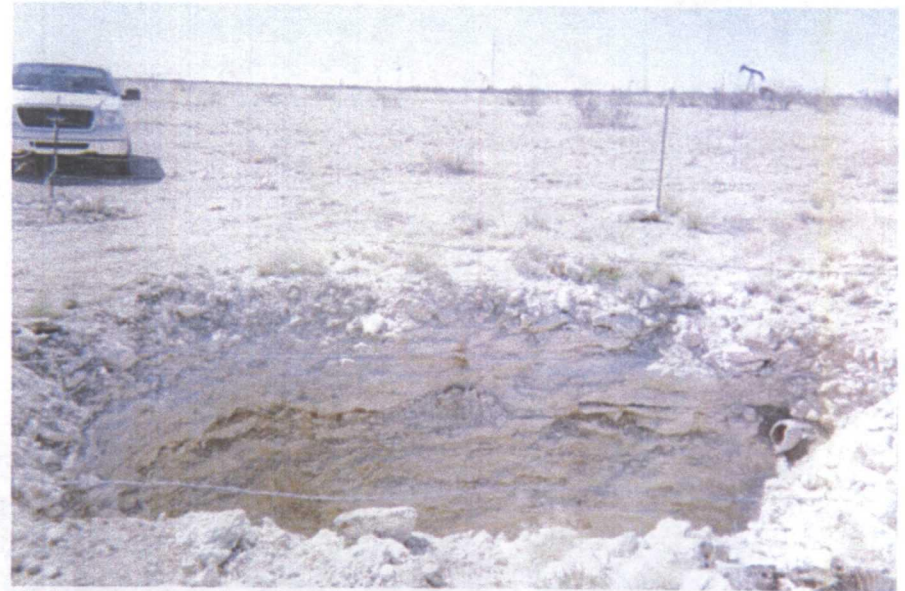
3/4/2008

delineation trench at former junction site, facing south

General Description of Remedial Action: This junction was addressed under the Vacuum SWD System abandonment. After this junction was removed, an investigation was conducted using a backhoe to collect soil samples at regular intervals producing a 5x3x14-ft-deep hole. Chloride field tests were performed on each sample, which yielded low concentrations. Organic vapors were measured using a PID, which also yielded low concentrations. The deepest sample, 14 ft BGS, was sent to a commercial laboratory for analysis of chloride and TPH, which confirmed low concentrations. The excavated soil was returned to the excavation and clean, imported soil was used to fill the excavation to ground surface and to contour to the surrounding area. On 3/20/2008, the site was seeded with a blend of native vegetation and is expected to return to a productive capacity at a normal rate.

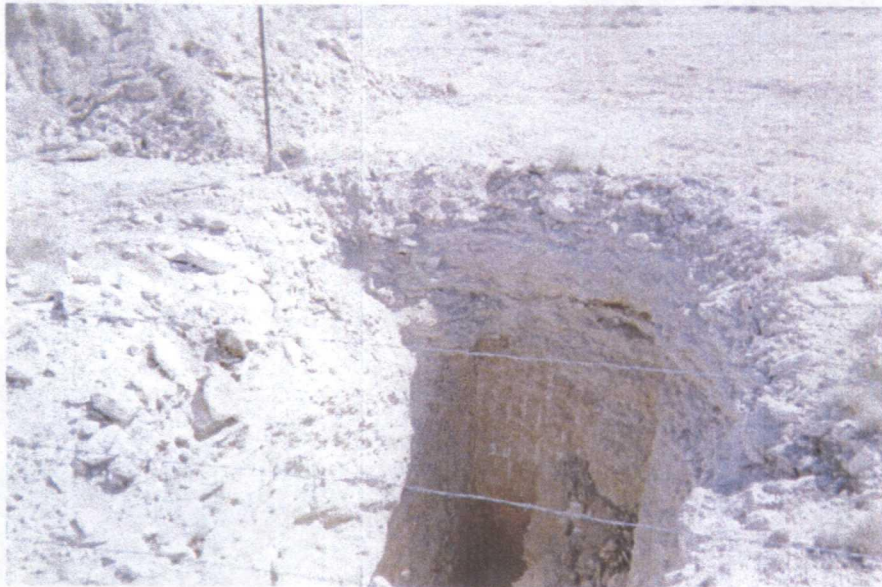
3/4/2008

delineation trench at former junction site, facing east

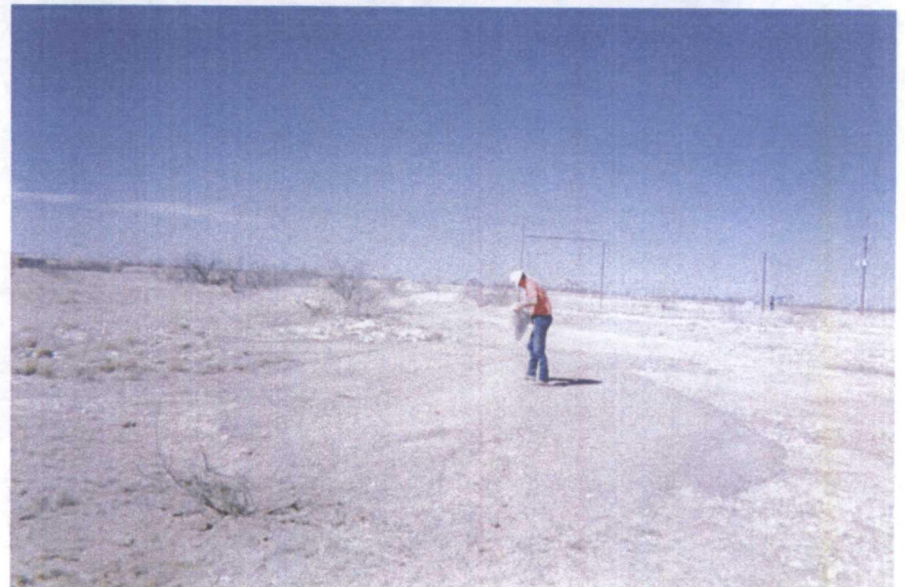
3/20/2008

seeding backfilled site, facing north
