RE: Termination Request
Vacuum Jct. C-31-1 (1R425-53): UL/C, Sec. 31, T17S, R35E
RICE Operating Company – Vacuum SWD System

**RICE OPERATING COMPANY
JUNCTION BOX FINAL REPORT**

Vacuum Jct. C-31-1

Unit C, Section 31, T17S, R35E

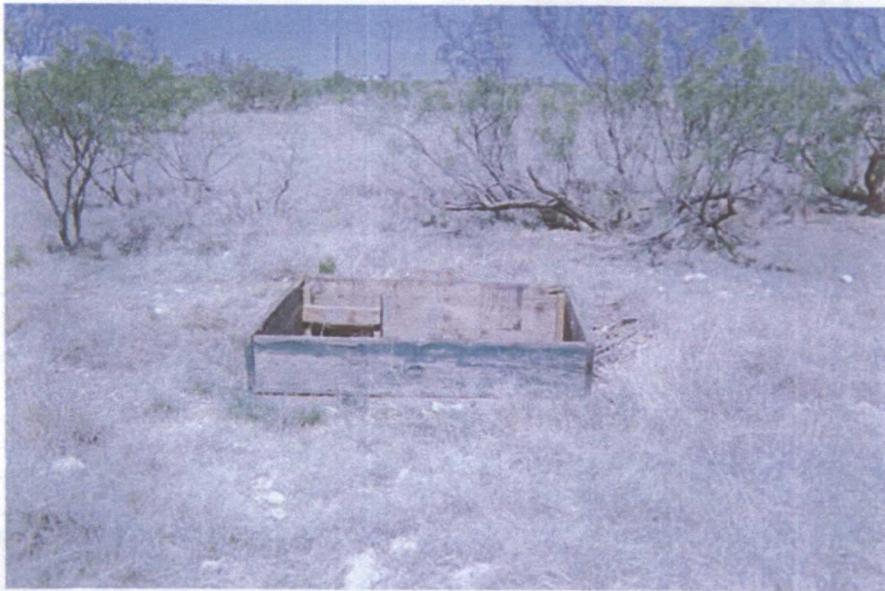
junction box prior to removal, facing west

5/27/2008

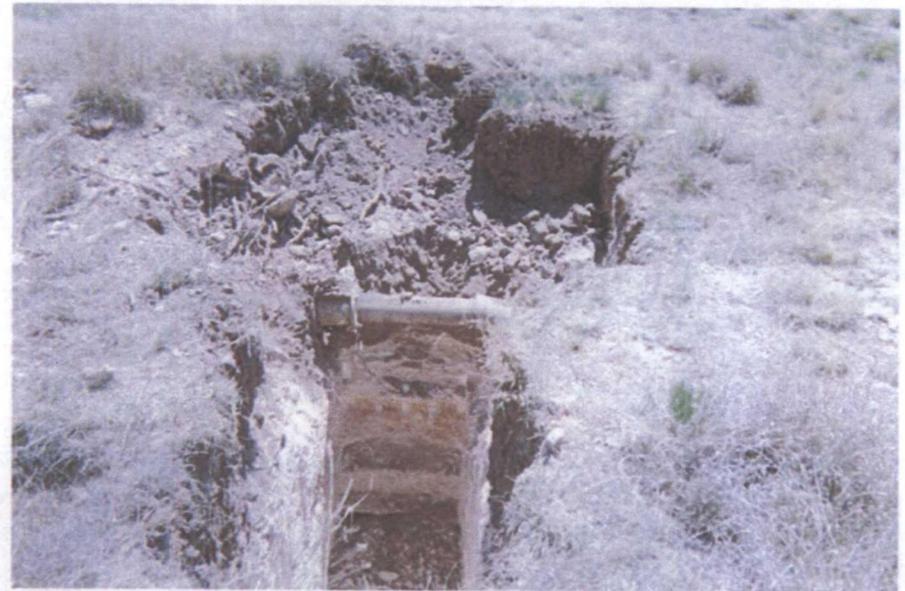
delineation trench at former junction site, facing east

5/27/2008

General Description of Remedial Action: This junction was addressed under the Vacuum SWD System abandonment. After the junction was removed, an investigation was conducted using a backhoe to collect soil samples at regular intervals producing a 5x3x8-ft-deep hole. Chloride field tests were performed on each sample, which yielded low concentrations. Organic vapors were measured using a PID, which also yielded low concentrations. The deepest sample, 8 ft BGS, was sent to a commercial laboratory for analysis of chloride and TPH, confirming low concentrations. The excavated soil was returned to the excavation and clean soil was imported and used as a top cap and to contour to the surrounding area. On 6/5/2008, the site was seeded with a blend of native vegetation and is expected to return to a productive capacity at a normal rate.

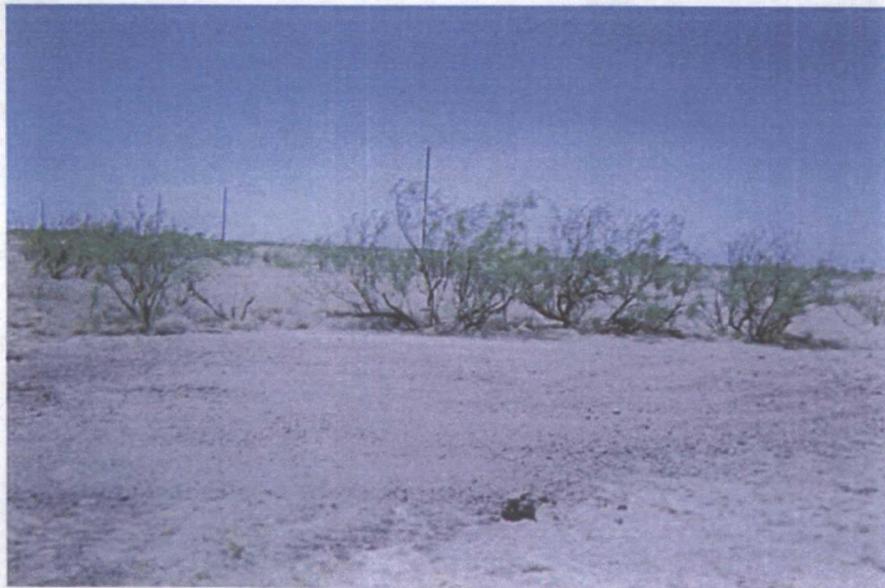
backfilled site, facing west

6/5/2008

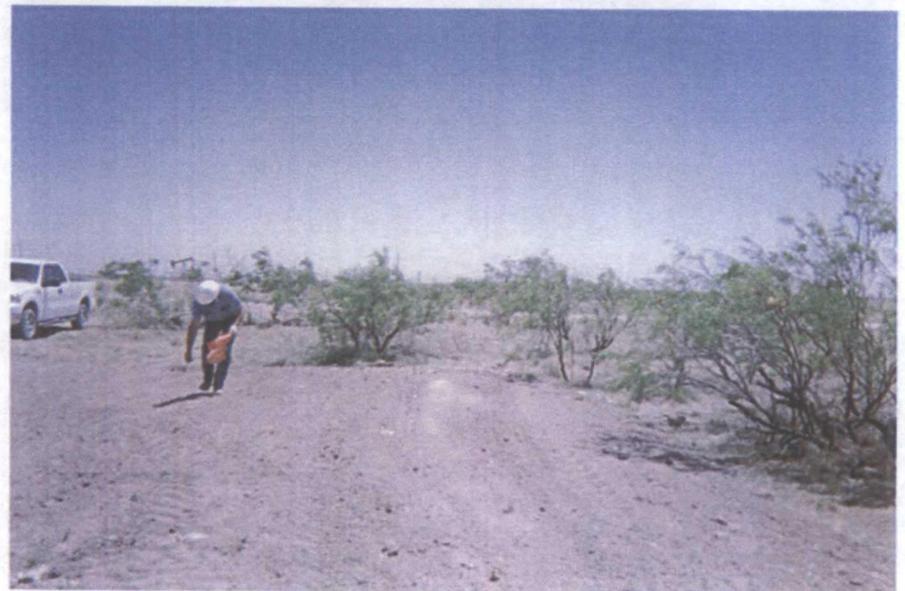
seeding backfilled site, facing south

6/5/2008
