EME Jct. J-25-1  
2011

**CLOSURE**

RE: Termination Request  
EME Jct. J-25-1: UL/J, Sec. 25, T19S, R36E  
RICE Operating Company – Eunice Monument Eumont SWD System

**RICE OPERATING COMPANY  
JUNCTION BOX FINAL REPORT**

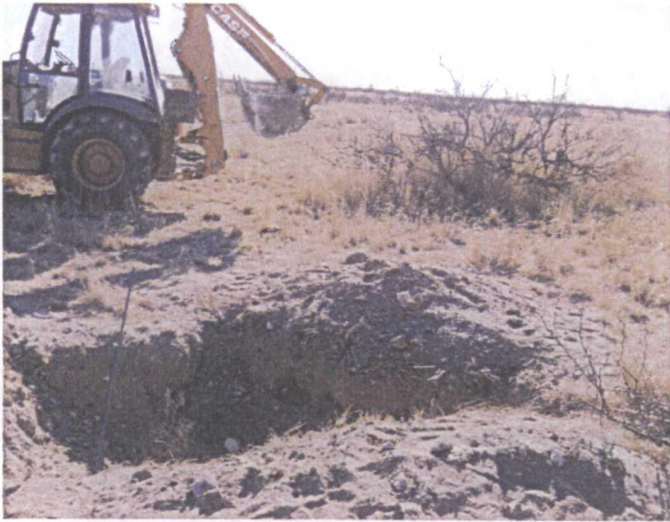
1.21.11

Excavating site, facing south

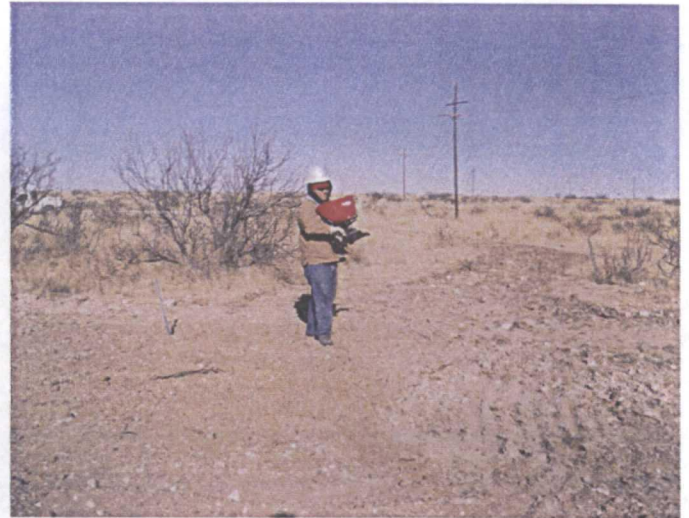
1.21.11

Seeding site, facing

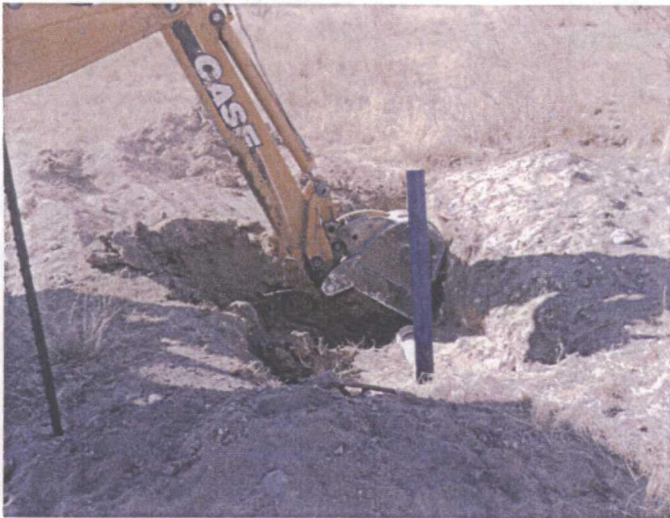
1.31.11

Excavating site, facing south

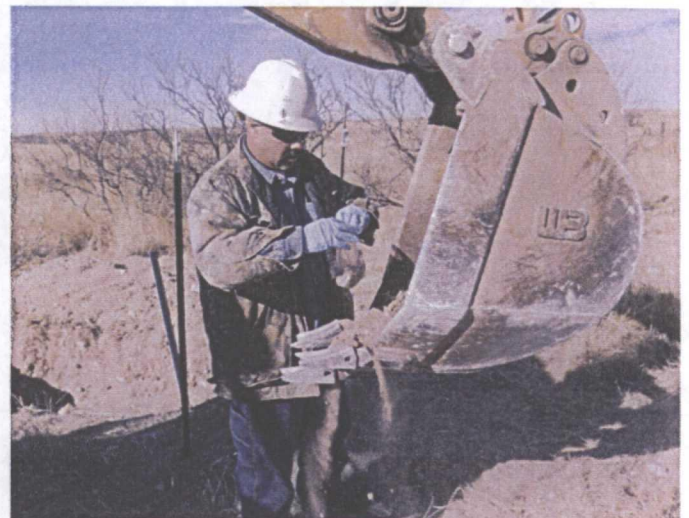
1.31.11

Collecting sample, facing west

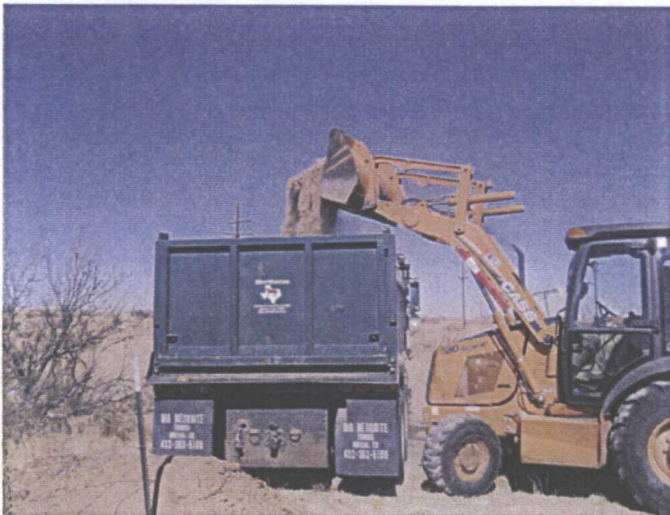
2.10.11

Exporting soil, facing north

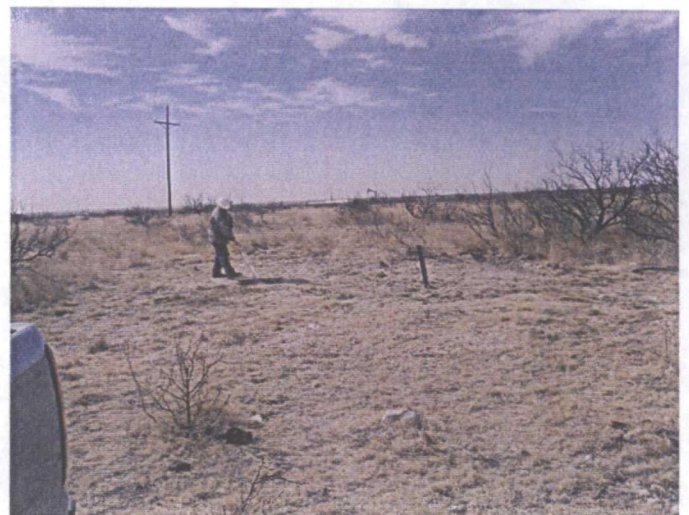
2.10.11

Raking in seed, facing south
