**RICE OPERATING COMPANY  
JUNCTION BOX DISCLOSURE\* REPORT**

SWD SYSTEM	JUNCTION	UNIT	SECTION	TOWNSHIP	RANGE	COUNTY	BOX DIMENSIONS - FEET		
Blinebry-Drinkard (BD)	Jct. P-11	P	11	22S	37E	Lea	Length	Width	Depth
							eliminated

# BD Jct. P-11

Unit P, Section 11, T22S, R37E

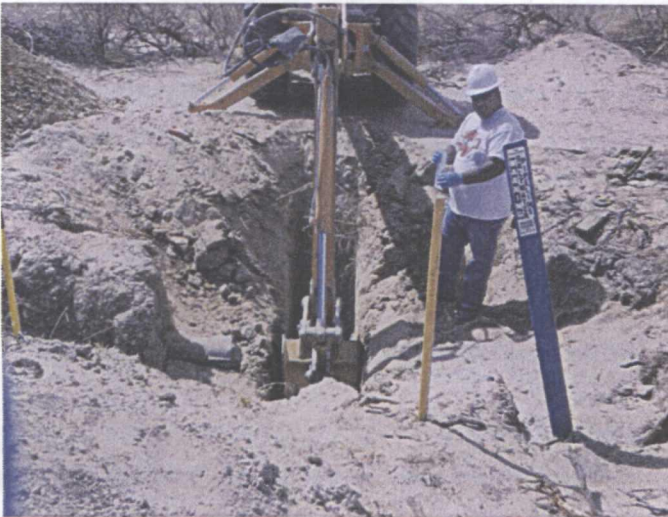
Excavating the former junction box, facing west  
3.31.11

**General Description of Remedial Action:** This junction was eliminated during the

pipeline replacement/upgrade program. After the former junction box was removed,

an investigation was conducted using a backhoe to collect soil samples at

regular intervals producing a 30x20x12-ft excavation. Chloride field tests performed on

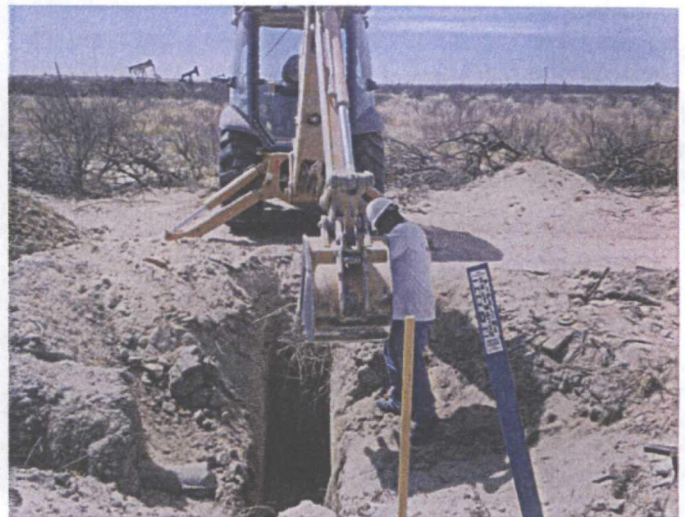
Collecting a soil sample, facing west  
3.31.11

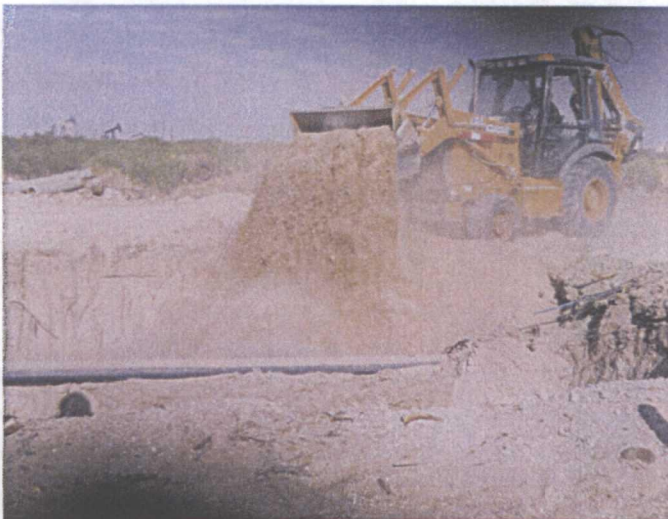
Backfilling the excavation up to 4-ft. BGS, facing west  
5.2.11

blended backfill was returned to the excavation to a depth of 4-ft BGS. On 5/2/2011, a 20-mil reinforced liner was installed at 4-ft BGS

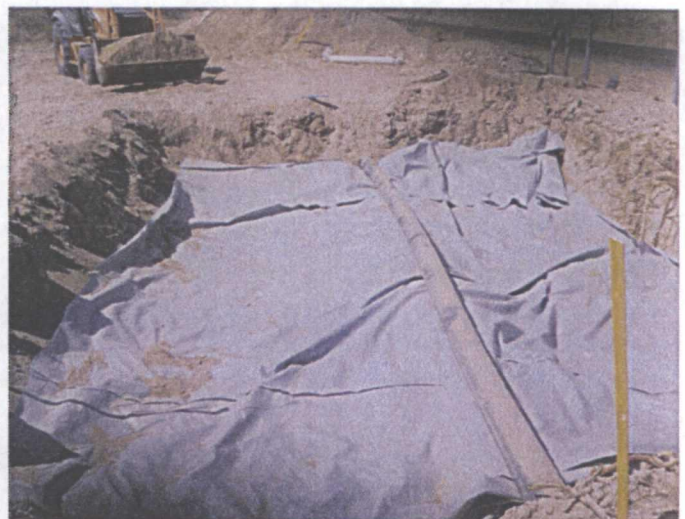
Installing a 30x20-ft., 20-mil reinforced liner at 4-ft. BGS, facing north  
5.2.11

and the excavation was backfilled with the remaining blended soil to ground surface and contoured to the surrounding area. On 5/3/2011,

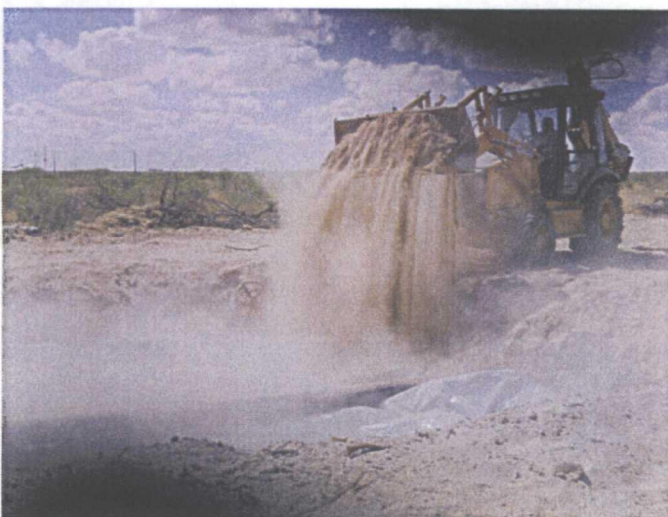
Backfilling site above liner, facing west  
5.2.11

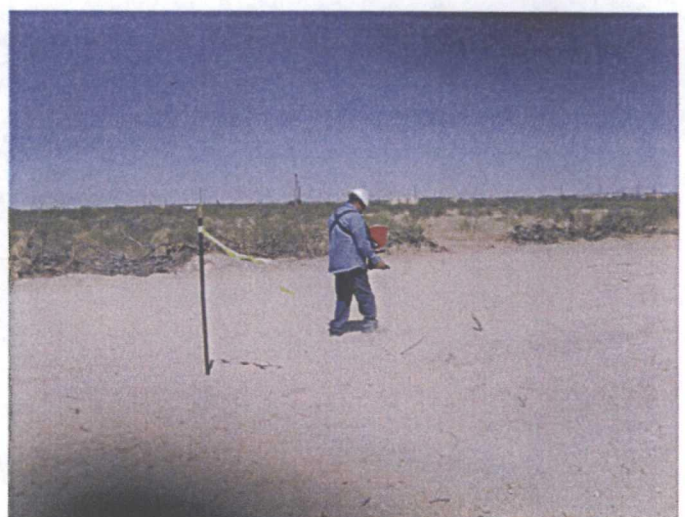
Seeding site, facing west  
5.3.11

the site was seeded with a blend of native vegetation and is expected to return to a productive capacity at a normal rate. NMOCD was
