From: Hansen, Edward J., EMNRD
Sent: Monday, June 11, 2012 4:06 PM
To: Hack Conder (hconder@riceswd.com)
Cc: Leking, Geoffrey R, EMNRD; Laura Pena (lpena@riceswd.com); Scott Curtis (scurtis@riceswd.com)
Subject: Remediation Plan (1R425-56) Termination - ROC Vacuum Jct N-33-1 Site

RE: Termination Request
Vacuum Jct. N-33-1 (1R425-56): UL/N, Sec. 33, T17S, R35E
RICE Operating Company – Vacuum SWD System

RICE OPERATING COMPANY
JUNCTION BOX FINAL REPORT

Vacuum Jct. N-33-1

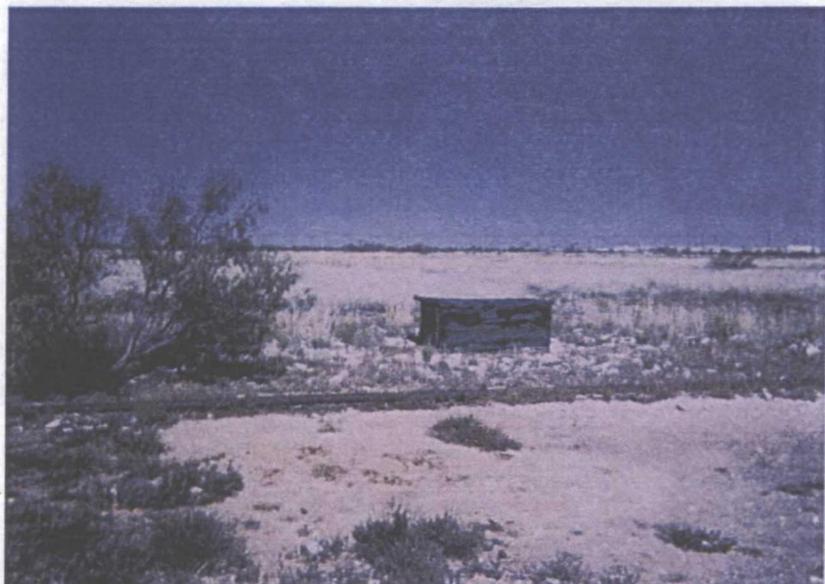
11/4/2005

undisturbed junction box

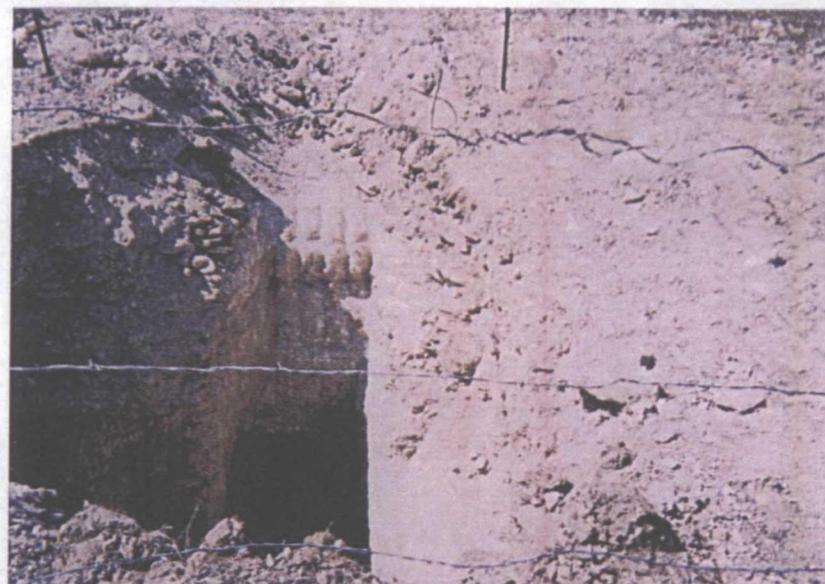
5/6/2008

delineation trench at former junction site

General Description of Remedial Action: This junction was eliminated during the Vacuum SWD system abandonment. After the former junction box was removed, an investigation was conducted using a backhoe to collect soil samples at regular intervals producing a 5x3x12-ft-deep excavation. Field data suggests the site is low in chloride and organic vapors, similar to that of the background. The deepest sample, 13 ft BGS, was sent to a commercial laboratory for analysis of chloride and TPH, which confirmed low

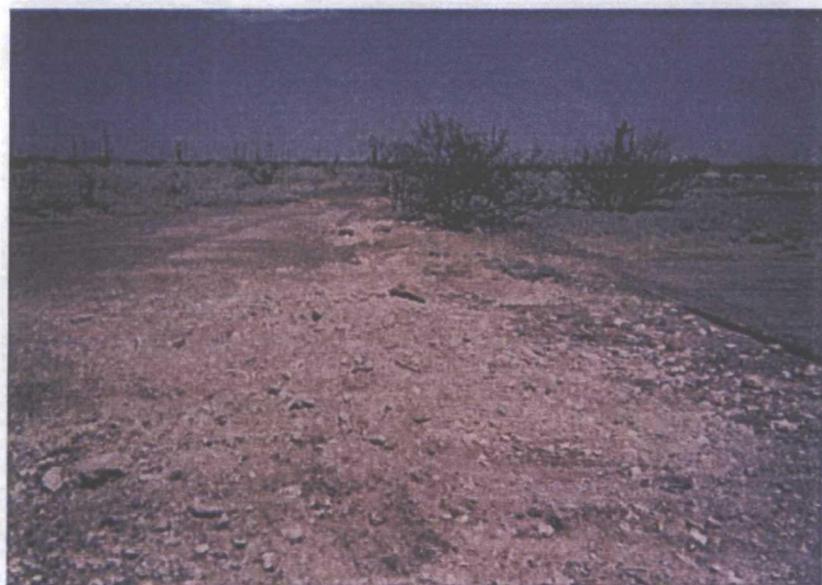
5/22/2008

backfilled excavation

concentrations. Clean soil was imported and used to backfill the excavation to ground surface and to contour the site to the surrounding area. On 5/22/2008, the site was seeded with a blend of native vegetation and is expected to return to a productive capacity at a normal rate.

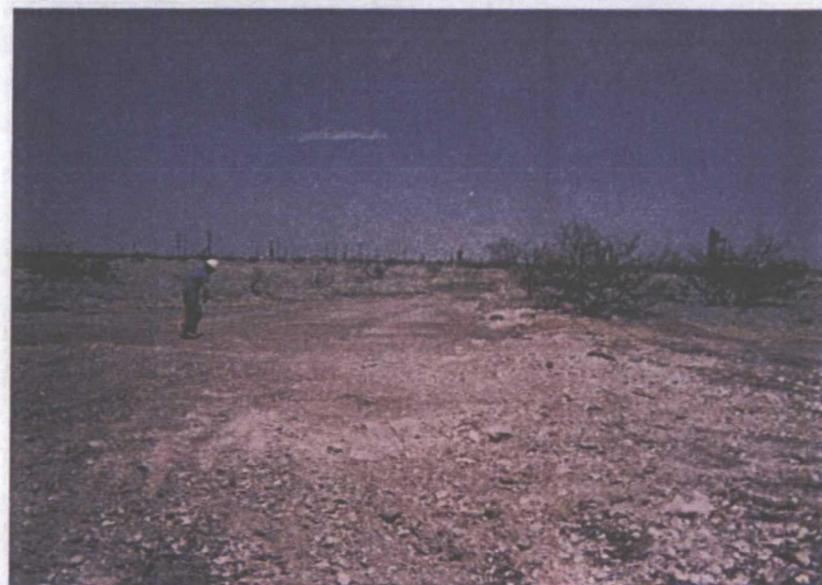
5/22/2008

seeding backfilled site
