1R - 427-316

**RE: Corrective Action Plan (CAP) for Groundwater
Rice Operating Company – EME SWD System
EME Jct. K-8-1 (1R427-316): UL/K sec. 8 T20S R37E
(formerly EME Jct. N-8-1)**

Corrective Action Plan for Groundwater

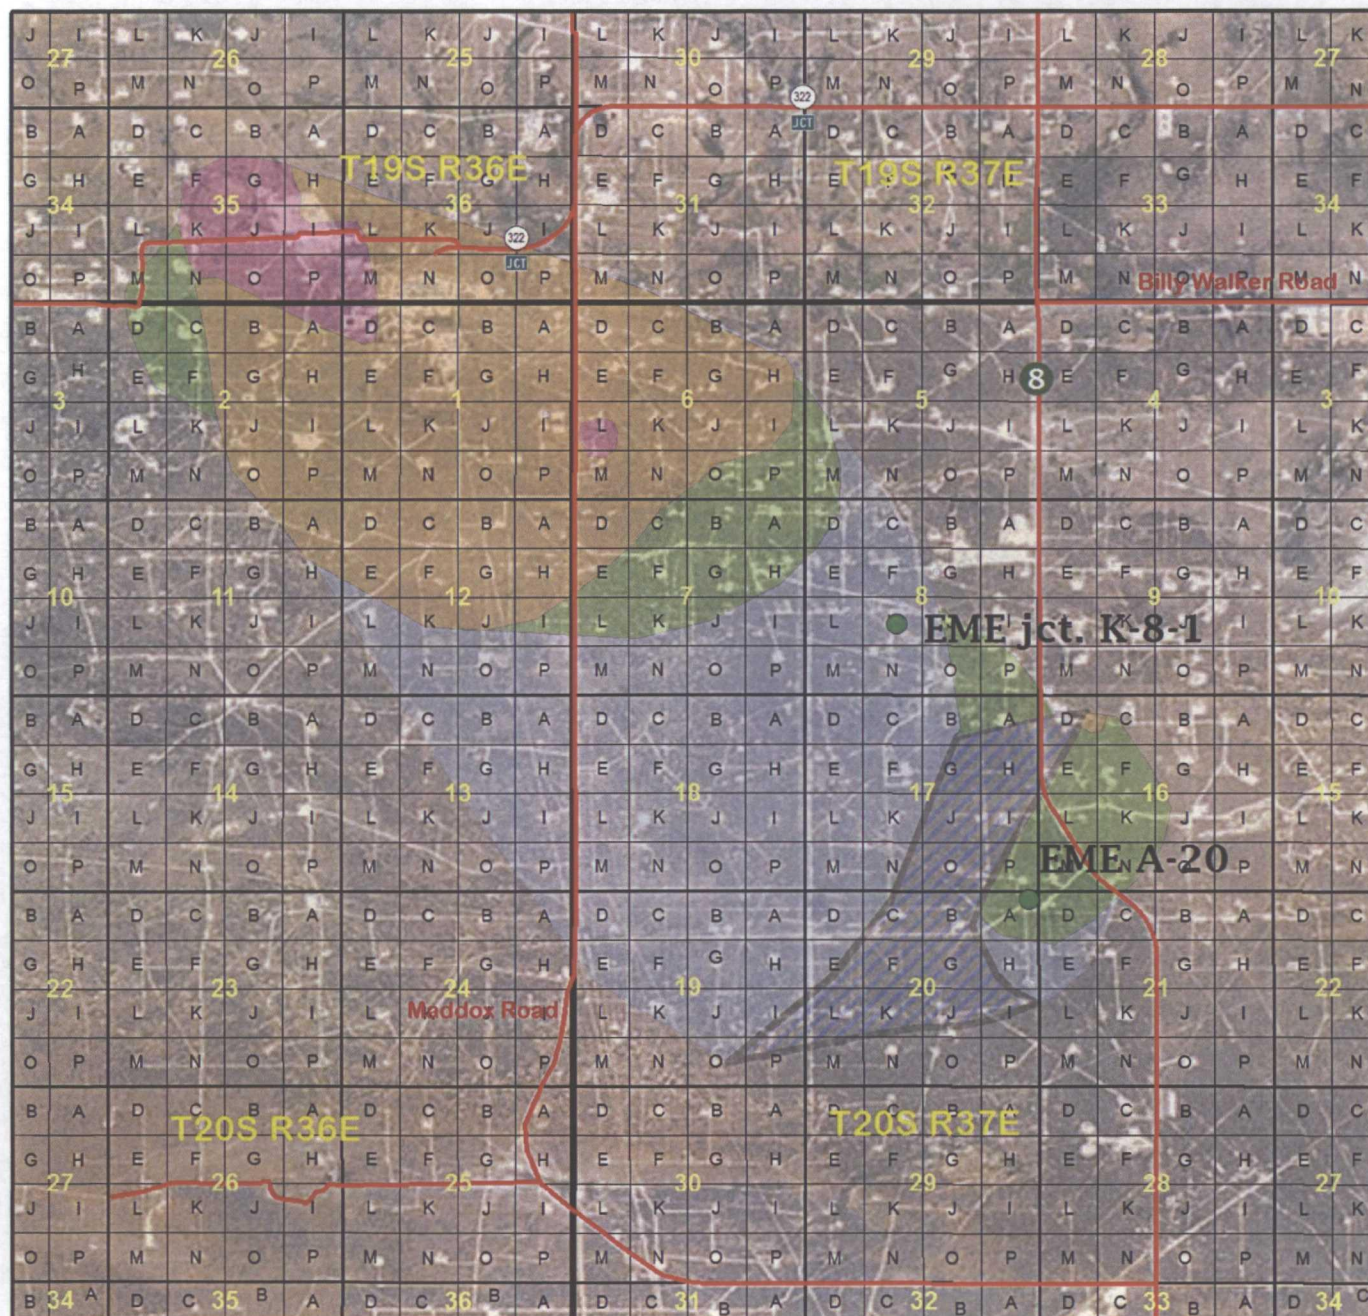
Hypothetical Cl ⁻ contamination area

This map was prepared for Rice Operating Company. This map represents the known chloride impact concentrations in the groundwater as of 2011. As conditions change and/or new monitor wells are added, the contamination plume will undergo permutations that will be reflected in future maps. Rice Operating Company does not assume any responsibility for the use of this information by others.

Therefore, ROC proposes to remove chloride impacted groundwater from the existing groundwater recovery system located at EME A-20. See Figure 3 for relationship of EME K-8-1 to EME A-20. Removed water will be used for pipeline and well maintenance. Our estimate conservatively reflects the net impact to groundwater at the site resulting from the former junction box site. It does not take into account other sources or regional conditions that may exist up gradient of the site.
