**RE: Termination Request
for the Rice Operating Company's
EME C-12-2 Site
Unit Letter C, Section 12, T20S, R36E, NMPM, Lea County, New Mexico
Remediation Plan (1R427-27) Termination**

RE: Termination Request
EME C-12-2 (1R427-27): UL/C Sec. 12, T20S, R36E
RICE Operating Company – Eunice Monument Eumont SWD System

**RICE OPERATING COMPANY
JUNCTION BOX FINAL REPORT**

EME C-12-2 (1R427-27)
Unit Letter C, Section 12, T20S, R36E

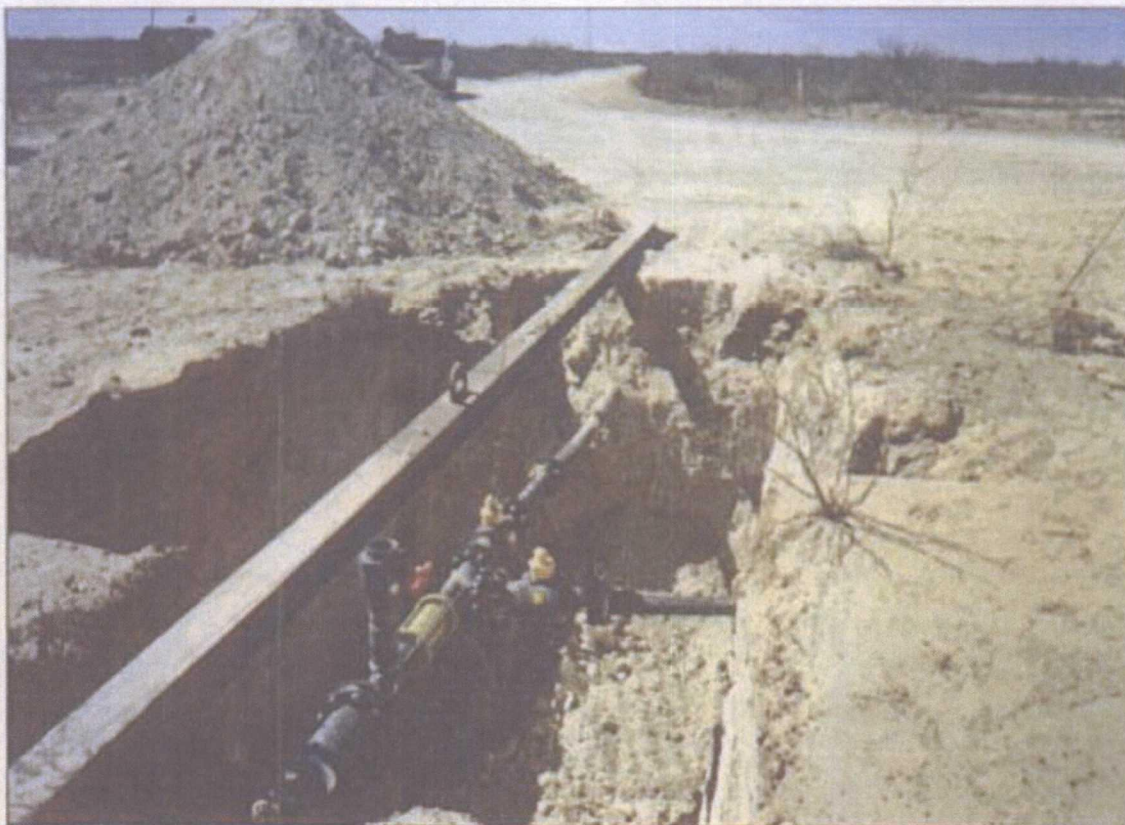
EME jct. C-12-2

General Description of Remedial Action: TPH ceased vertically at 6' bgs and chloride impact stopped at 8' bgs. The walls were extended as space allowed, producing a 8' x 18' x 8' excavation. The soil was landfarmed on site and then backfilled into the excavation. A water-tight junction box has been built over the location. The remediation activity is not considered a threat to groundwater, livestock, or public health. Any residual TPH is expected to naturally attenuate.

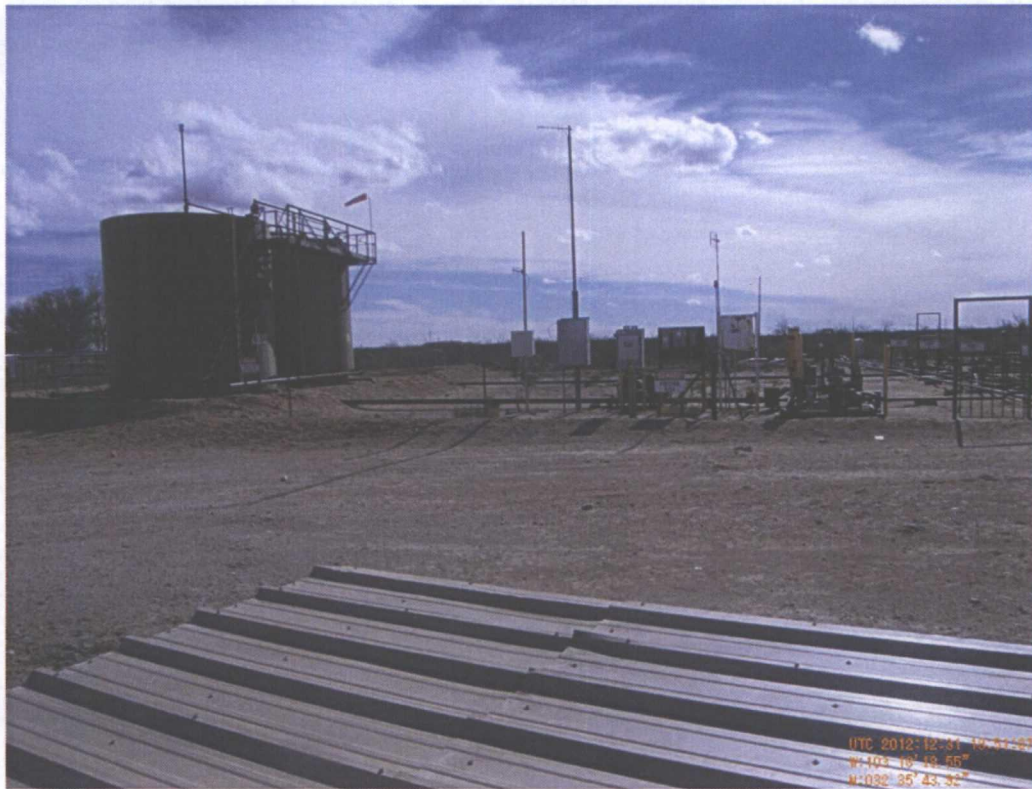
Facing South

was built over the same location. Since the site is located next to a lease road and facility, and a new box was built in the same place, seeding was not necessary.
