1R - 427-350

**RE: Termination Request  
for the Rice Operating Company's  
EME Jct H-29 Site  
Unit Letter H, Section 29, T19S, R37E, NMPM, Lea County, New Mexico  
Remediation Plan (1R427-350) Termination**

RE: Termination Request  
EME Jct. H-29 (1R427-350): UL/H, Sec. 29, T19S, R37E  
RICE Operating Company – Eunice Monument Eumont SWD System

**RICE OPERATING COMPANY  
JUNCTION BOX FINAL REPORT**

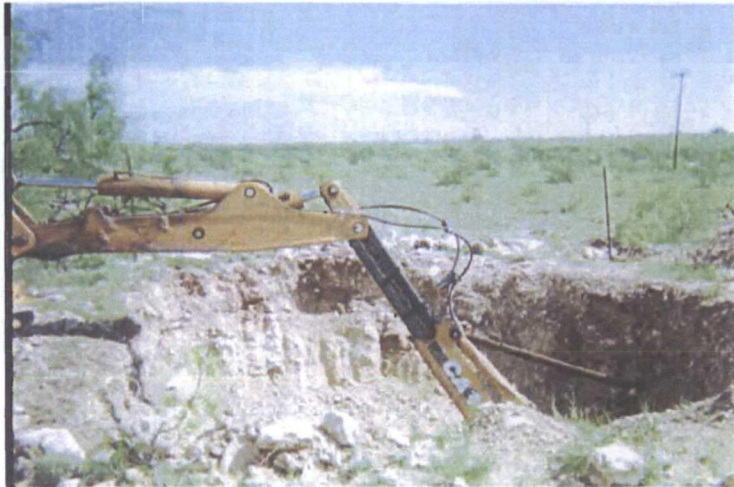
DELINEATION TRENCH BEING EXCAVATED

6/8/2010

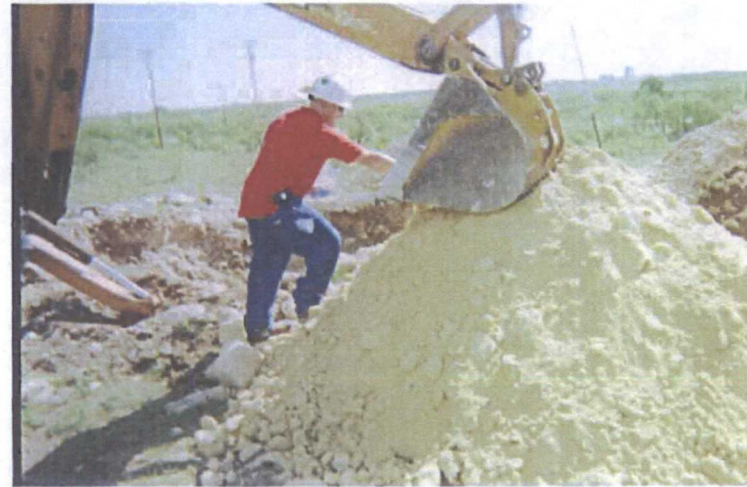
SAMPLING SOURCE

6/8/2010

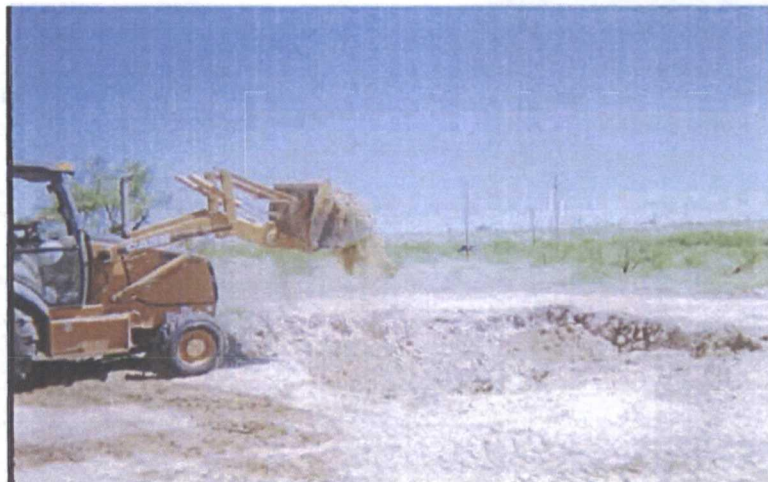
BACKFILLING EXCAVATION

8/2/2010

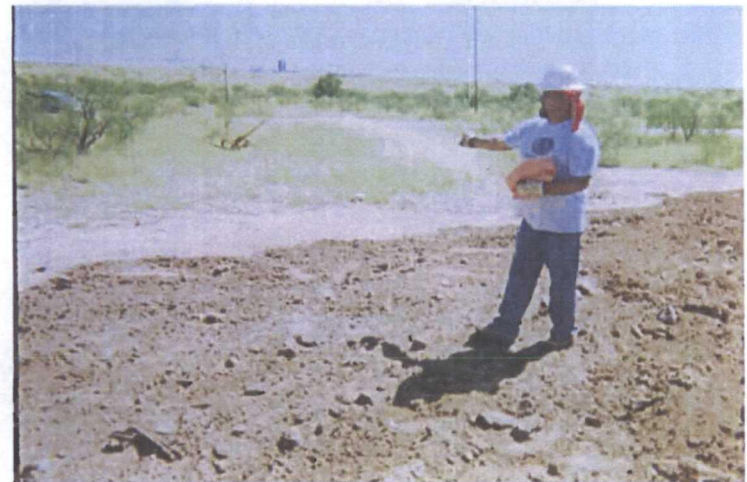
SEEDING EXCAVATION

8/23/2010

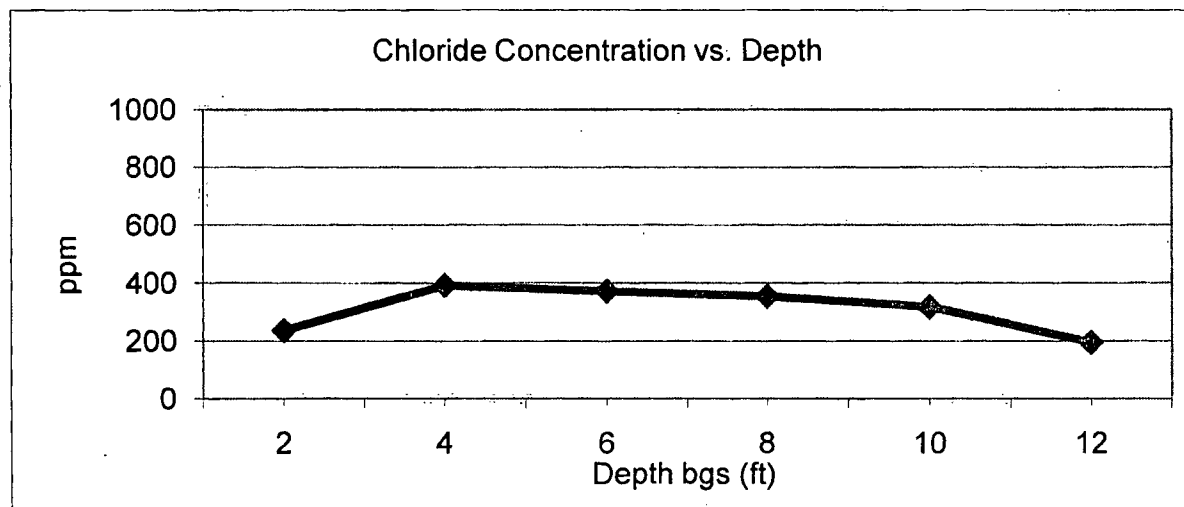
## CHLORIDE CONCENTRATION CURVE

*Delineation 15' East of Source*

Depth bgs (ft)	[Cl] ppm
2	237
4	392
6	372
8	355
10	318
12	196

Groundwater = 23 ft

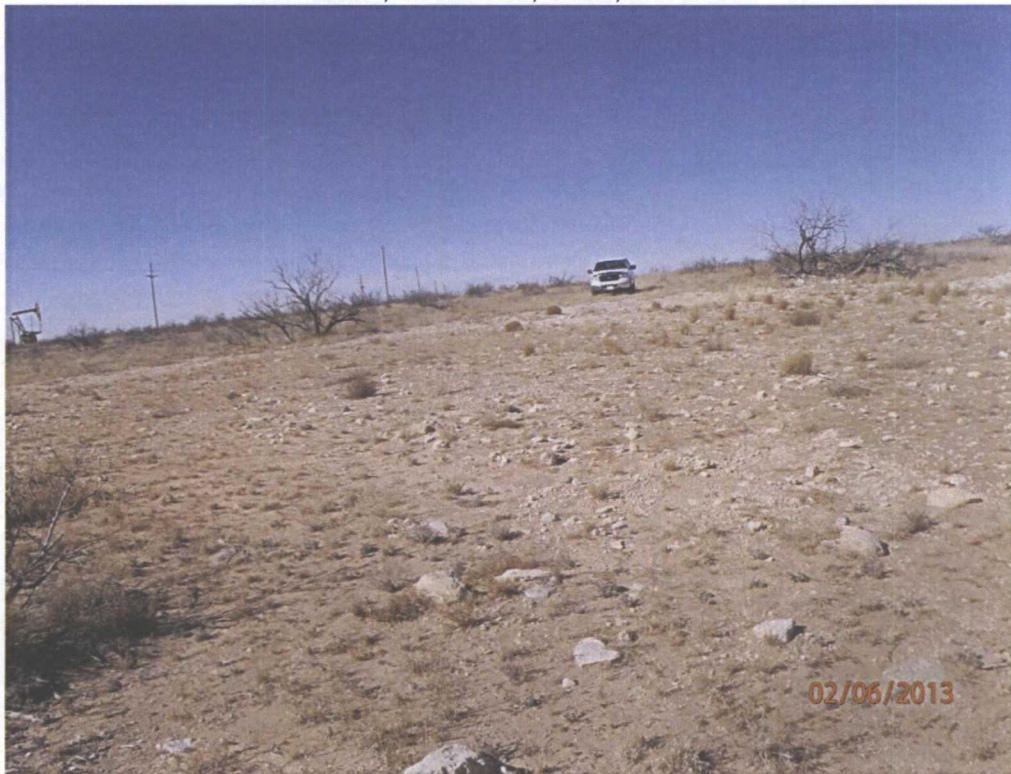
Facing west

2/6/2013

junction box is no longer needed at the site. Vegetation has rebounded at the site, so no re-vegetation efforts are needed.

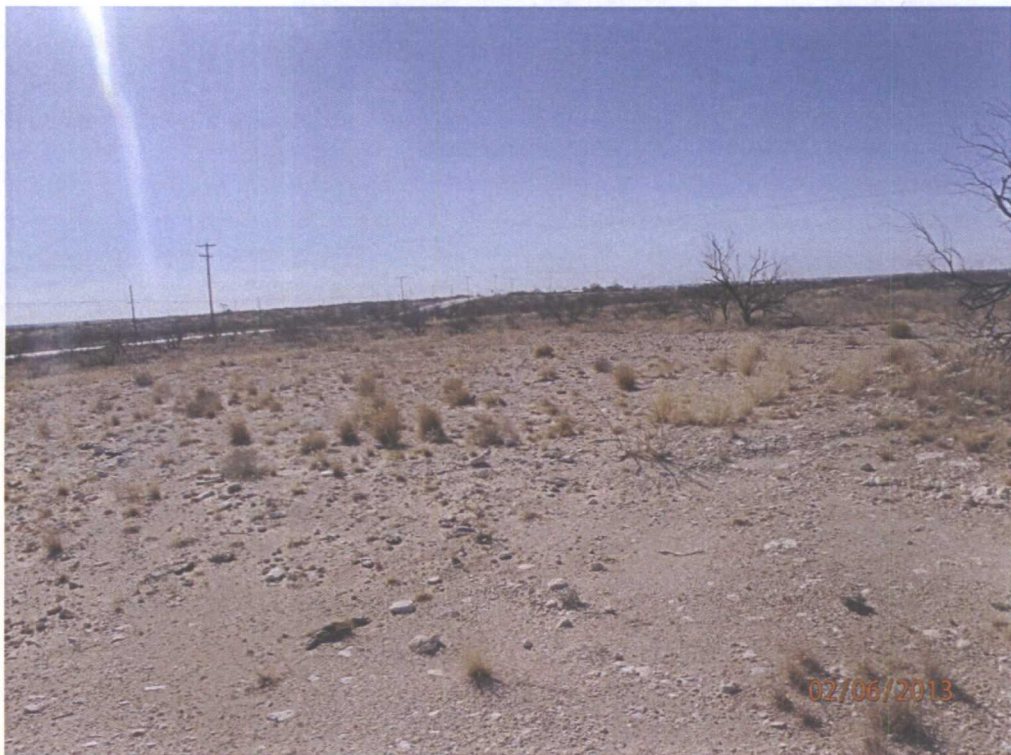
Facing south

2/6/2013
