**RE: Termination Request
for the Rice Operating Company's
EME P-25 EOL Site
Unit Letter P, Section 25, T20S, R36E, NMPM, Lea County, New Mexico
Remediation Plan (1R427-328) Termination**

RE: Termination Request
EME P-25 EOL (1R427-328): UL/P, Sec. 25, T20S, R36E
RICE Operating Company – Eunice Monument Eumont SWD System

**RICE OPERATING COMPANY
JUNCTION BOX FINAL REPORT**

EME P-25 EOL

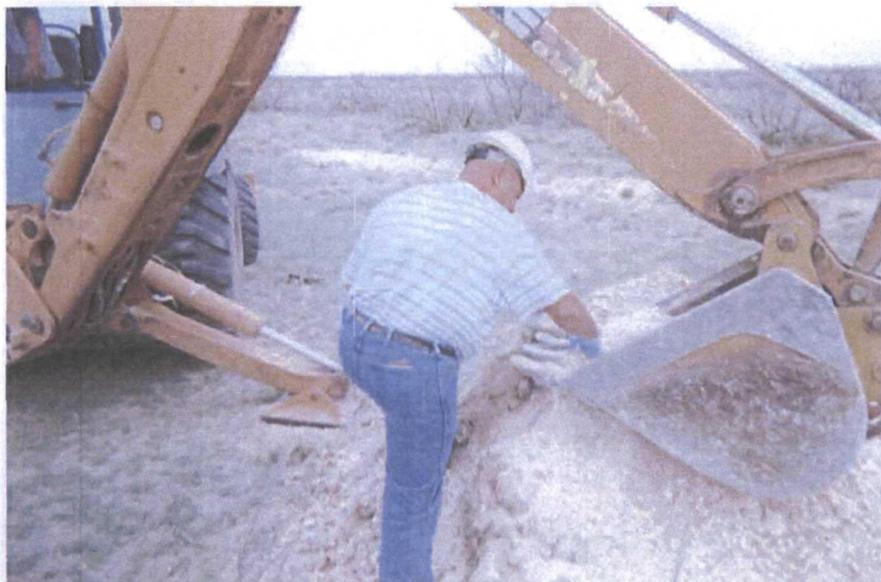
4/13/10

Sampling the source

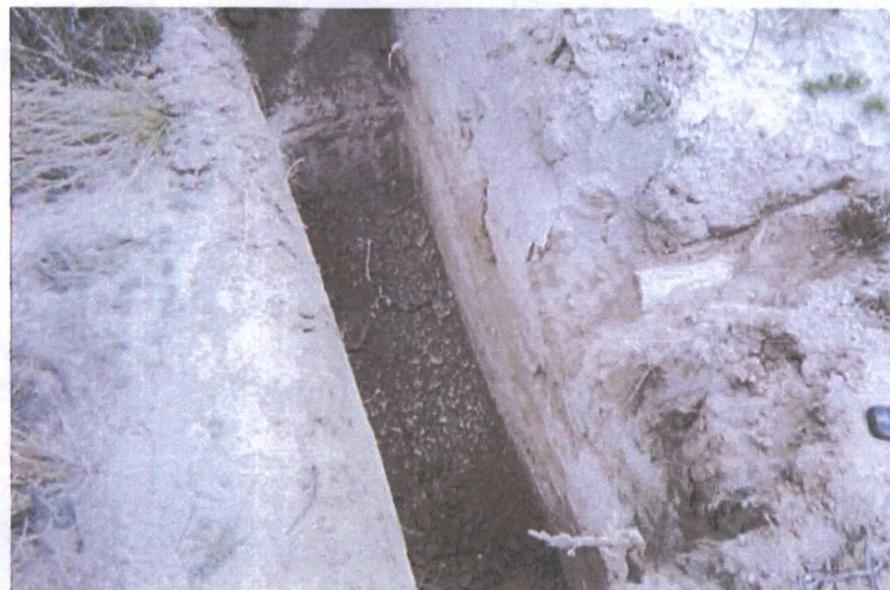
4/13/10

Final excavation

General Description of Remedial Action: This junction and line were eliminated during the pipeline replacement/upgrade program. After the former junction box was removed, an investigation was conducted using a backhoe to collect soil samples at regular intervals producing a 5X3X6-ft-deep excavation. Chloride field tests performed on each sample yielded low concentrations similar to that of the background. Organic vapors were measured using a PID, which also yielded low concentrations. The deepest sample, 6 ft BGS was sent to a commercial laboratory for analysis of chloride and TPH, which confirmed low concentrations. The excavated soil was returned to the excavation to ground surface and contoured to the surrounding area. On 4/13/2010, the site was seeded with a blend of native vegetation and is expected to return to a productive capacity at a normal rate.

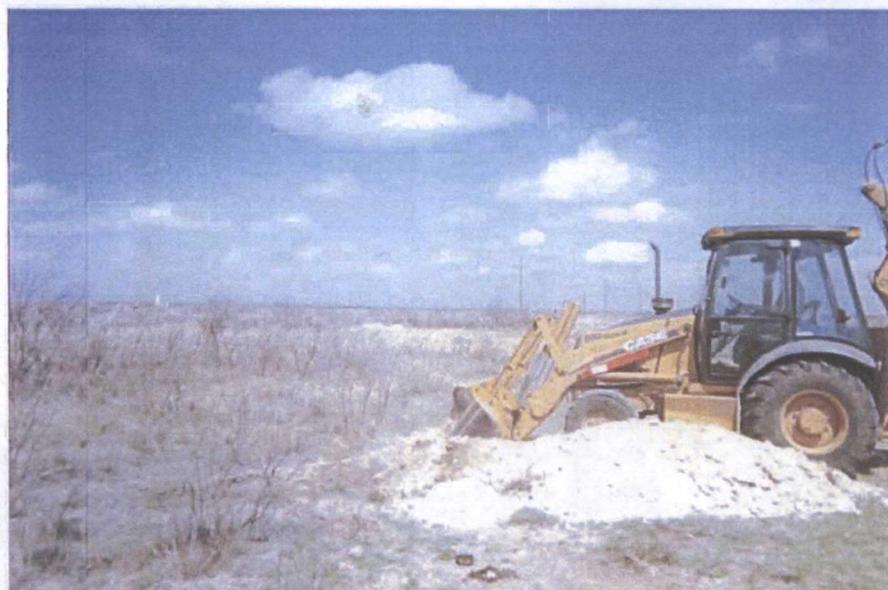
4/13/10

Backfilling excavation

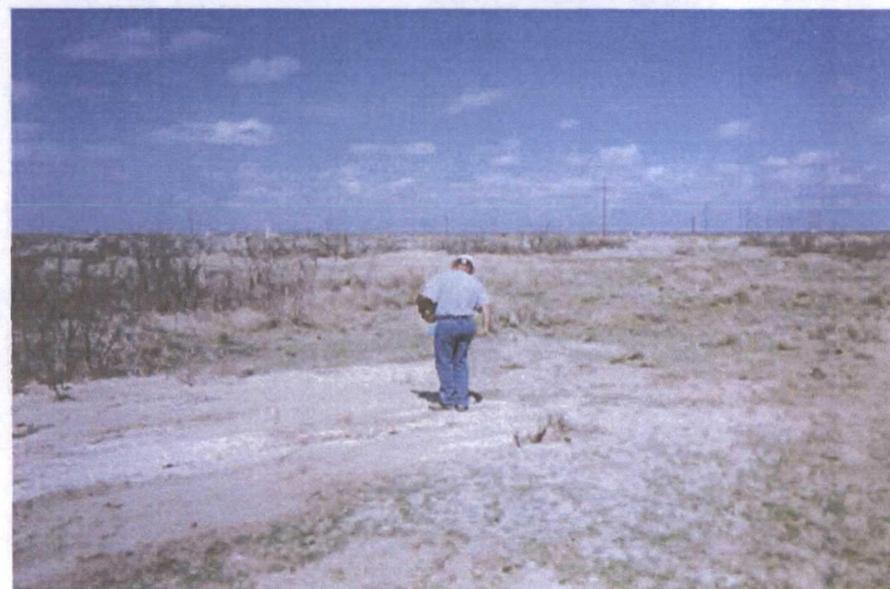
4/13/2010

Seeding excavation

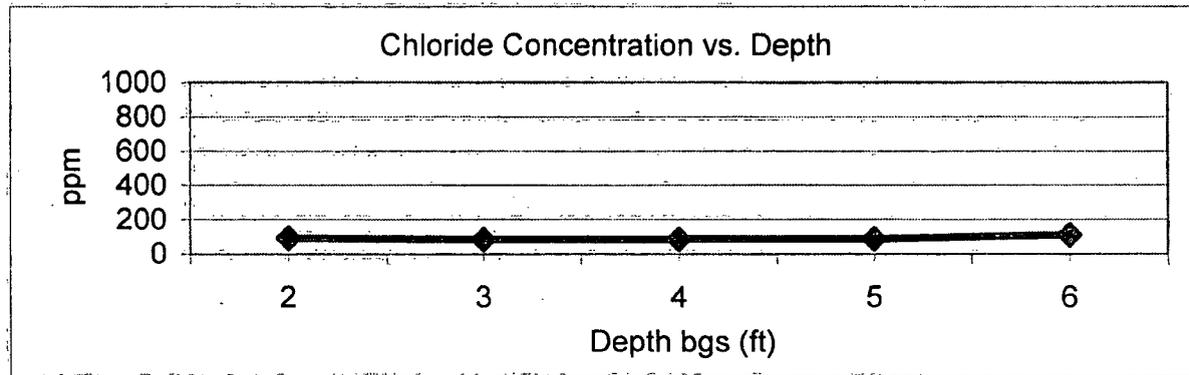
CHLORIDE CONCENTRATION CURVE

Backhoe samples at the junction (source)

Depth bgs (ft)	[Cl ⁻] ppm
2	95
3	85
4	87
5	89
6	113

Groundwater = 106 ft

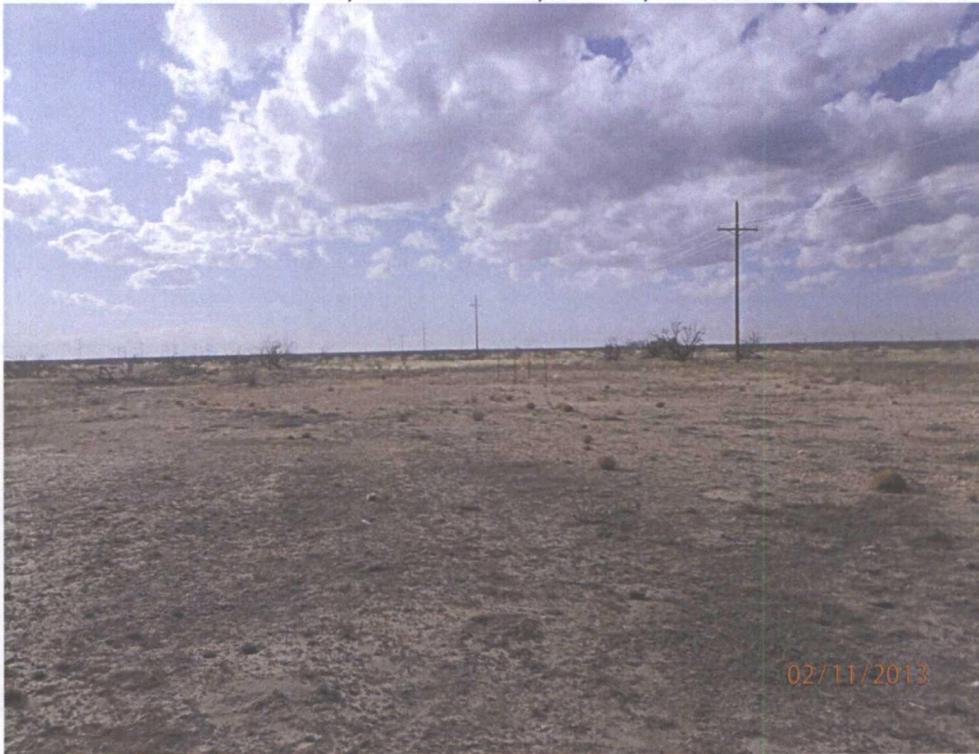
2/11/2013

Facing west

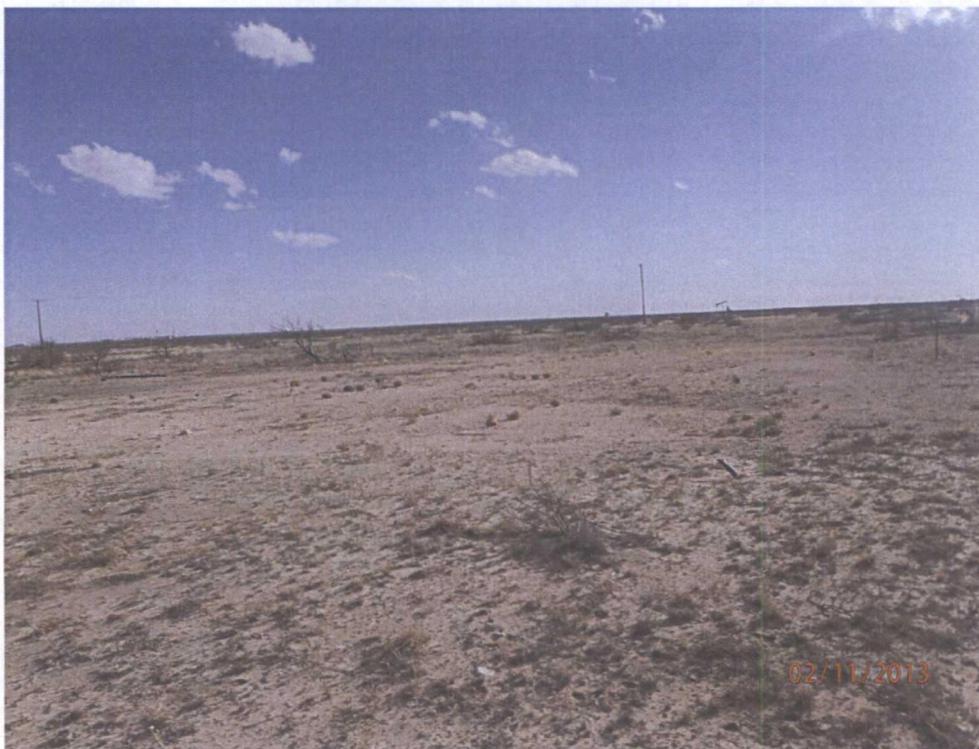
2/11/2013

Facing south
