**Subject:** Remediation Plan (1R427-321) Termination - ROC EME Jct N-13 Site

**EME Jct N-13 Site**

Remediation Plan (1R427-321) Termination

EME Jct. N-13 (1R427-321): UL/N, Sec. 13, T20S, R36E

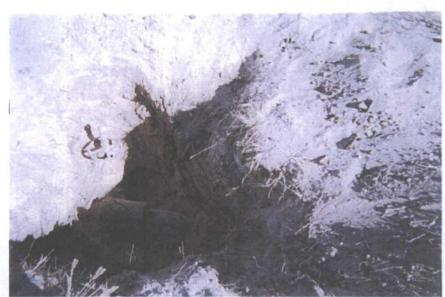
11/23/2010

Site prior to delineation

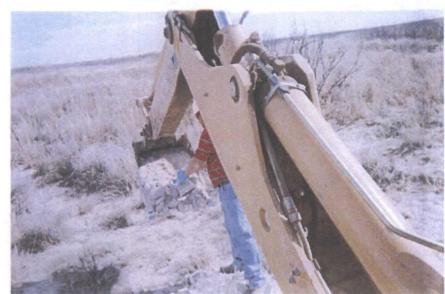
11/24/2010

Collecting sample

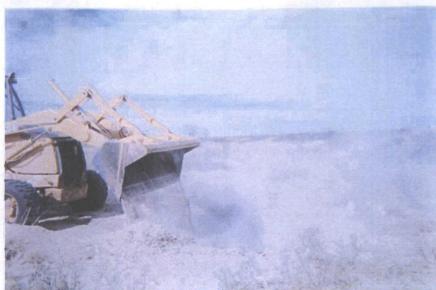
11/24/2010

Backfilling site

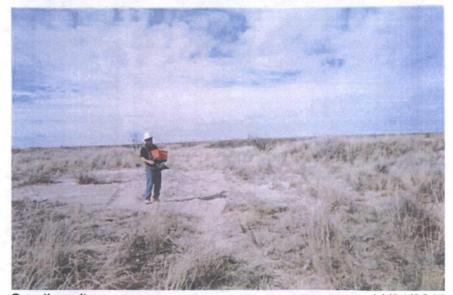
11/24/2010

Seeding site

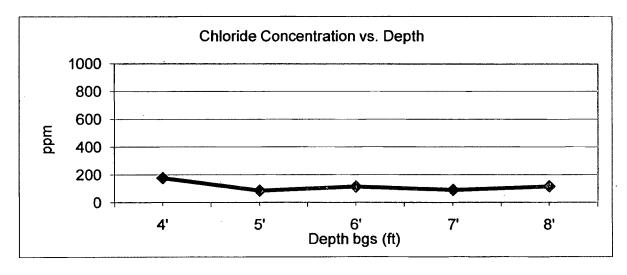
Backhoe samples at the junction (source)

Depth bgs (ft)	[Cl] ppm
4'	177
5'	85
6'	114
7'	90
8'	116

Groundwater = 29 ft

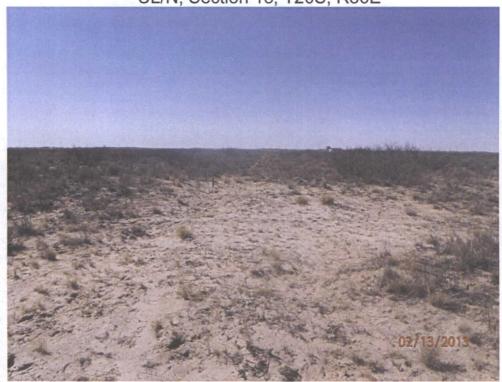
Facing south 2/13/2013

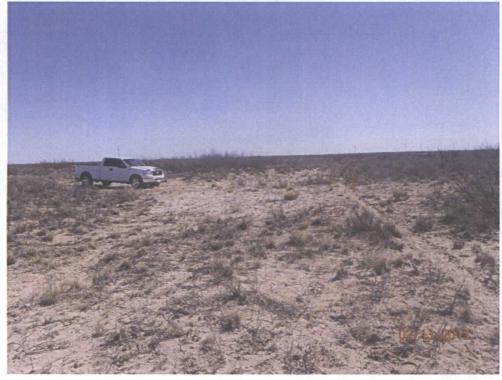
Facing east 2/13/2013
