From: Hansen, Edward J., EMNRD
Sent: Thursday, March 14, 2013 4:09 PM
To: Hack Conder (hconder@riceswd.com)
Cc: Leking, Geoffrey R, EMNRD; Laura Pena (lpena@riceswd.com); Katie Jones <kjones@riceswd.com> (kjones@riceswd.com); Scott Curtis (scurtis@riceswd.com)
Subject: Remediation Plan (1R427-325) Termination - ROC EME I-20 EOL Site

RE: Termination Request
EME I-20 EOL (1R427-325): UL/I, Sec. 20, T19S, R37E
RICE Operating Company – Eunice Monument Eumont SWD System

**EME I-20 EOL
(1R427-325)**

RICE OPERATING COMPANY
JUNCTION BOX FINAL REPORT

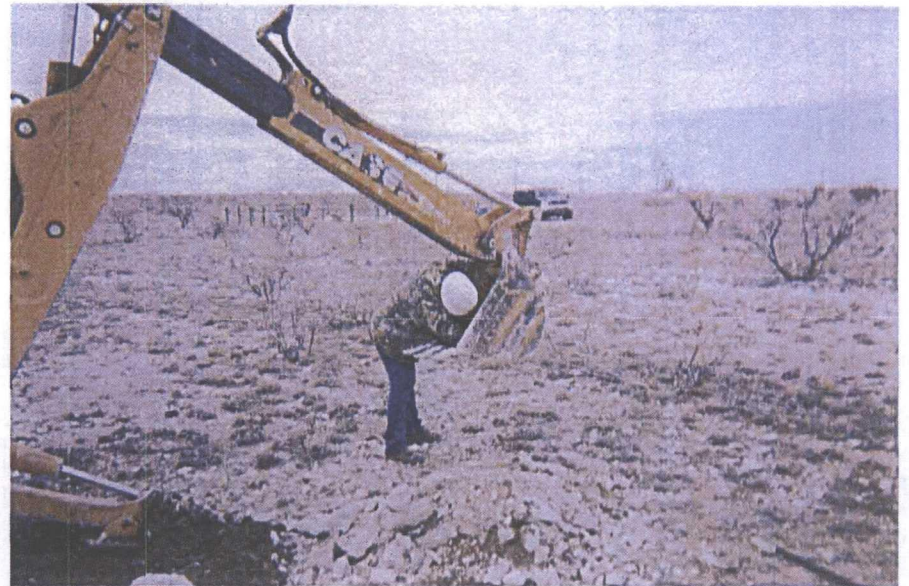
2/25/2010

Sample being taken

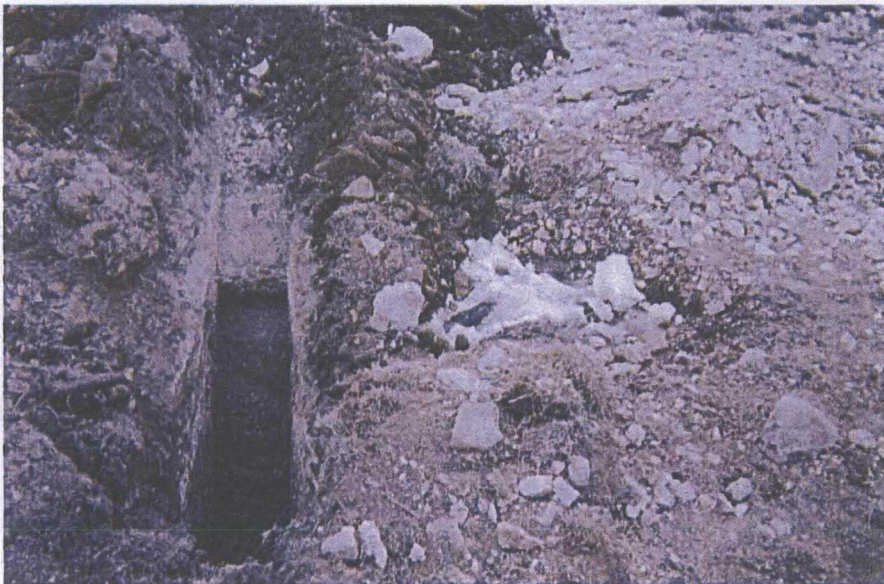
2/25/2010

Final excavation

analysis, which confirmed low concentrations of chloride and organics. The excavated soil was returned to the excavation to ground

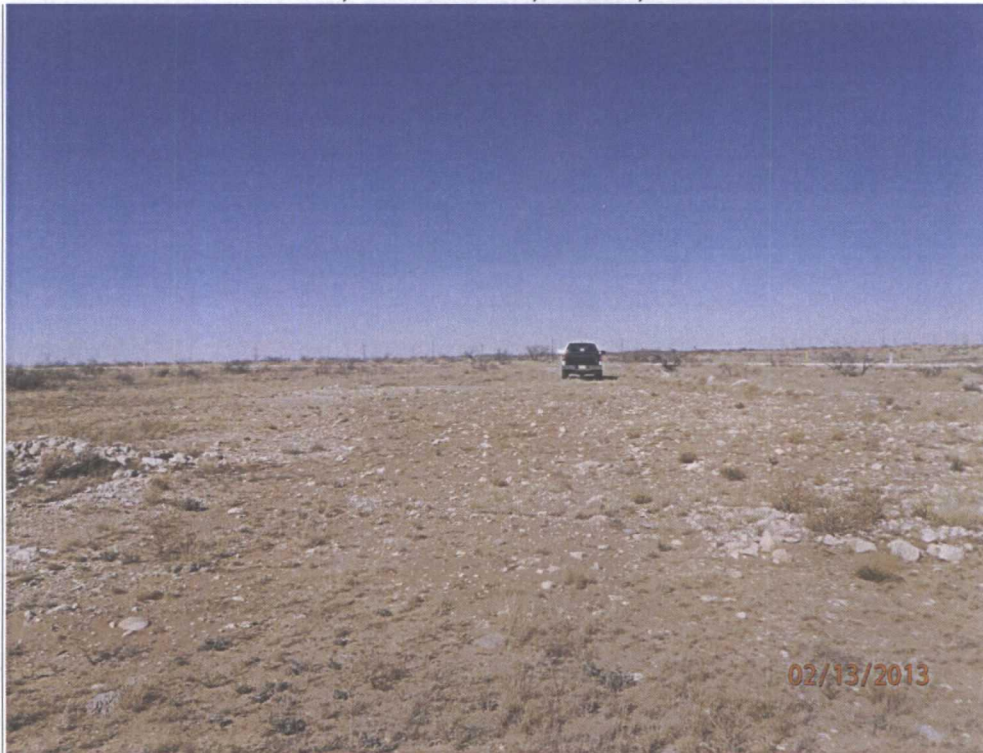
2/13/2013

Facing north

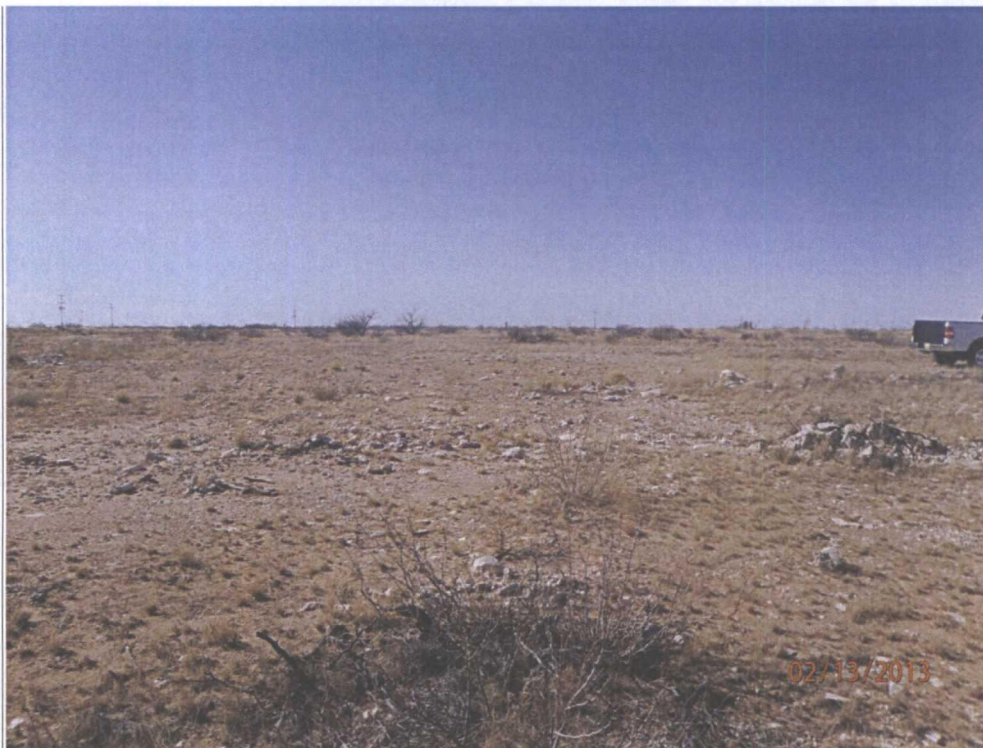
2/13/2013

Facing west
