**RE: Termination Request
for the Rice Operating Company's
EME Jct F-10 Site
Unit Letter F, Section 10, T21S, R36E, NMPM, Lea County, New Mexico
Remediation Plan (1R427-338) Termination**

RE: Termination Request
EME Jct. F-10 (1R427-338): UL/F, Sec. 10, T21S, R36E
RICE Operating Company – Eunice Monument Eumont SWD System

**RICE OPERATING COMPANY
JUNCTION BOX FINAL REPORT**

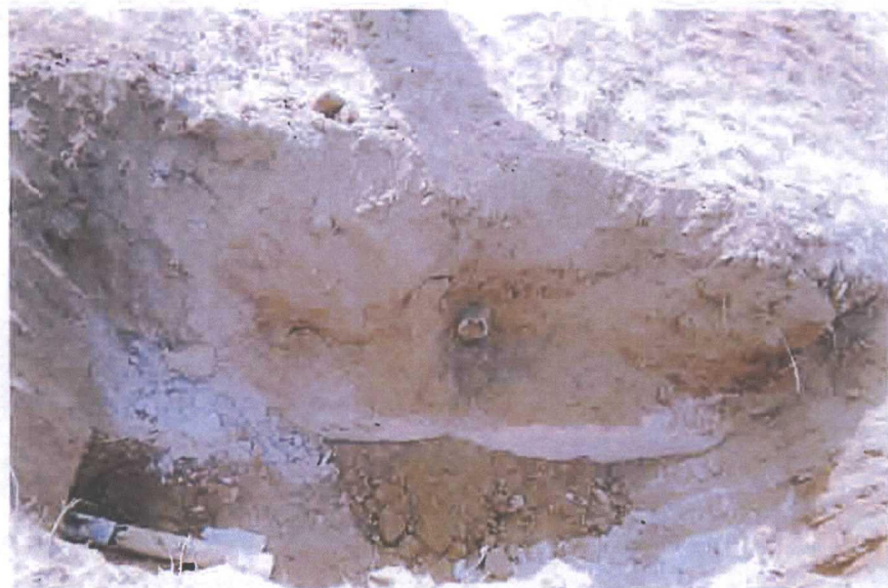
10/15/2010

Site prior to delineation

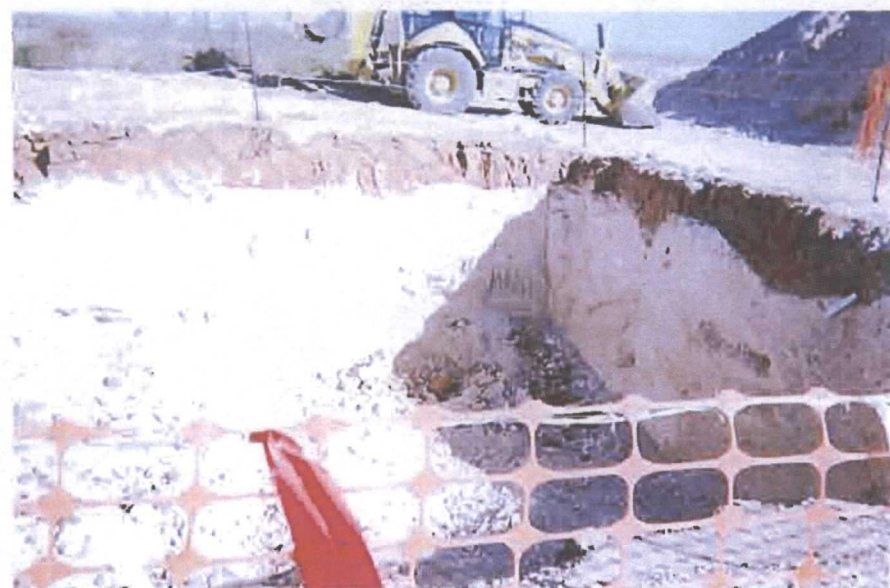
10/26/2010

Final Excavation

during the pipeline replacement/upgrade program. After the former junction box was removed, an investigation was conducted using a backhoe to collect soil samples at regular intervals creating a 30X30X12-ft. deep excavation. Chloride field test performed on each sample yielded chloride concentrations that did not relent with depth. Organic vapors were measured using a PID, which yielded some elevated concentrations. 286 yards of excavated soil was hauled to a NMOCD approved facility. The remaining excavated soil was blended on site and representative samples were collected from the blended backfill, the bottom of the excavation, and excavation walls. The representative samples were sent to a commercial laboratory for analysis of chloride, TPH, and BTEX.

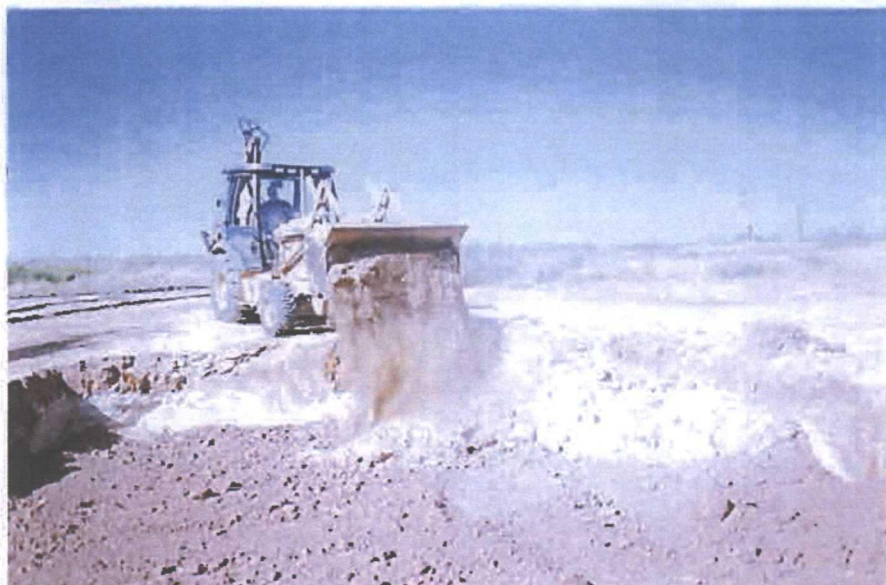
11/8/2010

Backfilling excavation above clay liner

At 5-4 ft., a 1-ft. thick clay barrier was installed with compaction test performed on 11/08/2010. The remaining excavation was backfilled using the blended backfill to 2 ft. BGS and the remaining excavation was backfilled with clean imported soil to ground surface and contoured to the surrounding area. On 11/11/2010, the site was seeded with a blend of native vegetation and is expected to return to a productive capacity at a normal rate. An identification plate was placed on the surface of the former junction box site to mark the presence of clay below. To further investigate the depth of chloride presence, a soil bore was initiated on 11/18/2010 at 15 ft. east of the former junction box. The boring was advanced to a depth of 35 ft. BGS with soil samples collected every 5 ft. between 15-35 ft. Chloride field test performed on each sample yielded chloride concentrations that did relent with depth. Organic vapors were measured using a PID, which yielded low concentrations. The 20 ft. and 35 ft. sample were sent to a commercial laboratory for analysis of chloride and TPH. The entire bore was plugged with bentonite to ground surface.

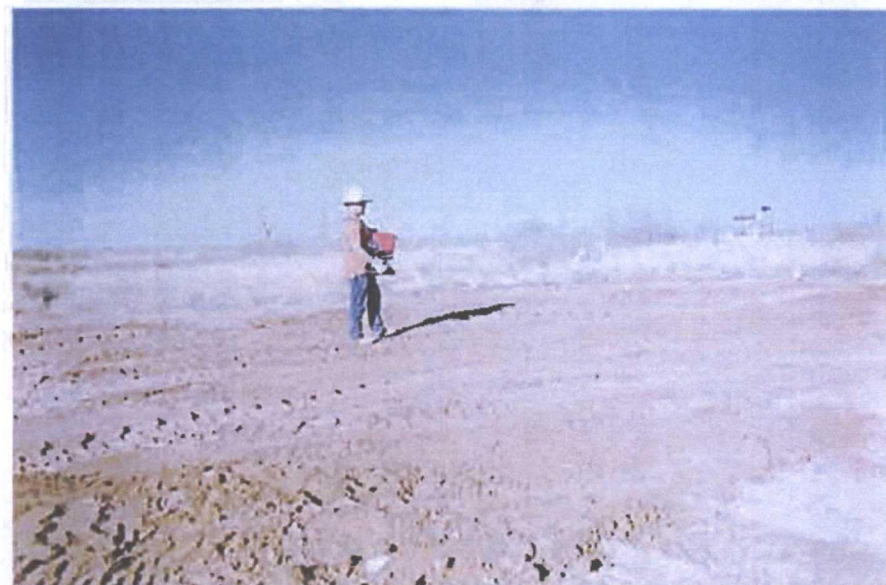
11/11/2010

Seeding site

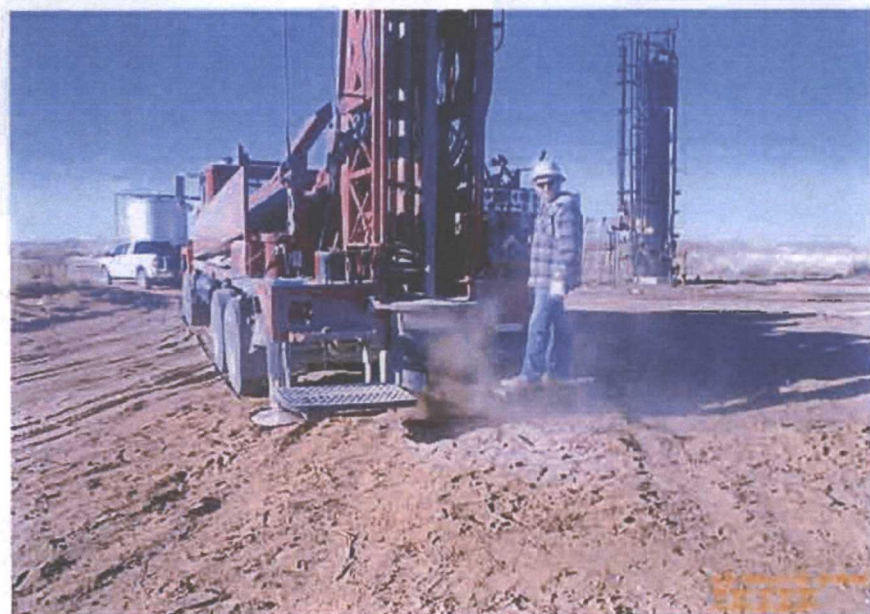
11/18/2010

Installing Soil Bore

To further investigate the depth of chloride presence, a soil bore was initiated on November 18, 2010 at 15 ft east of the former junction box site. The boring was advanced to a depth of 35 ft BGS with soil samples collected every 5 ft. Each sample was field titrated for chlorides and field screened using a PID for hydrocarbons, resulting in concentrations that did not vary with depth. The 20 ft and 35 ft samples were sent to a commercial laboratory for analysis. The 15 ft sample resulted in a chloride concentration of 2,280 mg/kg and GRO and DRO concentrations below detectable limits. The 35 ft sample resulted in a chloride concentration of 128 mg/kg and GRO and DRO concentrations below detectable limits. The entire bore hole was plugged with bentonite to ground surface.

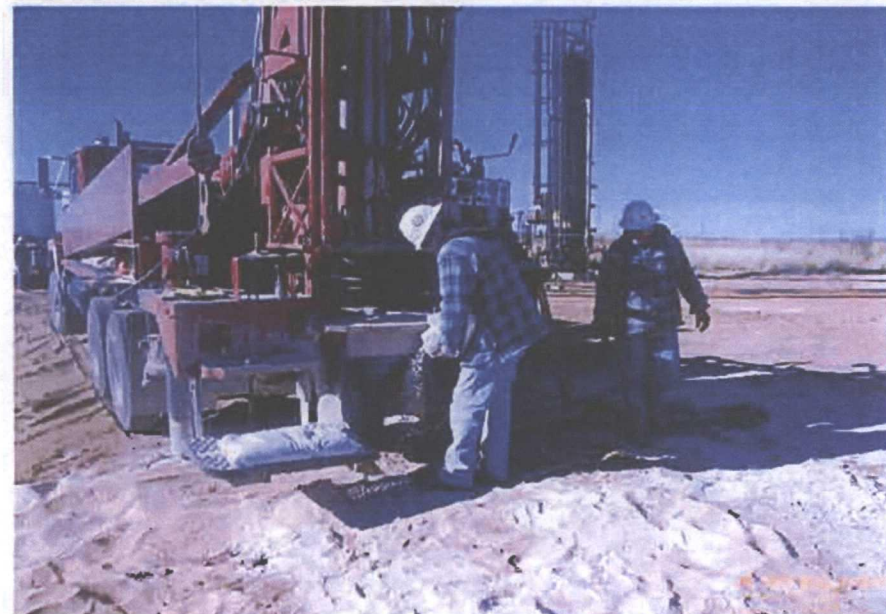
11/18/2010

Plugging the soil bore with bentonite

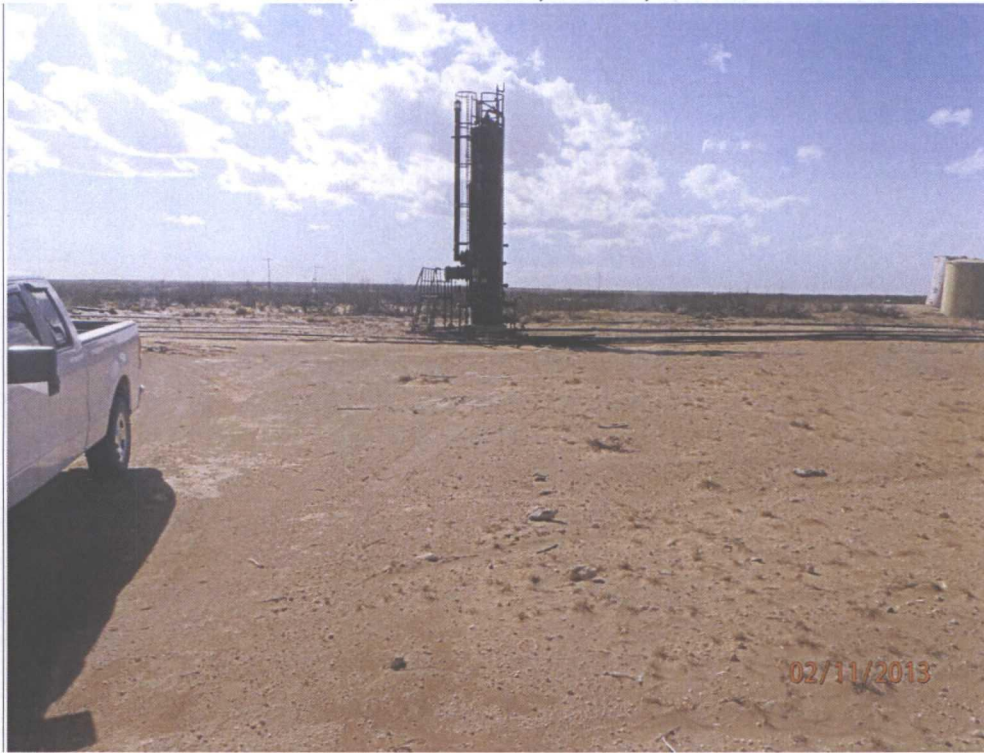
2/11/2013

Facing west

A junction box is no longer needed at the site. The site is adjacent to a working lease road and facility, so no re-vegetation efforts are needed.

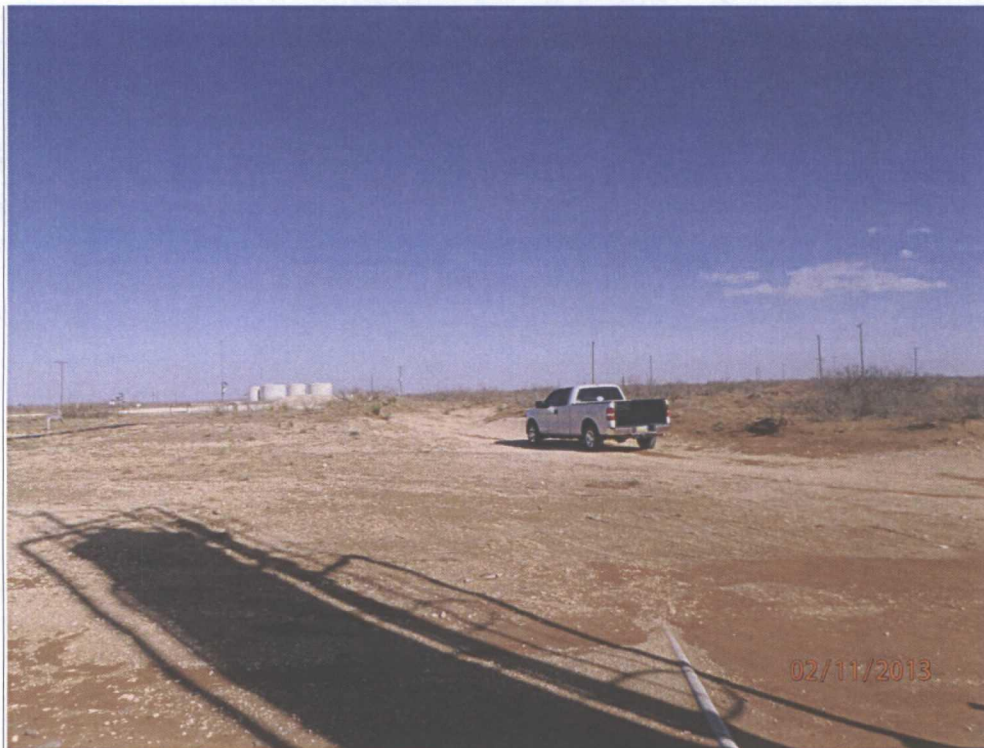
2/11/2013

Facing east
