**RE: Termination Request
for the Rice Operating Company's
EME Jct C-13 Site
Unit Letter C, Section 13, T20S, R36E, NMPM, Lea County, New Mexico
Remediation Plan (1R427-365) Termination**

**Corrective Action Plan (CAP) Report and Termination Request
EME Jct. C-13
Unit C, SEC. 13, T20S, R36E, Monument, Lea County, New Mexico
NMOCD CASE # 1R427-365**

**EME Jct. C-13 (1R427-365)
Unit C, Section 13, T20S, R36E**

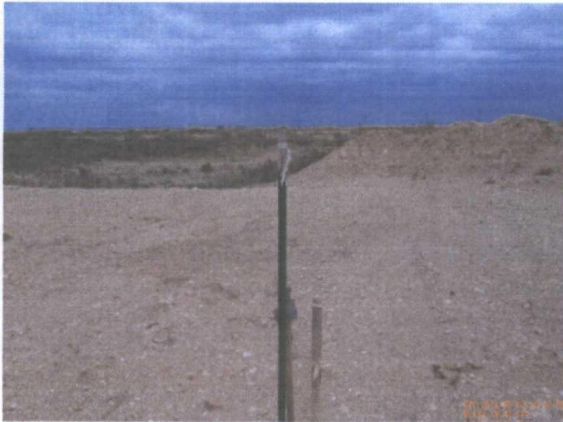
Site prior to scraping, facing north
5/7/2012

As proposed in the CAP dated September 4, 2012 and subsequent Addendum, which was approved by NMOCD on September 18, 2013, the site was scraped to a depth of 6 inches to one foot, backfilled with clean soil, and seeded with native vegetation. CAP activities were conducted from November 20 through December 17, 2012. The spoil pile (a total of 396 cubic yards) was transported to Sundance Services for disposal. A total of 144 cubic yards of imported topsoil was spread at the site. A composite sample of the imported topsoil was analyzed by a commercial laboratory, resulting in a chloride concentration below detectable limits and a PID (field) reading of 0.0 ppm. The site was then seeded with 12 pounds of Blue Grama grass and 6 pounds of winter wheat. Photographs of CAP activities, revegetation form, and laboratory data and photoionization detector documentation of imported clean soil is attached.

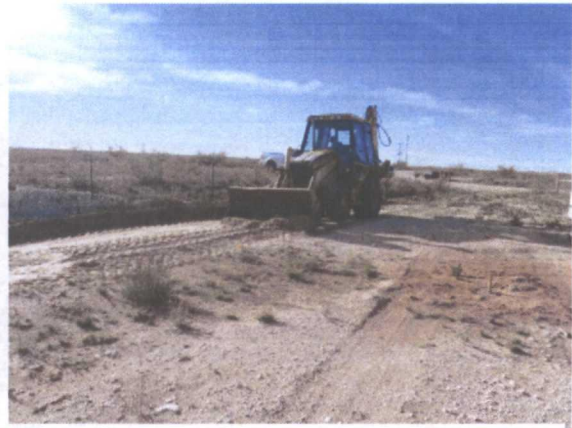
Scraping site, facing south
11/20/2012

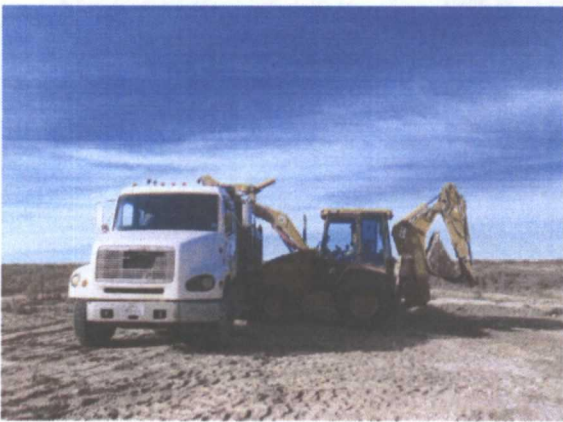
Exporting soil, facing north
11/20/2012

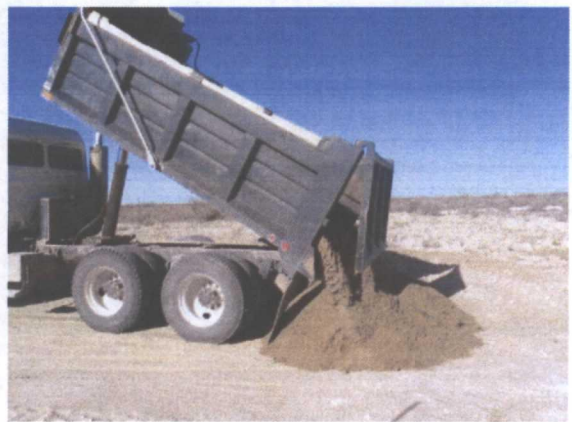
Importing soil, facing west
12/13/12

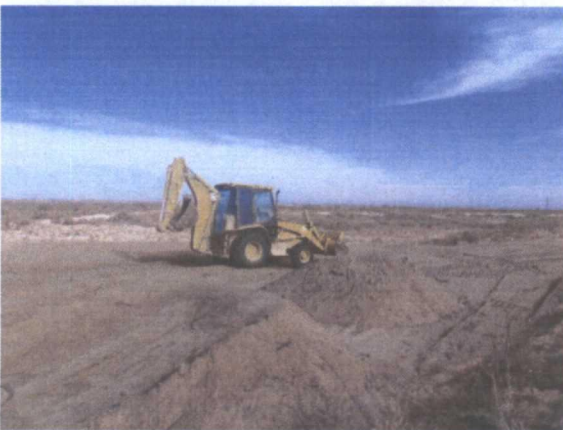
Contouring the site, facing north
12/14/2012

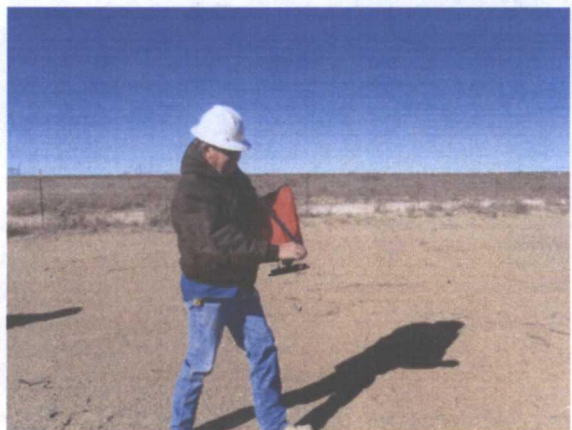
Seeding the site, facing west
12/17/2012

Custom seed mix <input checked="" type="checkbox"/>	Prescribed mix <input type="checkbox"/>	Seed mix name: 12 lbs Blue Grama 6 lbs Winter Rye	Seeding date: 12/17/2012
Broadcast <input checked="" type="checkbox"/>			
Method: Mechanical Hand Seeder			
Soil conditions during seeding: Dry <input checked="" type="checkbox"/> Damp <input type="checkbox"/> Wet <input type="checkbox"/>			
Photos attached <input type="checkbox"/>	Observations:		
Number of photos:
